Property Condition Assessment

Sykes Realty Call Centers – Pikeville, Kentucky

55 Sykes Boulevard
Pikeville, KY 41501

RE: PROPERTY CONDITION ASSESSMENT
Sykes Realty Call Centers – Pikeville, Kentucky
55 Sykes Boulevard
Pikeville, KY 41501
Vannoy & Associates Project No. V285-001

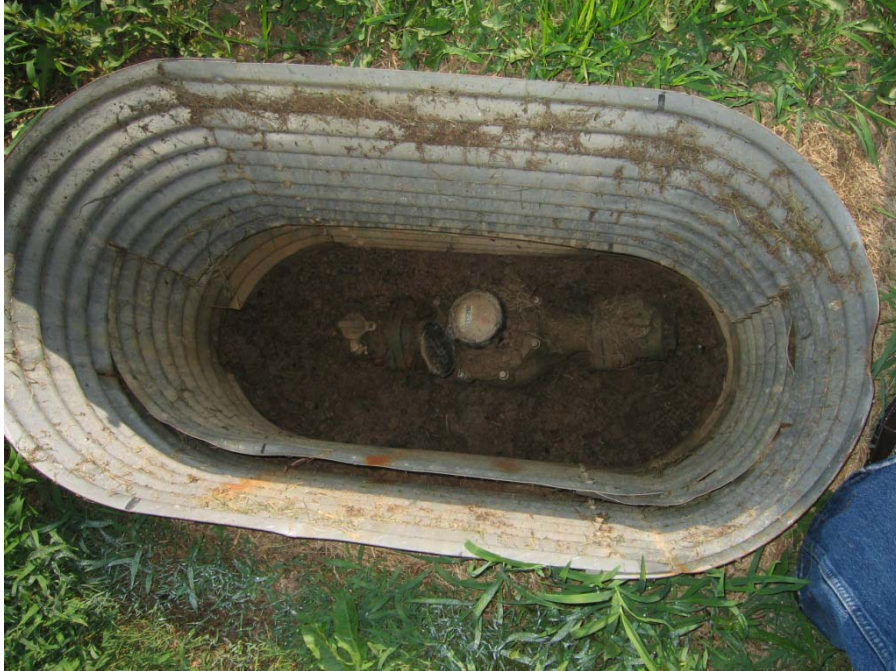
Photograph 43

43. View of the water meter.
44. View of the hot water heater located in the janitor's closet.

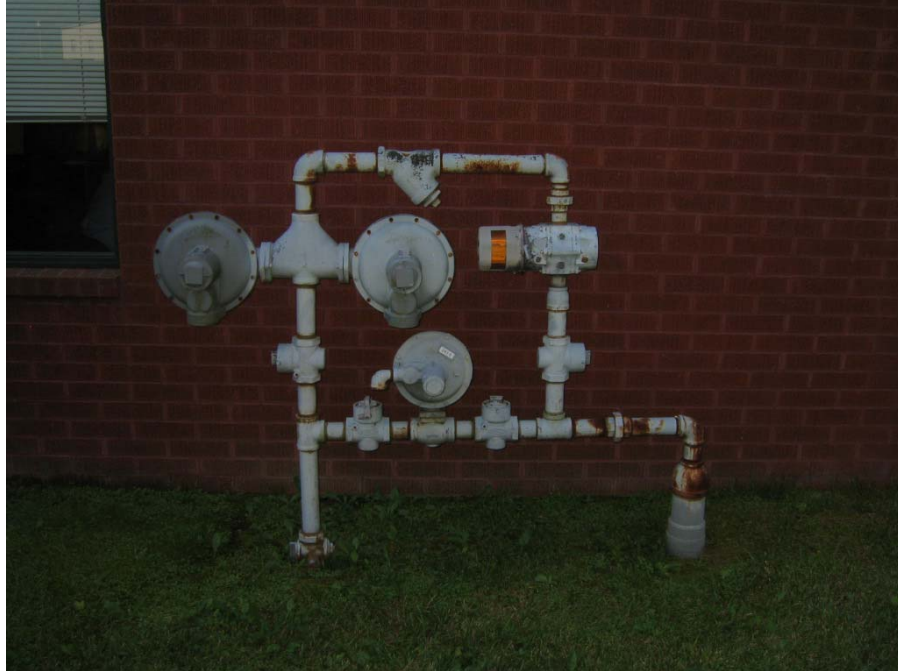
Photograph 45

45. View of the gas service meter.
46. View of the pad mounted utility transformer.
47. View of a panel board in the electrical room.
48. View of the emergency generator.
49. View of the switchboard for the emergency generator.
50. View of the riser for the fire sprinkler system.
51. View of the pre-action sprinkler system located in the janitor's closet.
52. View of an emergency strobe light in the bathroom.
53. View an accessible bathroom stall with grab rails.
54. View of accessible bathroom sinks.
