Daybreak Home Inspections, Inc.  
534 Derstine Avenue  
Lansdale, Pennsylvania 19446  
Joe Kovatch  
ASHI Certified Inspector #207821

# Building Inspection

2128 N Broad Street  
Lansdale, Pennsylvania 19446

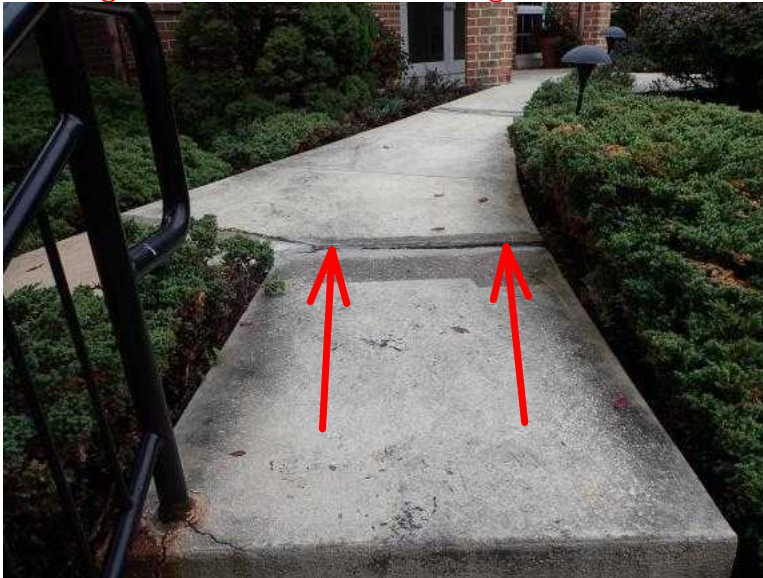
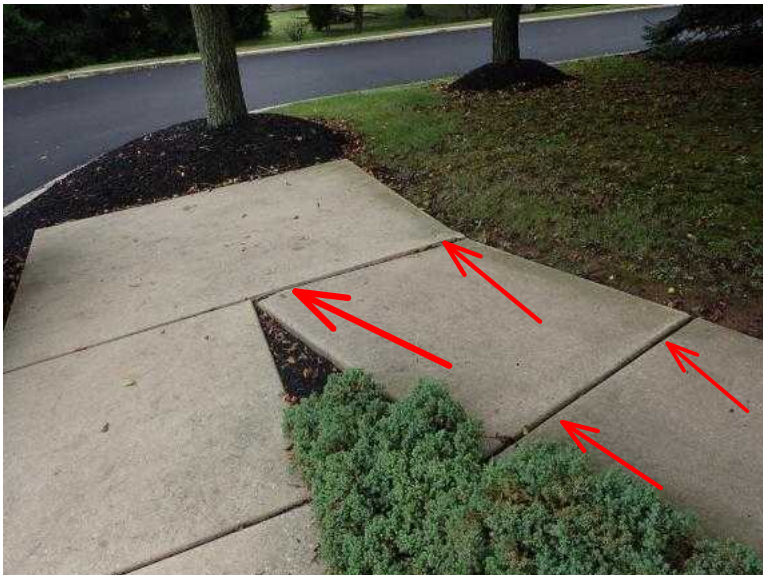
1.      Walks: Concrete: **Walk has settled throughout leaving a trip hazard and step into right rear side door too high, recommend repair to reduce risk of injury.**

<u>Low</u>	<u>High</u>
<u>Lots and Grounds</u>		
Walks: Walk has settled throughout leaving a trip hazard and step into right rear side door too high, recommend repair to reduce risk of injury.	\$ 2000	\$ 3000
<u>Exterior Surface and Components</u>		
Type: Gaps not properly sealed at the penetrations in the stucco, gaps, loose and missing stucco in areas. Stained, recommend an intrusive stucco test to determine if there is a moisture problem in the substrate prior to repairs. Cost estimate is for testing only.	\$ 850	\$ 850
<u>Roof</u>		
Chimney: Chimney needs to have tuck point repairs done to reduce the risk of water damage.	\$ 750	\$ 1250
<u>Basement</u>		
Moisture Location: Pooling water in perimeter drain with mold growth on drywall and on dirt stuck to the block wall, recommend repair to reduce the risk of illness.	\$ 500	\$ 800
<u>Crawl Space</u>		
Moisture Penetration: Water stains present on the right rear wall, recommend evaluation and repair.	\$ 750	\$ 1250

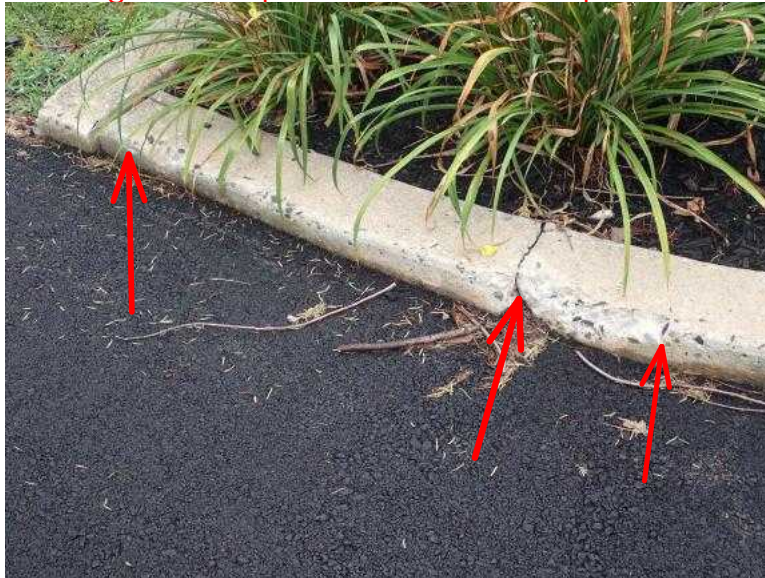
- 4.      Basement Stairwell: Concrete
- 5.      Exterior Surface Drain: Surface drain
- 6.      Vegetation: Shrubs/Trees
- 7.      Grading: Minor slope: **Improper soil slope towards foundation, recommend the addition of fill dirt below the mulch to improve grade**
- 8.      Driveway: Asphalt
- 9.      Parking Lot: Asphalt: **Approximately 64 parking spaces, 2 handicap. Damaged curbing from impact, recommend replacement of damaged curbing.**

Parking Lot: Approximately 64 parking spaces, 2 handicap. Damaged curbing from impact, recommend replacement of damaged curbing.

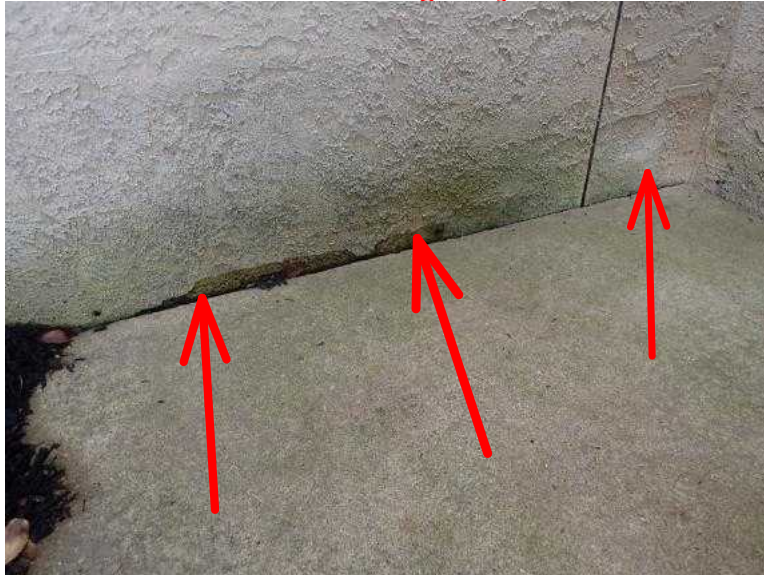
- 1.      Type: Brick, Stucco: **Gaps not properly sealed at the penetrations in the stucco, gaps, loose and missing stucco in areas. Stained, recommend an intrusive stucco test to determine if there is a moisture problem in the substrate prior to repairs.**  
**Cost estimate is for testing only.**

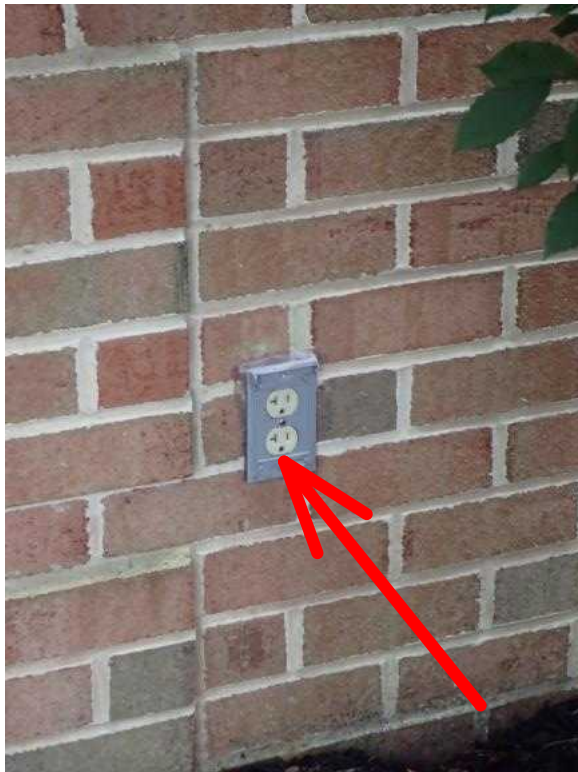
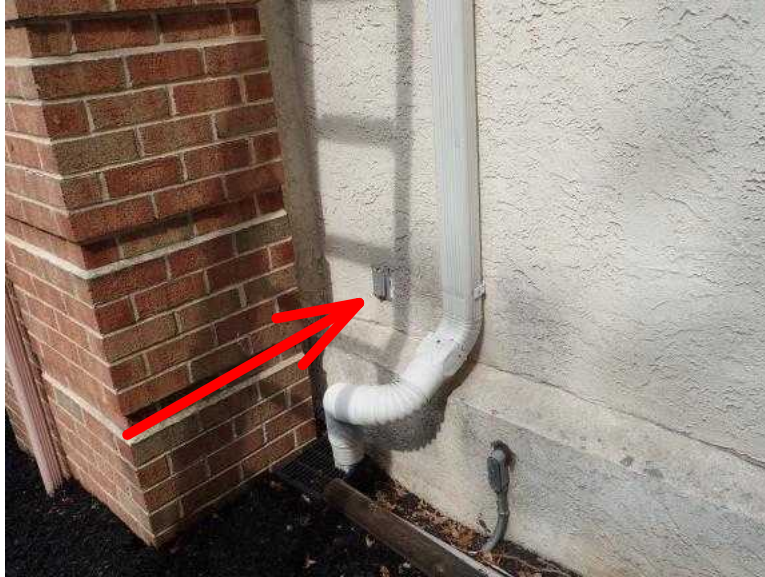
- 11.  Windows: Aluminum clad wood double hung, Wood double hung, Aluminum clad wood awning
- 12.  Exterior Lighting: Surface mount
- 13.  Exterior Electric Outlets: 120 VAC GFCI: **Loose or missing moisture cover at the right rear, left front outlet will not reset, recommend replacement to reduce the risk of shock**

Exterior Electric Outlets: Loose or missing moisture cover at the right rear, left front outlet will not reset, recommend replacement to reduce the risk of shock

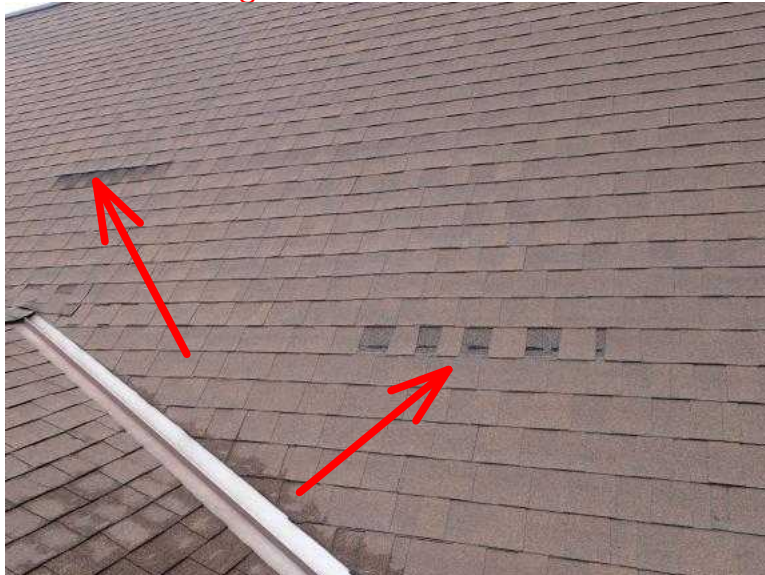
1. Method of Inspection: On roof
2.  Unable to Inspect: 10%
3.  Material: Asphalt shingle: **Roof existing beyond design life, Roof shows signs of deterioration with brittle, cracked and missing shingles throughout. Fiberglass showing throughout, recommend replacement to reduce the risk of water damage.**

Material: Roof existing beyond design life, Roof shows signs of deterioration with brittle, cracked and missing shingles throughout. Fiberglass showing throughout, recommend replacement to reduce the risk of water damage.

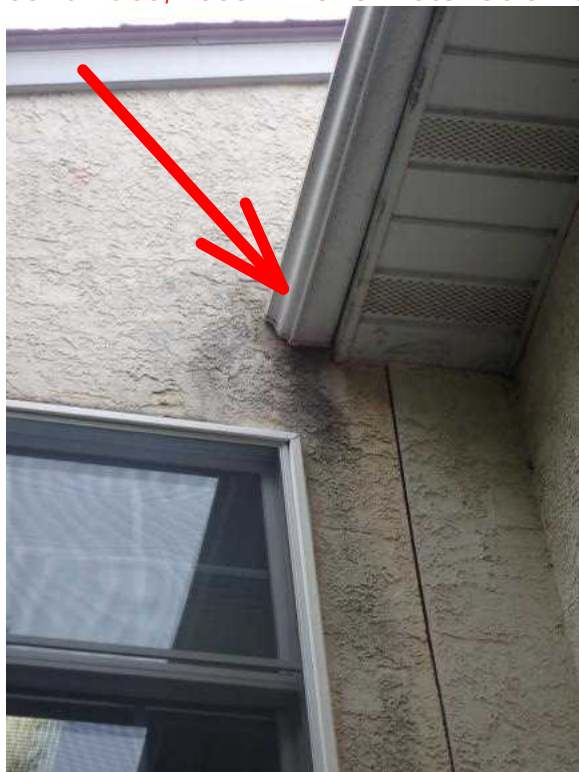
- 4. Type: Gable
- 5. Approx Age: 23 Years
- 6.      Flashing: Aluminum: **Missing diverter flashing where the roof ends and the wall continues, recommend installation to reduce risk of water damage.**

Flashing: Missing diverter flashing where the roof ends and the wall continues, recommend installation to reduce risk of water damage.

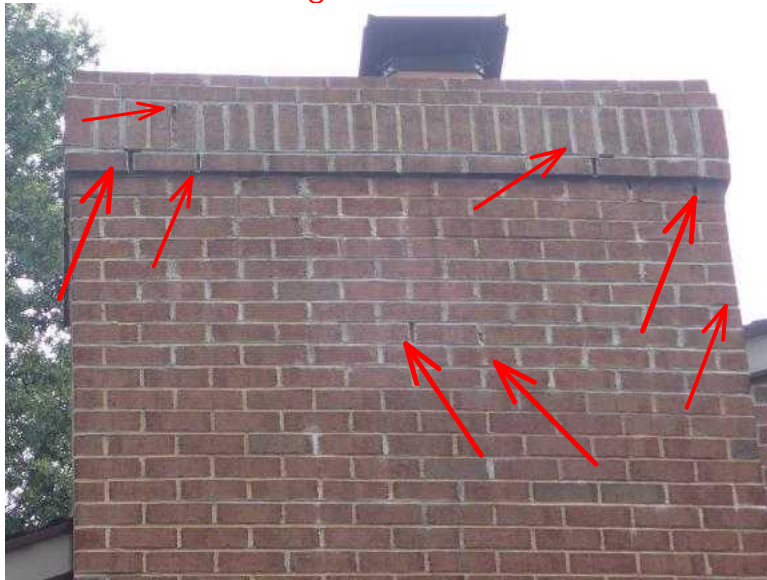
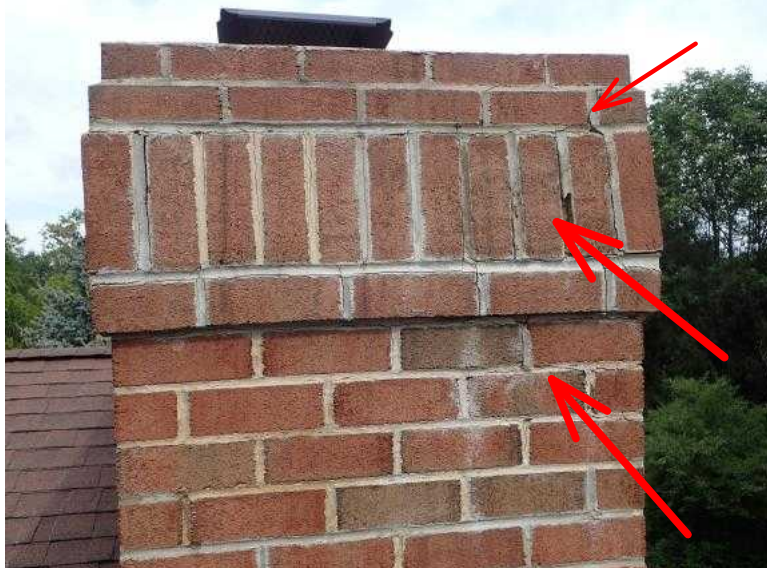
8.      Chimney: Brick: **Chimney needs to have tuck point repairs done to reduce the risk of water damage.**

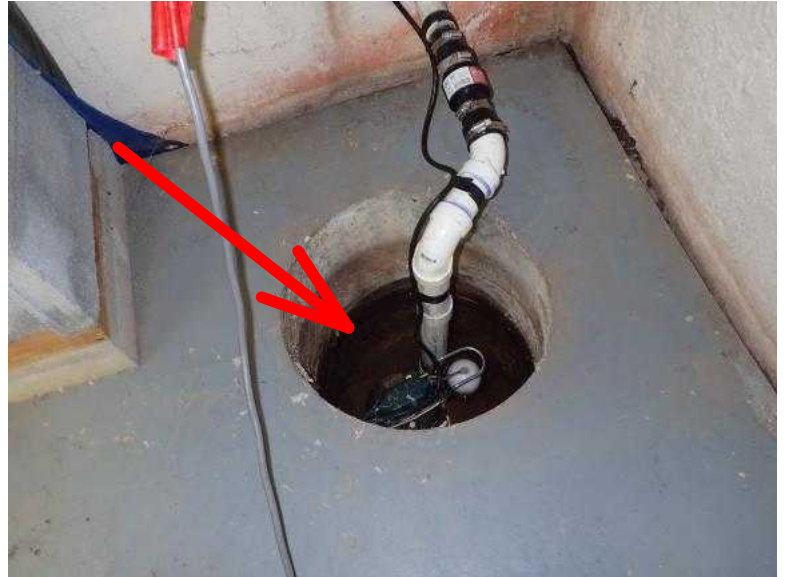
9.  Sump Pump: Pedestal, Submerged: **Recommend the installation of a cover to reduce the amount of moisture in the air.**

2. Main Basement Sump Pump: Pedestal, Submerged: **Recommend the installation of a cover to reduce the amount of moisture in the air.**

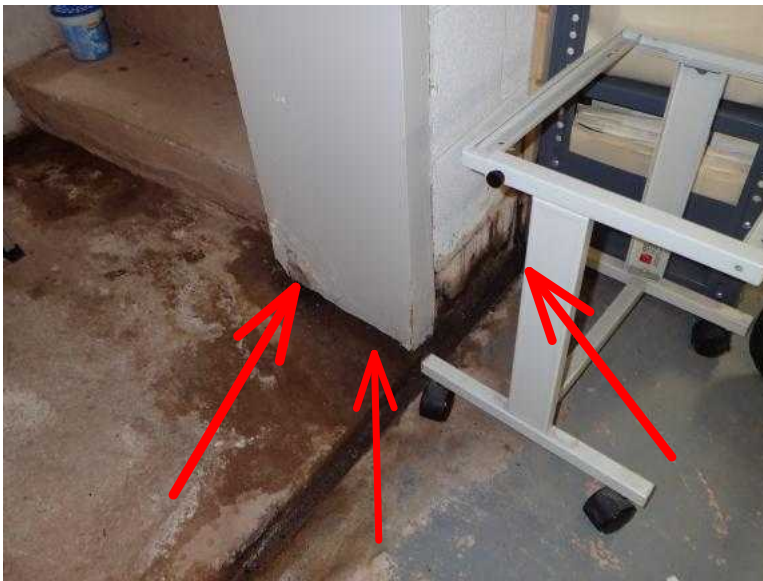
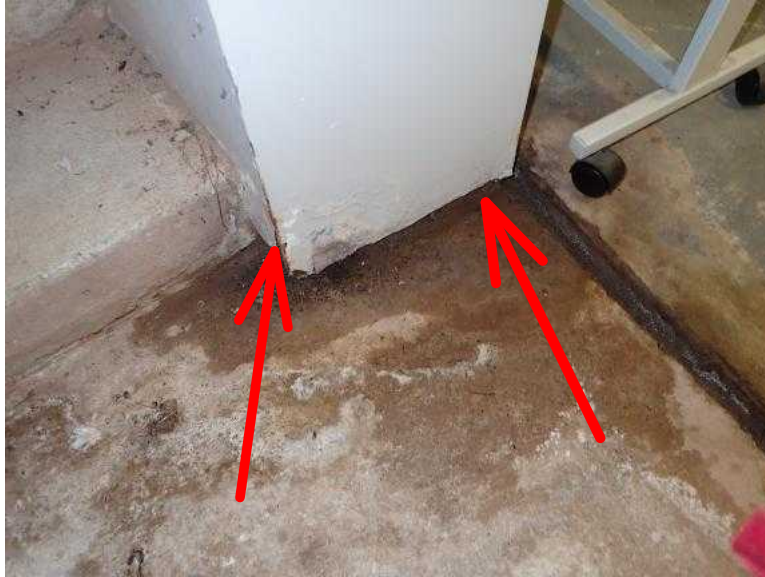
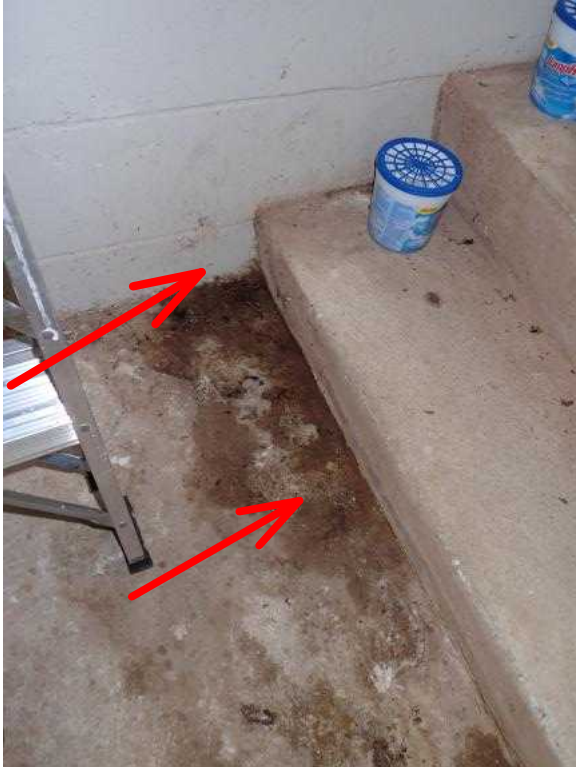
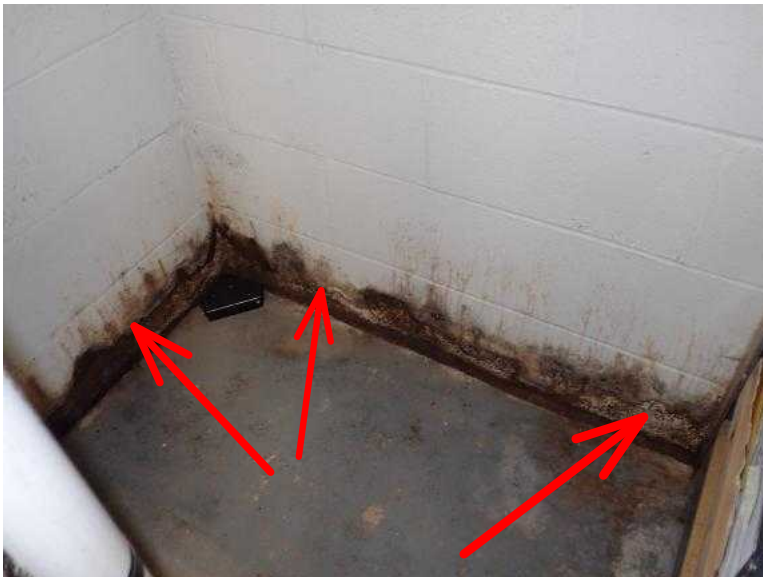
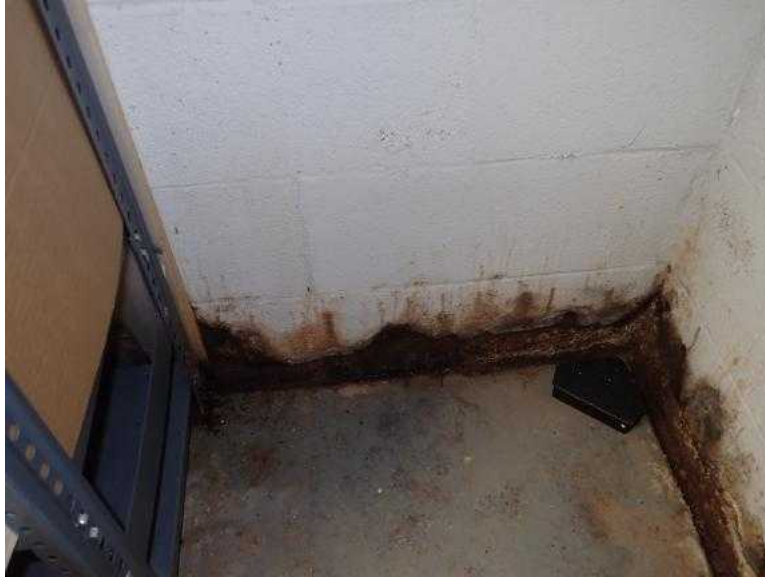
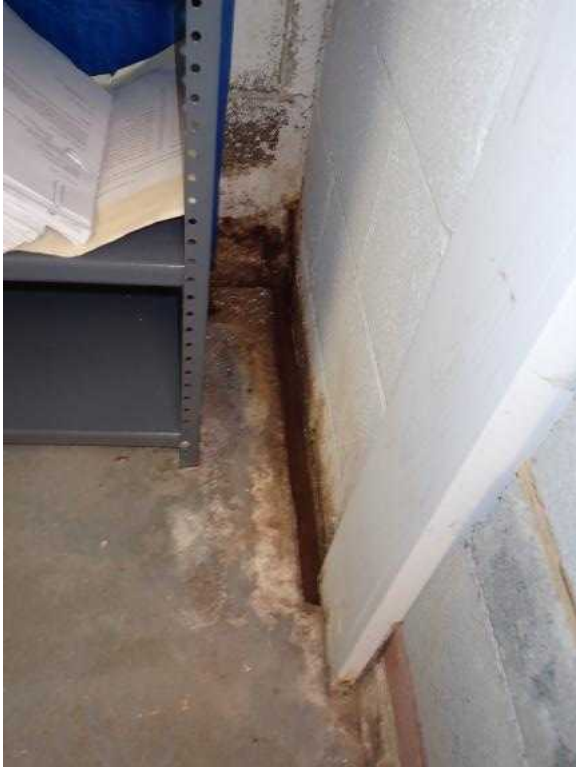
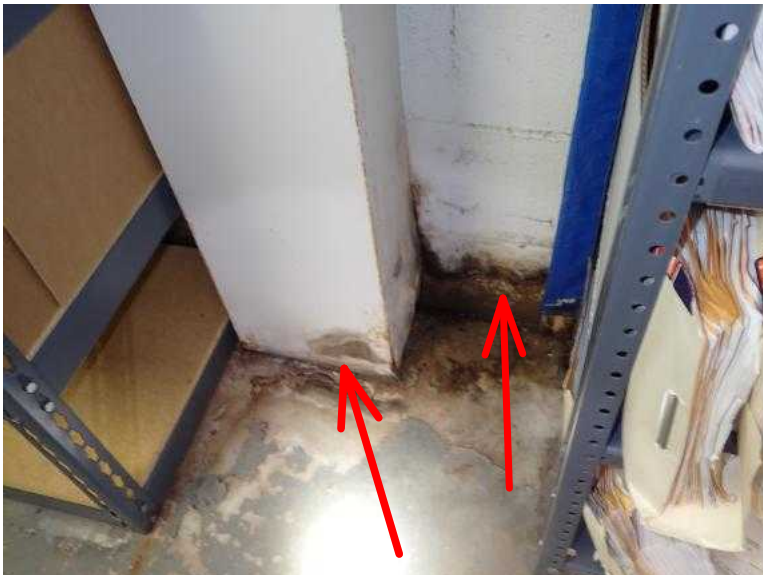
10.  Moisture Location: Right side: **Pooling water in perimeter drain with mold growth on drywall and on dirt stuck to the block wall, recommend repair to reduce the risk of illness.**

8. Main Basement Moisture Location: Right side: Pooling water in perimeter drain with mold growth on drywall and on dirt stuck to the block wall, recommend repair to reduce the risk of illness.

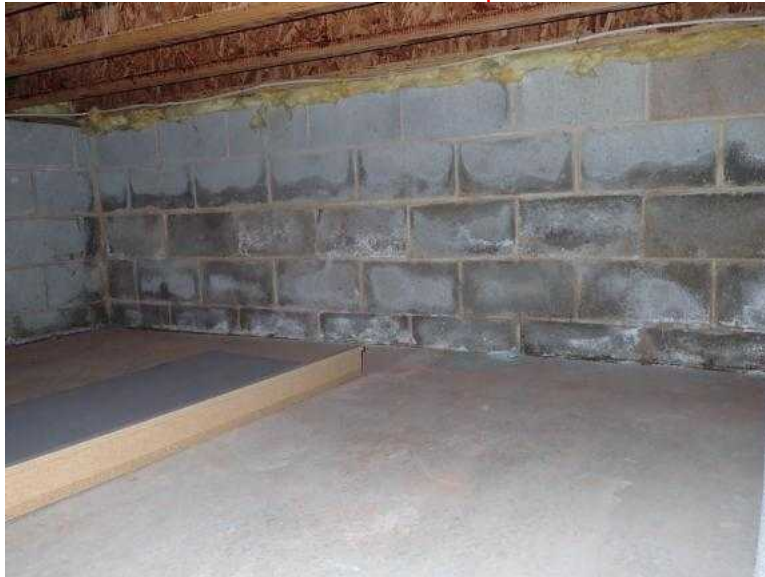
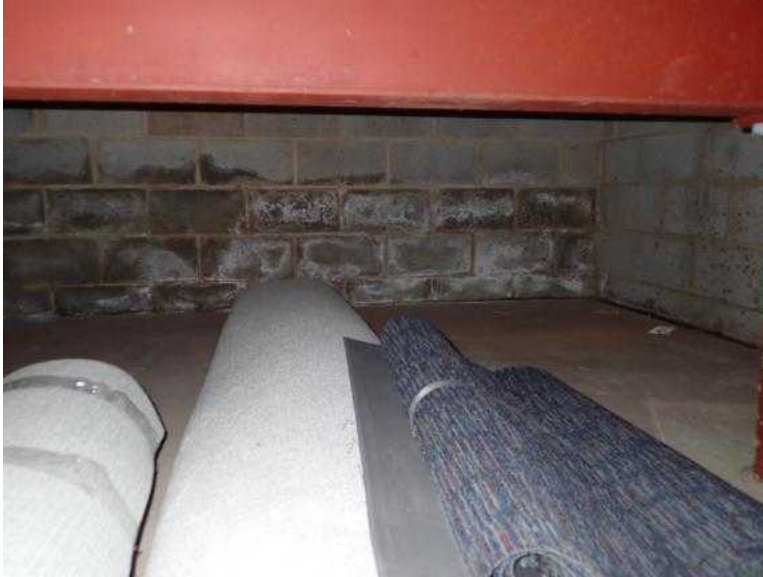
1. Method of Inspection: In the crawl space
2.  Unable to Inspect: 30%
3.  Access: Small
4.  Moisture Penetration: Yes: **Water stains present on the right rear wall, recommend evaluation and repair.**

9. Rear Crawl Space Moisture Penetration: Yes: Water stains present on the right rear wall, recommend evaluation and repair.

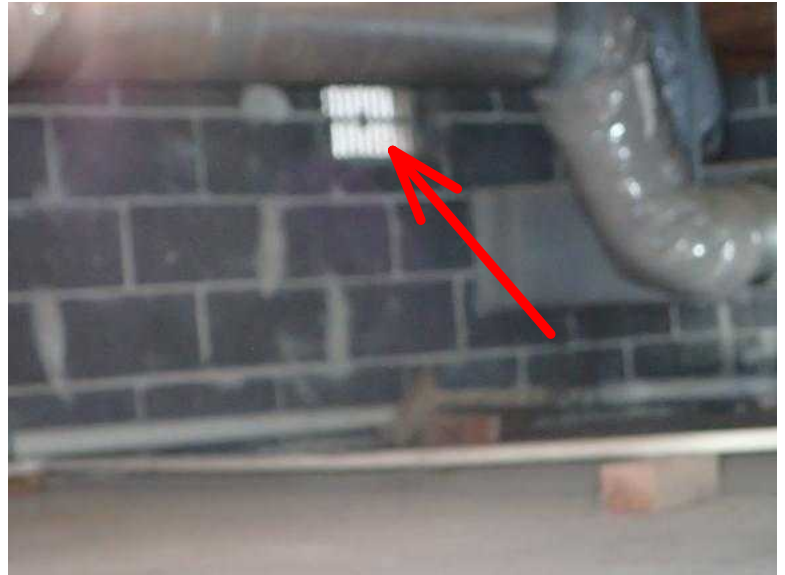
6.  Ventilation: Vents: **Recommend sealing vents to reduce the risk of high moisture in the air.**

3. Rear Crawl Space Ventilation: Vents: **Recommend sealing vents to reduce the risk of high moisture in the air.**

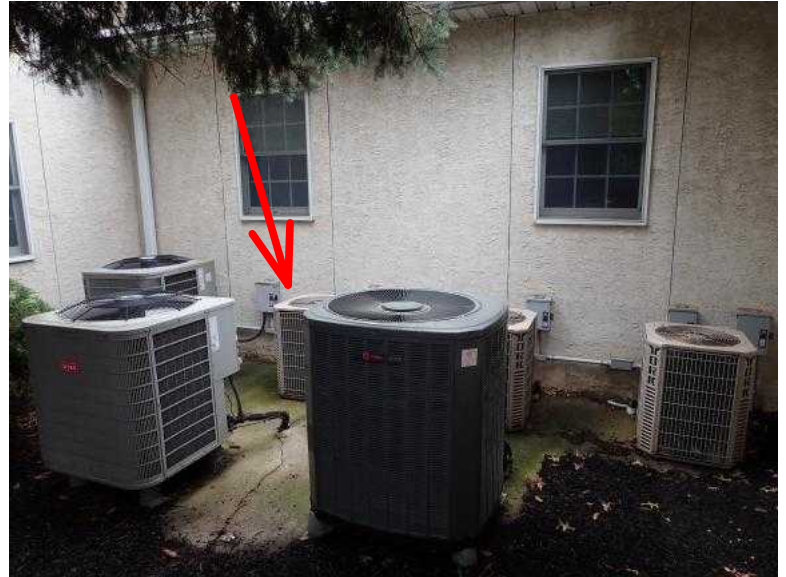
- 9.      A/C System Operation: Functional: **The unit is currently in service beyond the manufactures stated design life.**

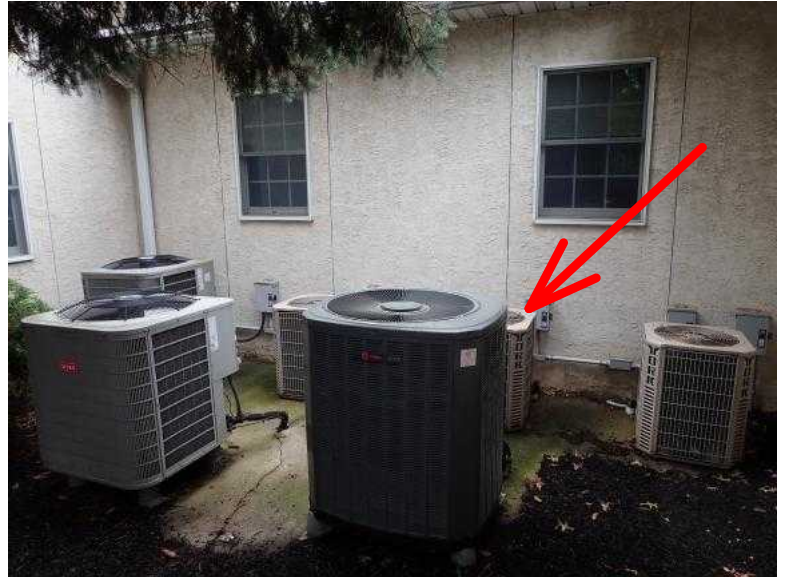
17.  A/C System Operation: Functional: **The unit is currently in service beyond the manufactures stated design life**

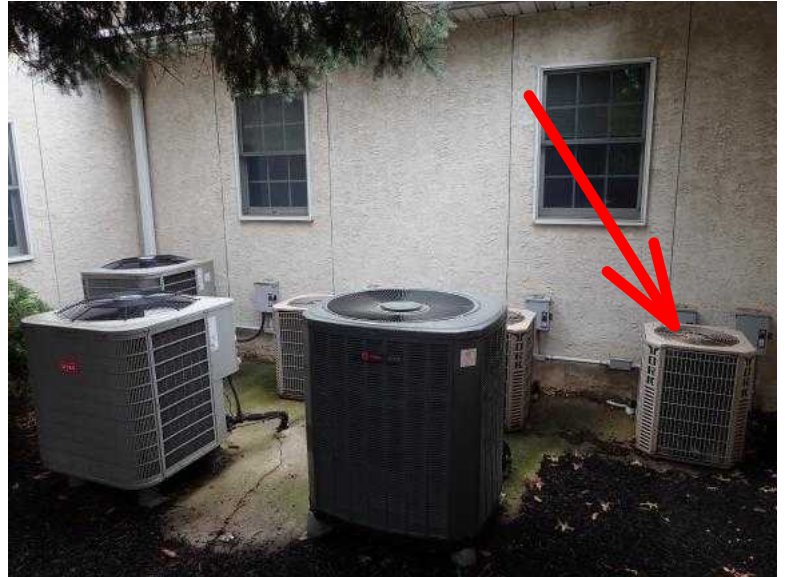
25.      A/C System Operation: Functional: **The unit is currently in service beyond the manufactures stated design life**

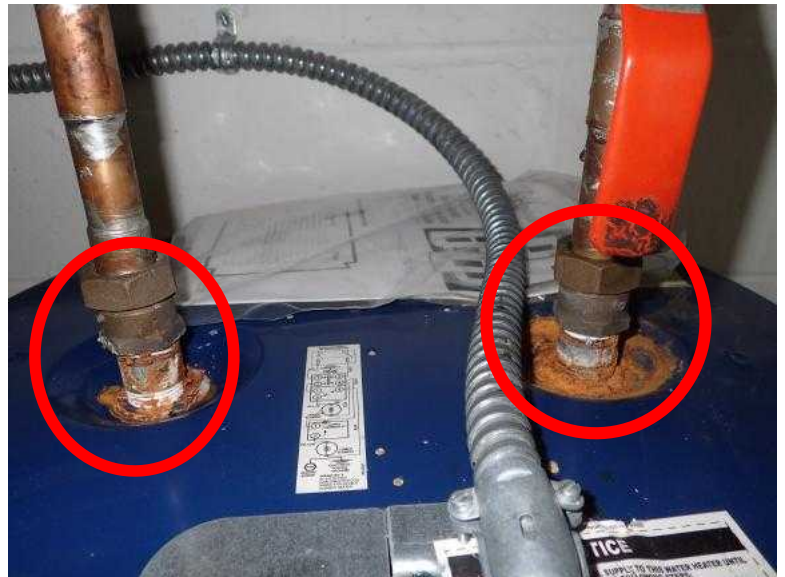
- 6.  Water Heater Operation:  
Recommend service: **Corrosion from dissimilar metals at the top of unit, recommend repair.**

7. Basement right Water Heater Water Heater Operation: Recommend service: **Corrosion from dissimilar metals at the top of unit, recommend repair.**

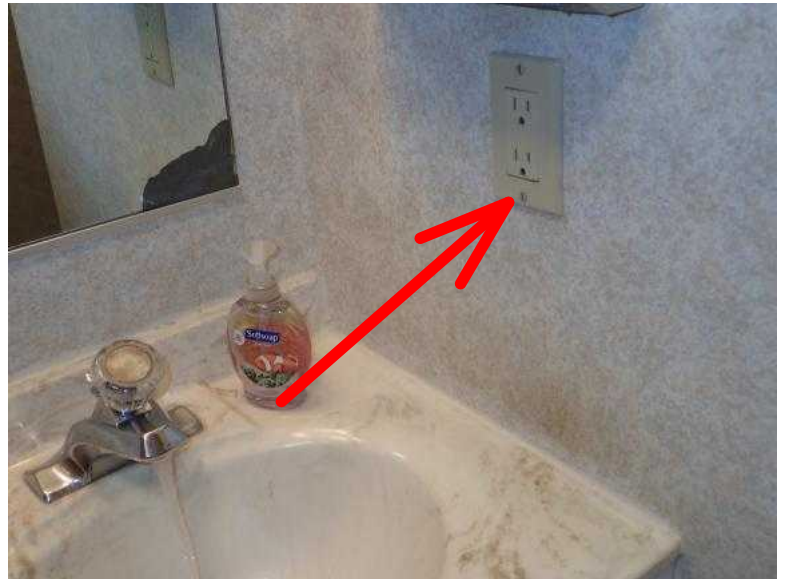
45.  Electrical: 120 VAC: **Non-GFCI outlet at sink, recommend installation to reduce risk of shock.**

Electrical: Non-GFCI outlet at sink, recommend installation to reduce risk of shock.

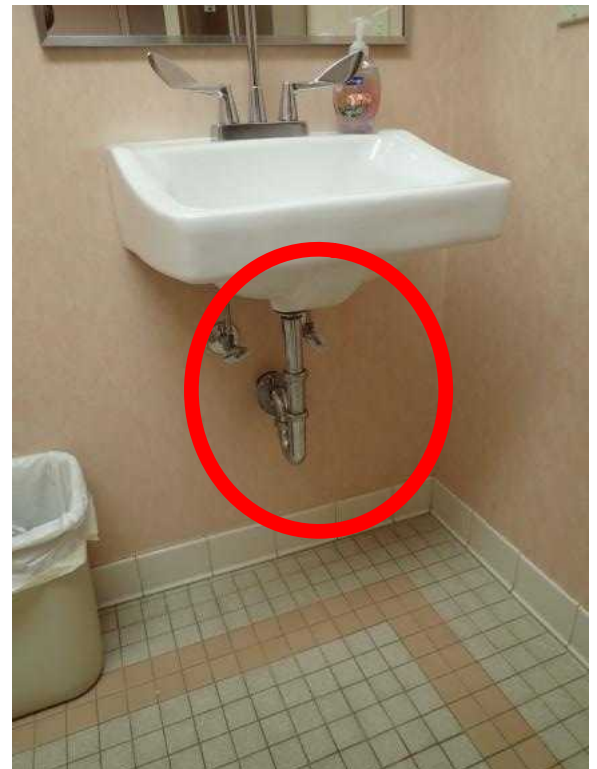
- 68.      Ceiling: Paint
- 69.      Walls: Wallpaper
- 70.      Floor: Ceramic tile
- 71.      Doors: Wood
- 72.      Electrical: 120 VAC
- 73.      Sink/Basin: Porcelain coated
- 74.      Faucets/Traps: Moen fixtures with a metal trap
- 75.      Urinals: Kohler
- 76.      Toilets: Kohler
- 77.      Grab Bars: Metal
- 78.      Partitions: Stall with door
- 79.      HVAC Source: Air Register
- 80.      Ventilation: Electric ventilation fan
- 81.      ADA Compliant: No: **Missing padded protection at sink drain, recommend installation**

ADA Compliant: Missing padded protection at sink drain, recommend installation

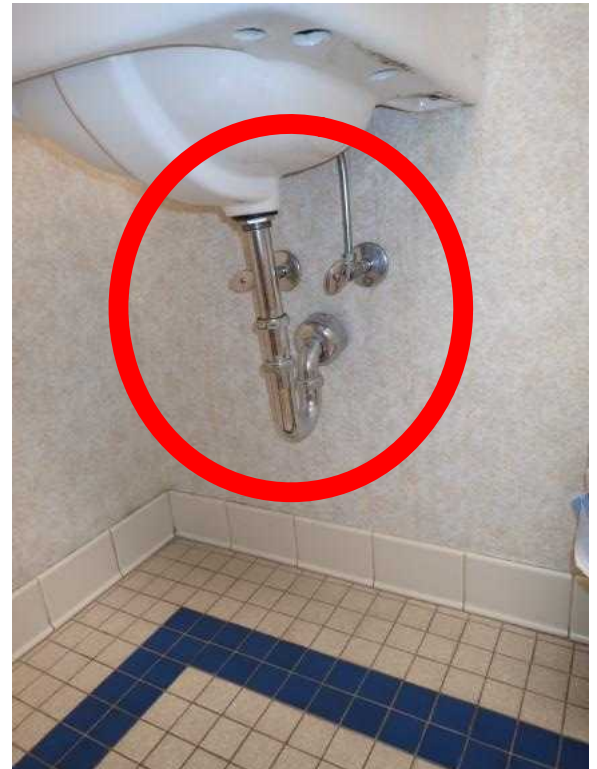
- 83.      Ceiling: Paint
- 84.      Walls: Wallpaper
- 85.      Floor: Ceramic tile
- 86.      Doors: Wood
- 87.      Electrical: 120 VAC
- 88.      Sink/Basin: Porcelain coated
- 89.      Faucets/Traps: Moen fixtures with a metal trap
- 90.      Toilets: Kohler
- 91.      Grab Bars: Metal
- 92.      Partitions: Stall with door
- 93.      HVAC Source: Air Register
- 94.      Ventilation: Electric ventilation fan
- 95.      ADA Compliant: No: **Missing padded protection at sink drain, recommend installation**

ADA Compliant: Missing padded protection at sink drain, recommend installation

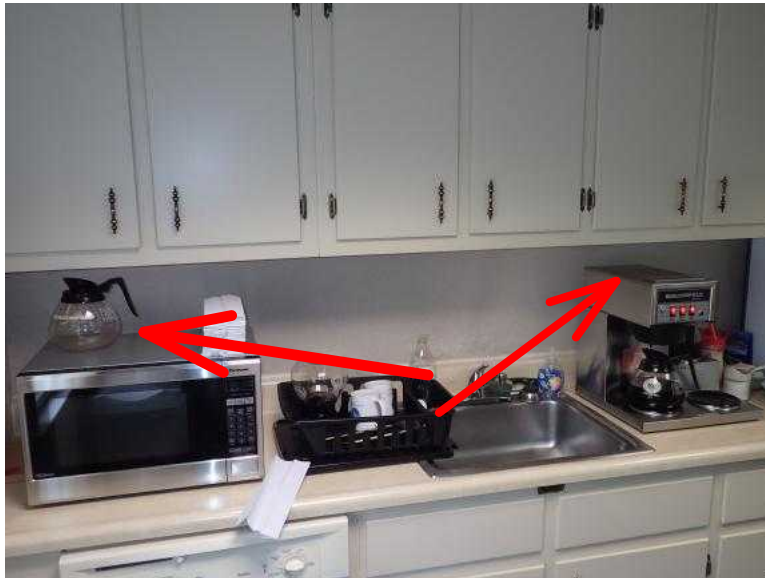
1.      Sink: Stainless Steel
2.      Electrical: 120 VAC: **Non-GFCI outlets at sink and missing a cover plate under the sink, recommend installation to reduce risk of shock.**

Electrical: Non-GFCI outlets at sink and missing a cover plate under the sink, recommend installation to reduce risk of shock.

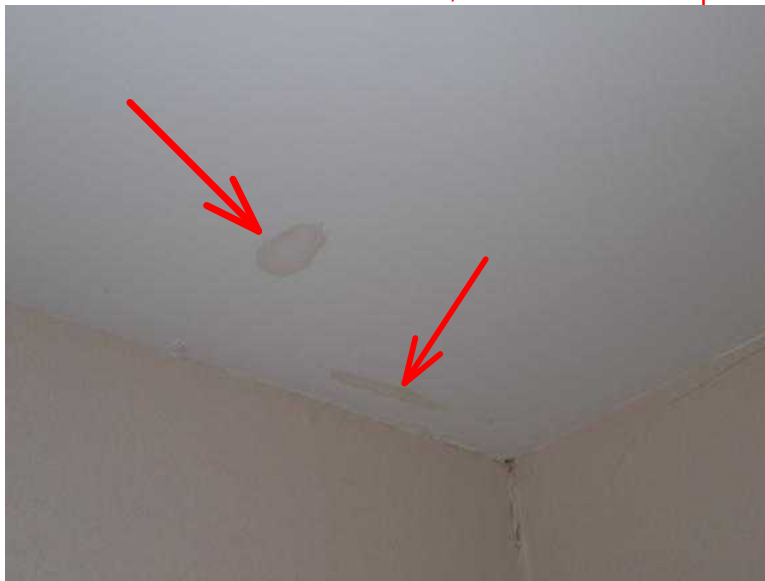
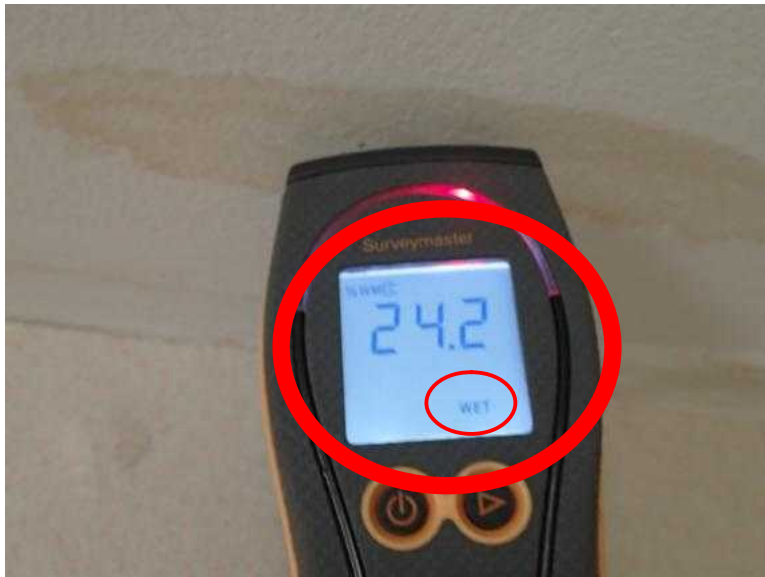
1.      Ceiling: Paint: Water stains present in left front office, Clemens office and left side office with active leaks, recommend repair to damaged areas.

15. 1st Floor, 2nd Floor Office Space Ceiling: Paint: **Water stains present in left front office, Clemens office and left side office with active leaks, recommend repair to damaged areas.**
