RE: Comprehensive Asbestos Survey Report  
American Bank & Trust Company Building  
**1518 Hull Street**  
Richmond, VA 23224  
FEI Project Number: FEI-19AL171

# **ASBESTOS SURVEY REPORT**

**AMERICAN BANK & TRUST COMPANY  
1518 HULL STREET  
RICHMOND, VIRGINIA 23219**

FEI PROJECT NO. FEI-19AL171

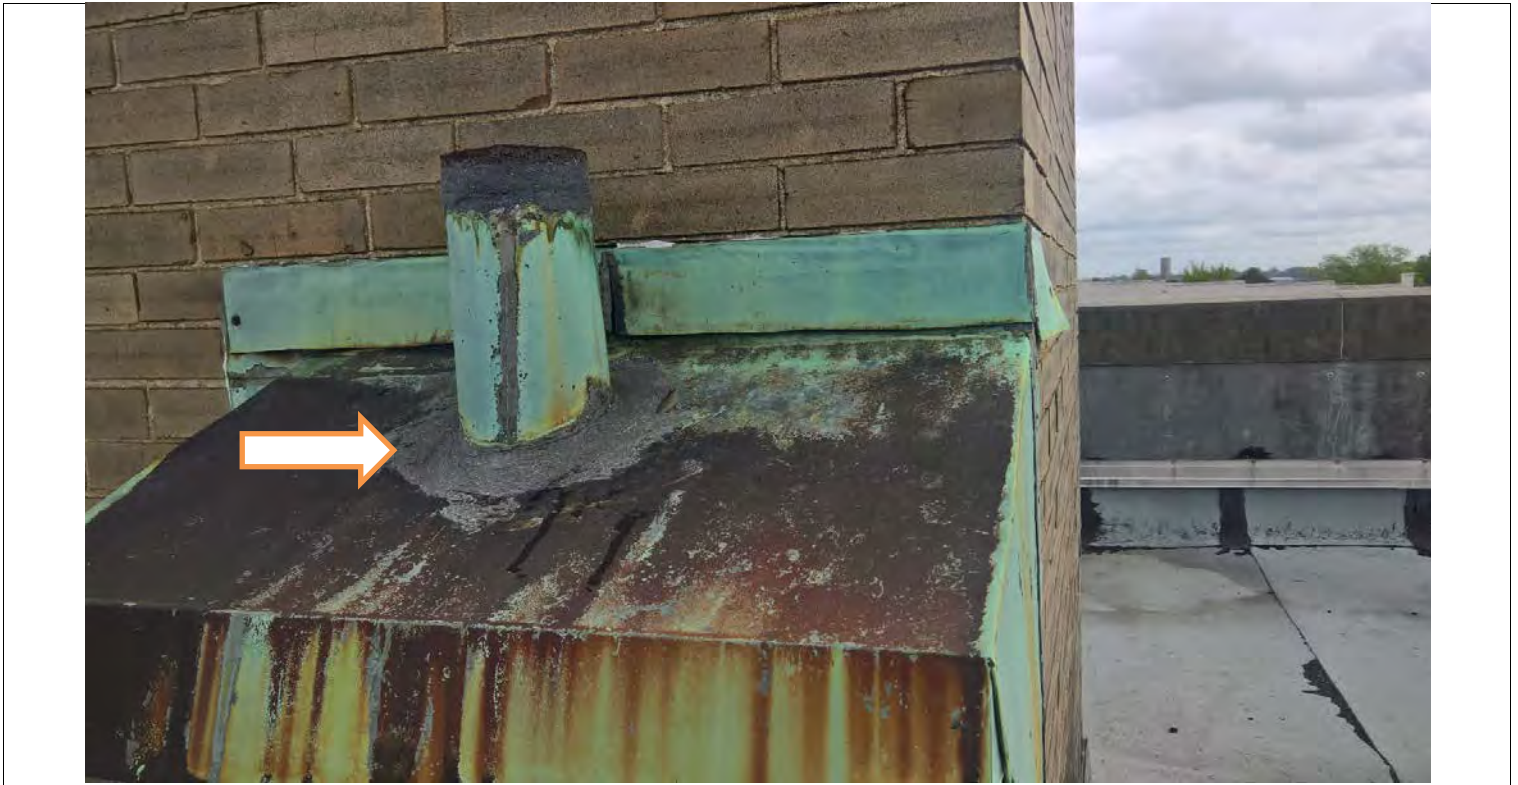
**Photograph No. 1**

American Bank & Trust Co., 1518 Hull Street Richmond VA, Photo of Asbestos Containing Materials: Black Vent Mastic

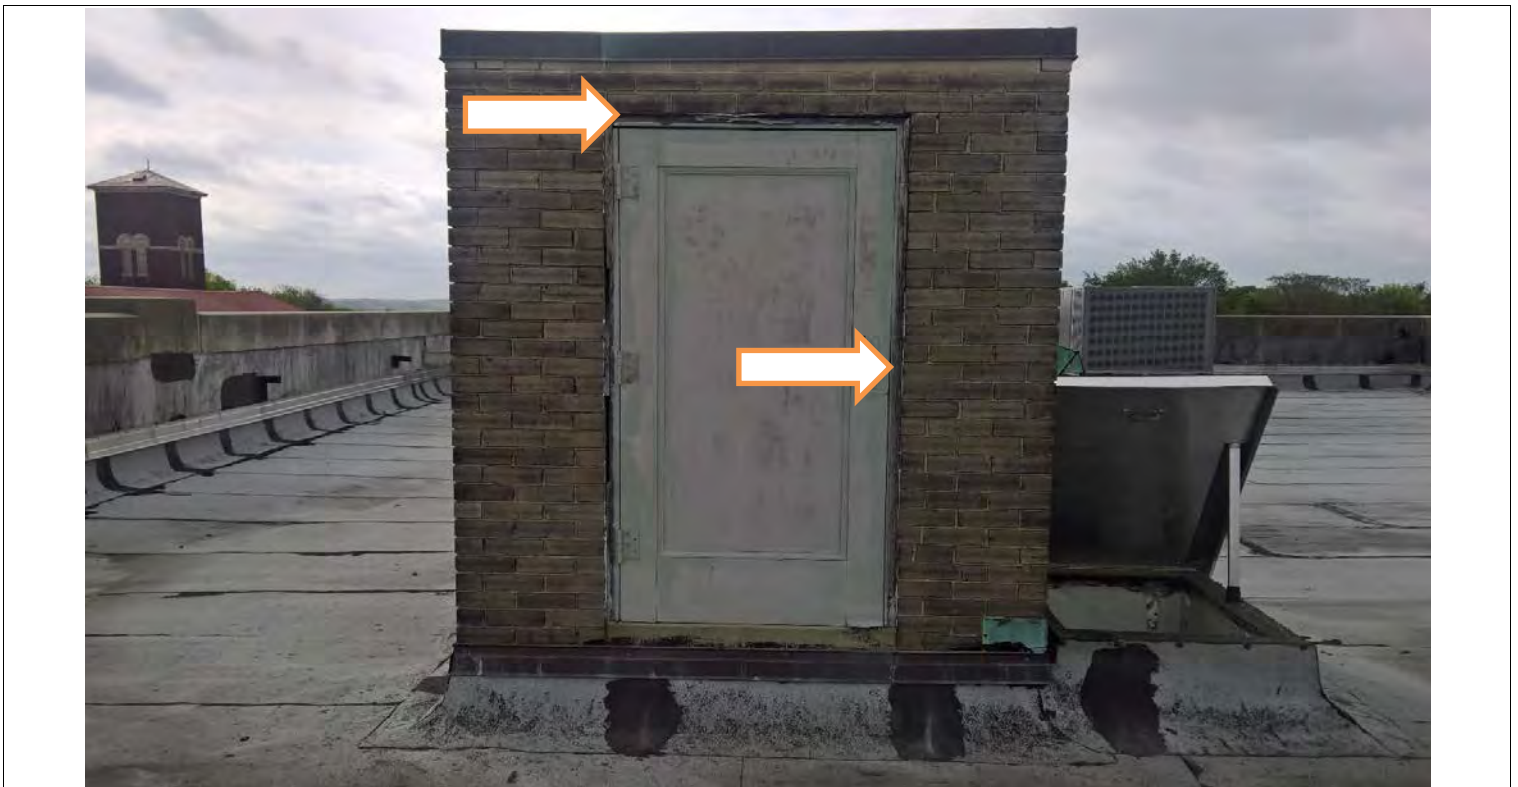
**Photograph No. 2**

American Bank & Trust Co., 1518 Hull Street Richmond VA, Photo of Asbestos Containing Materials: Exterior door caulk

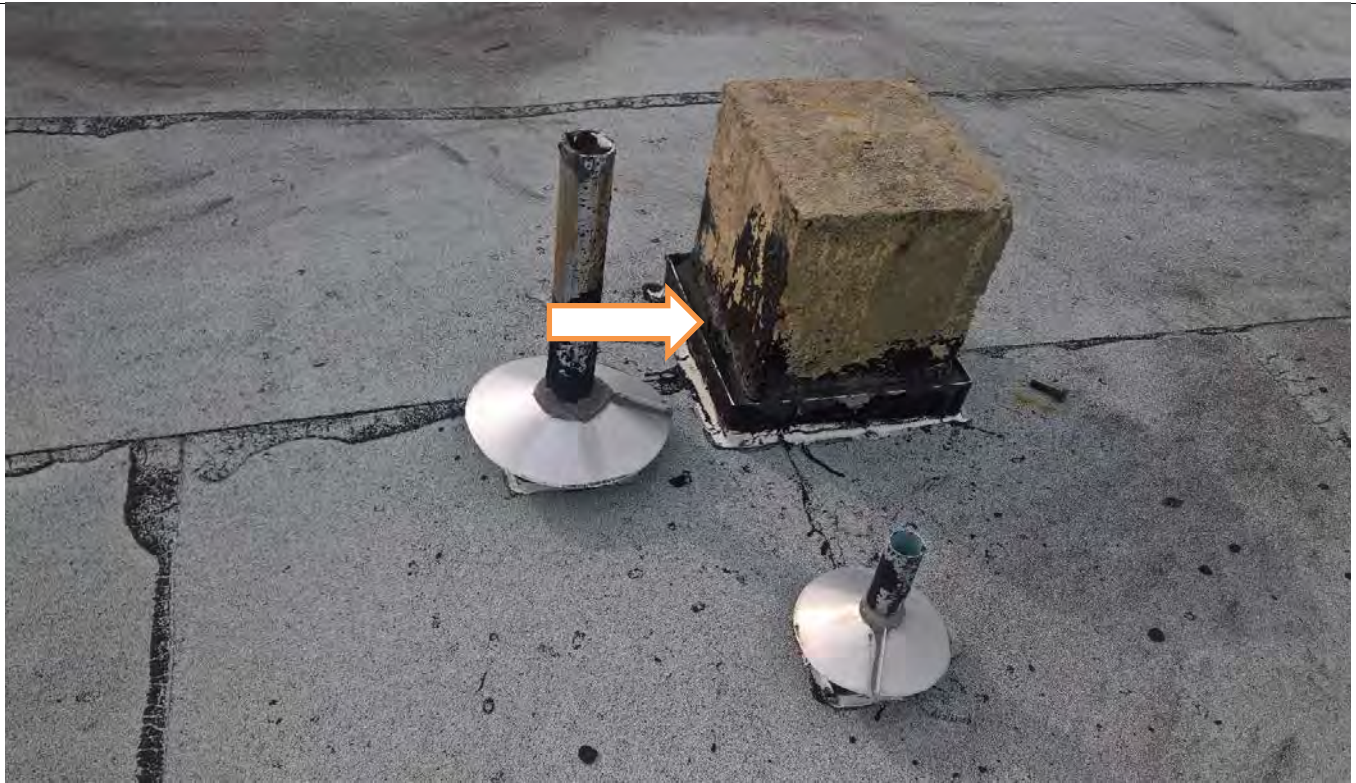
**Photograph No. 3**

American Bank & Trust Co., 1518 Hull Street Richmond VA, Photo of Asbestos Containing Materials: Black Pitch Pocket

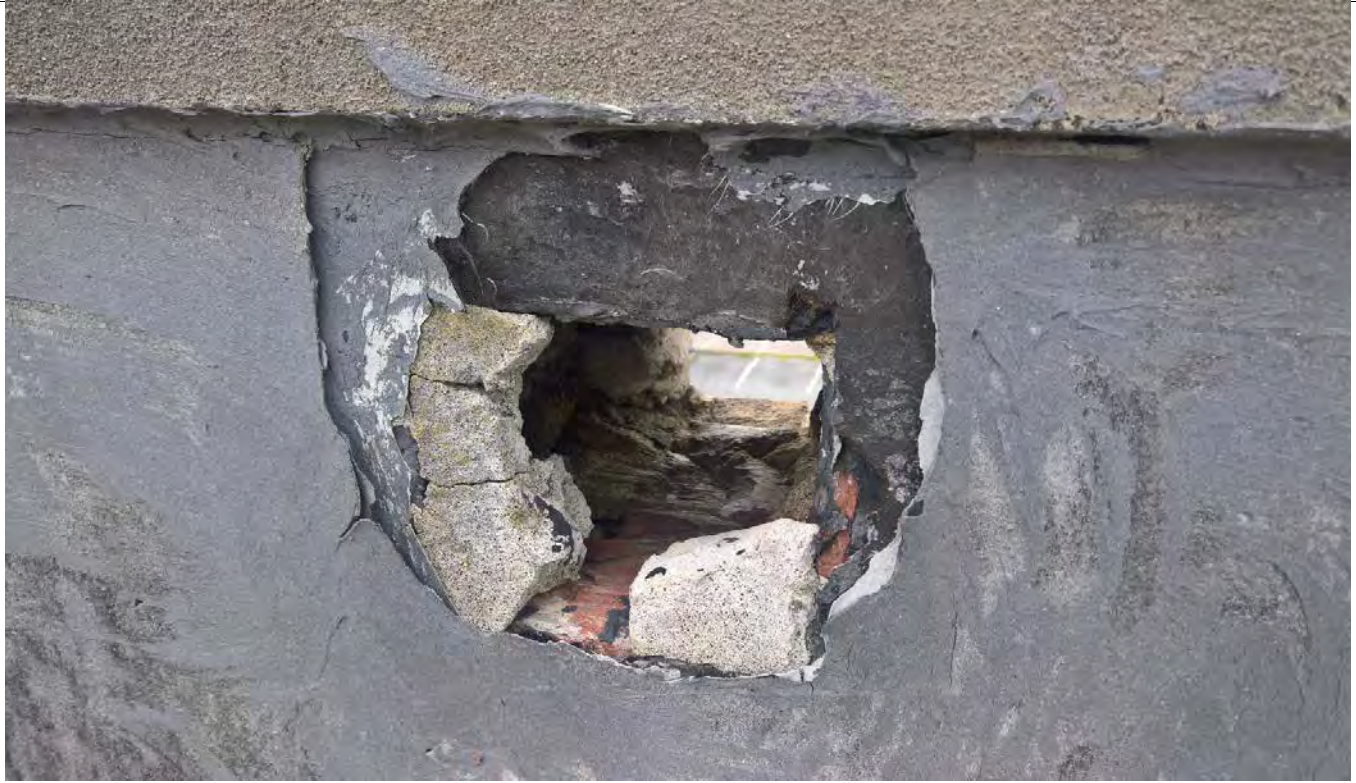
**Photograph No. 4**

American Bank & Trust Co., 1518 Hull Street Richmond VA, Photo of Asbestos Containing Materials: Black Fiberboard with Grey Mastic and Black Membrane under Black Fiberboard

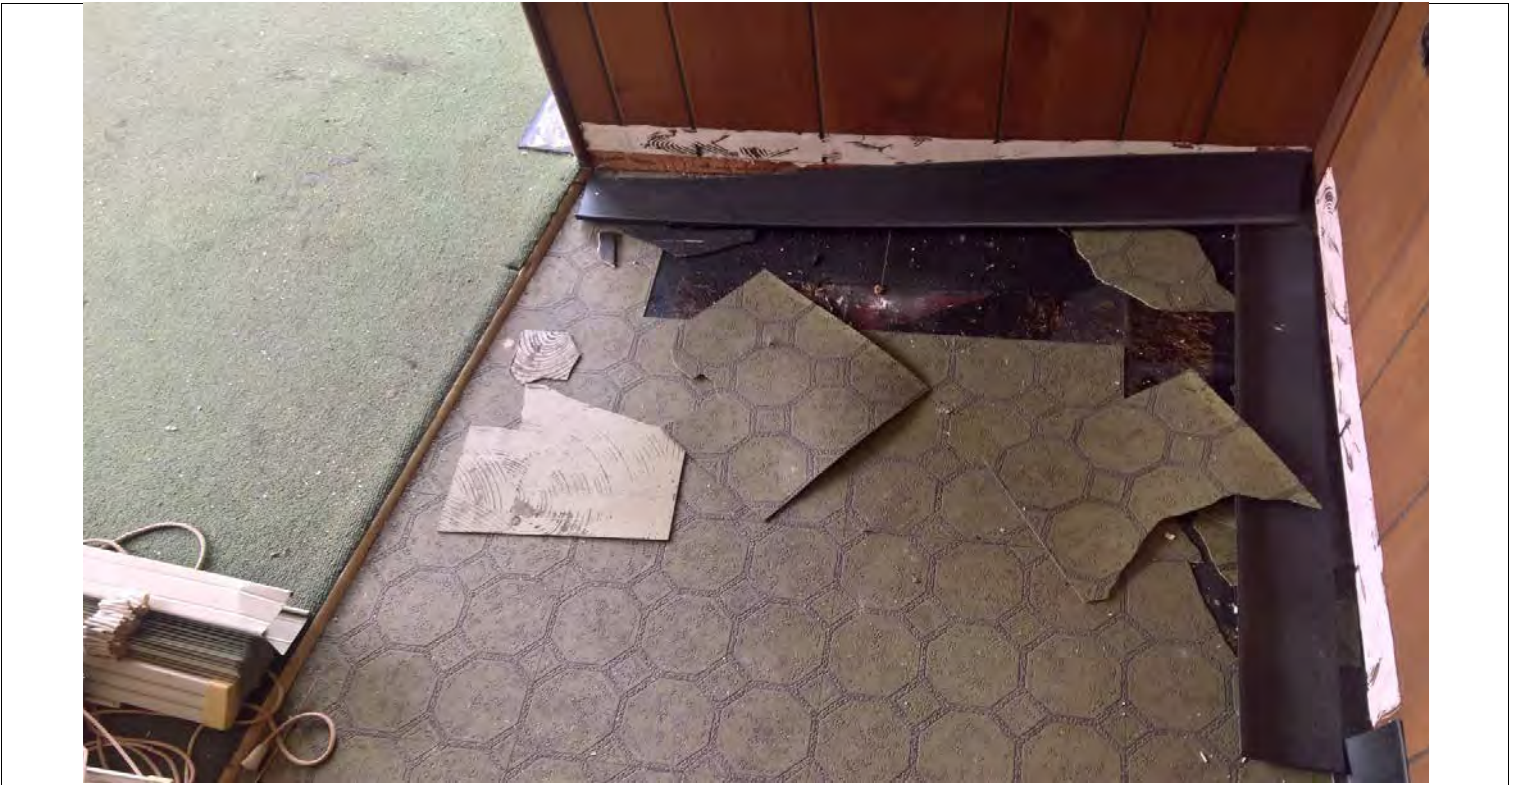
**Photograph No. 5**

American Bank & Trust Co., 1518 Hull Street Richmond VA, Photo of Asbestos Containing Materials: Thin Olive 12"x12" Vinyl Floor Tile and Black Mastic

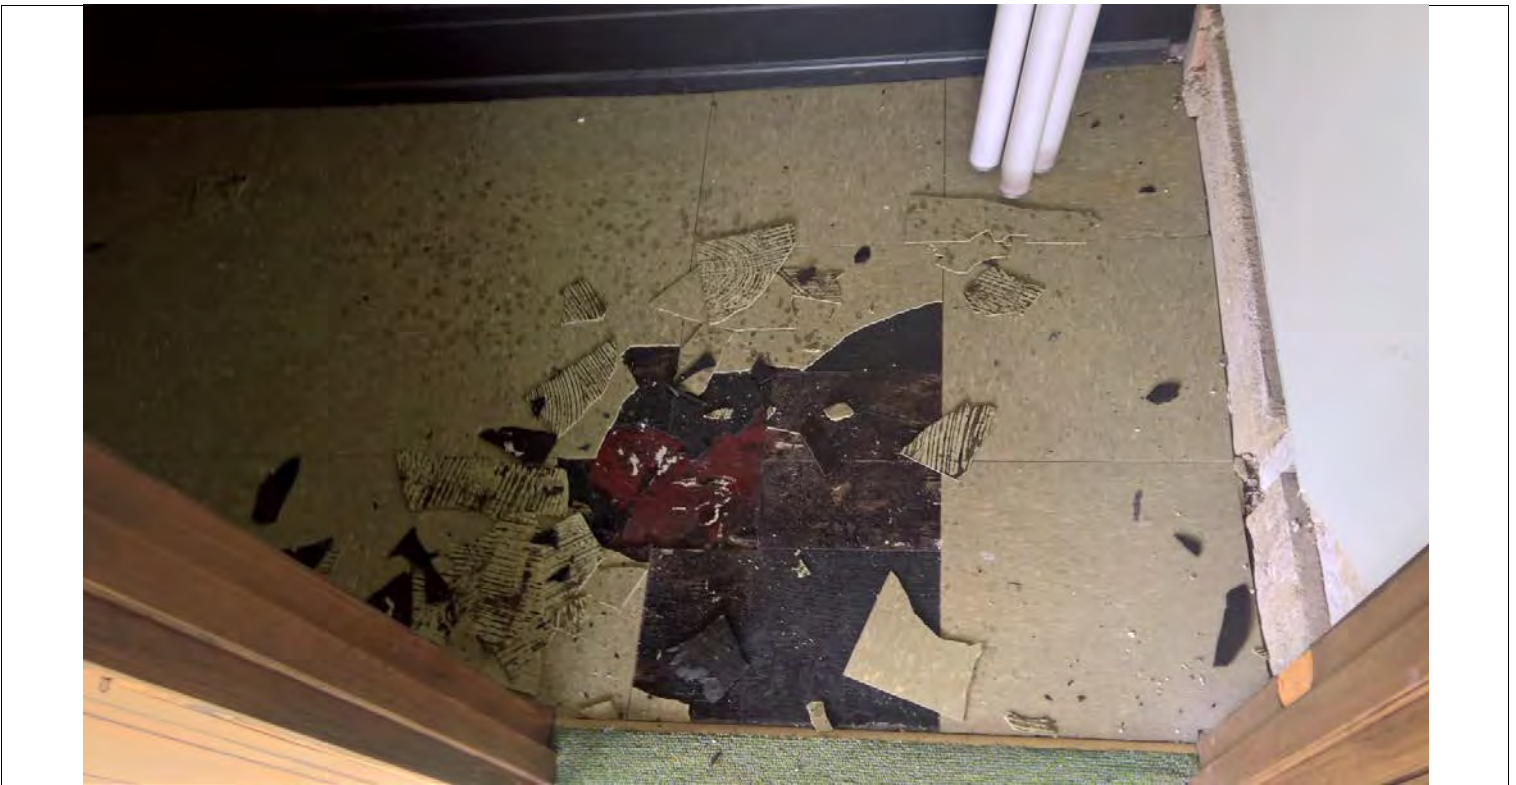
**Photograph No. 6**

American Bank & Trust Co., 1518 Hull Street Richmond VA, Photo of Asbestos Containing Materials: Olive 9"x9" Vinyl Floor Tile with Black Mastic Over Black 9"x9" Vinyl Floor Tile with Black Mastic

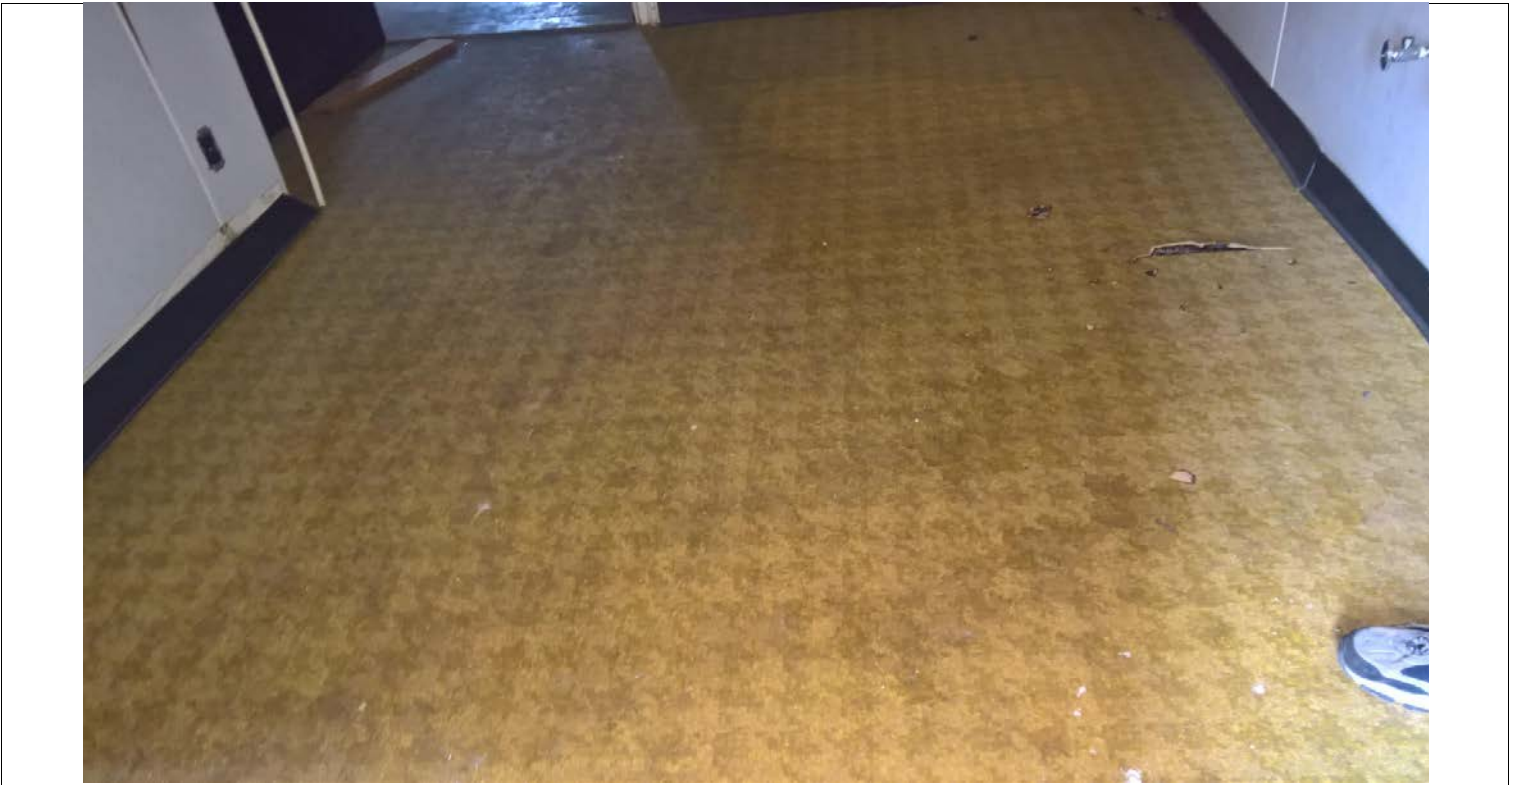
**Photograph No. 7**

American Bank & Trust Co., 1518 Hull Street Richmond VA, Photo of Asbestos Containing Materials: Yellow Resilient Sheet Flooring

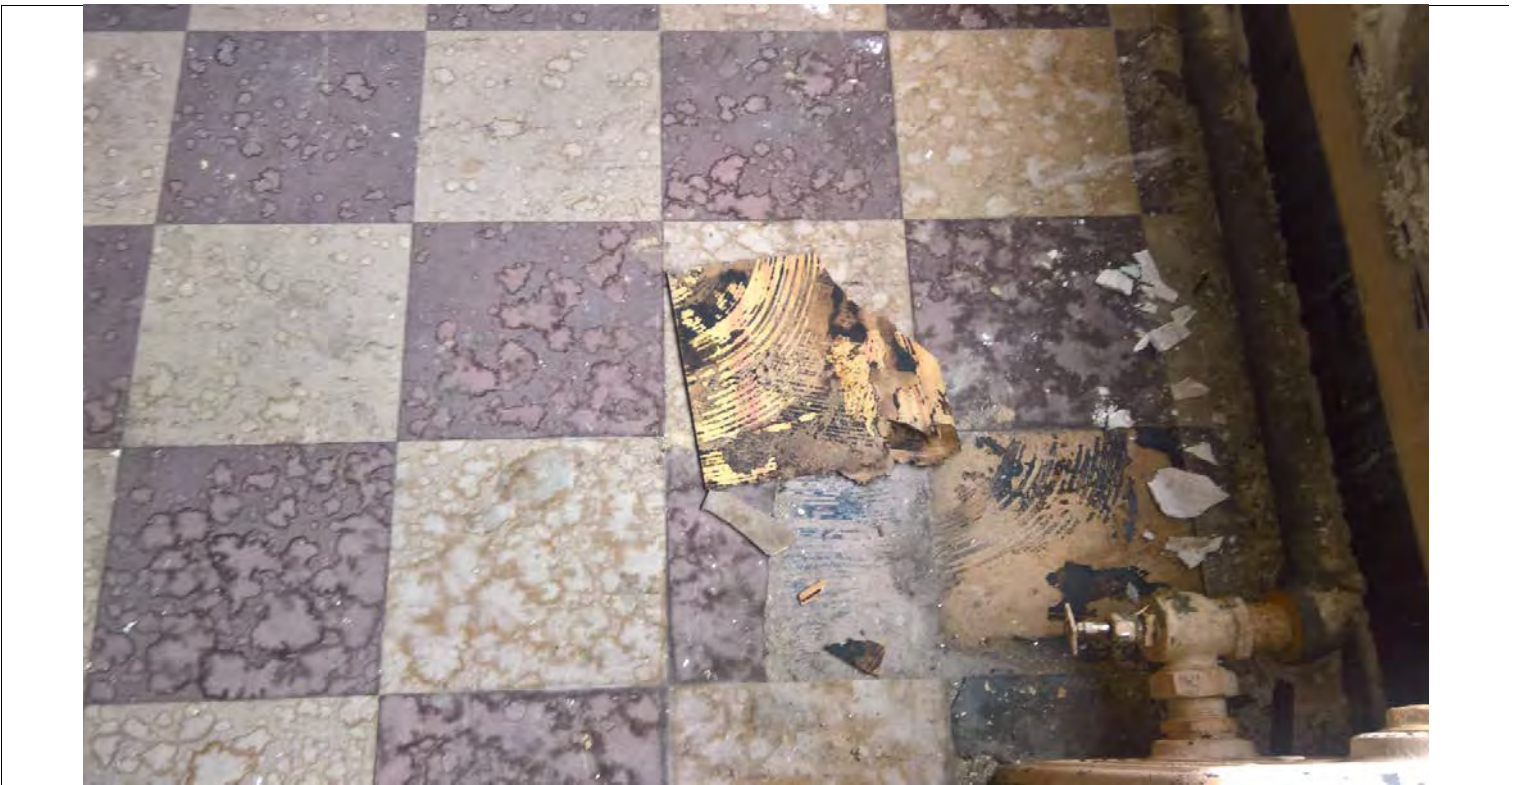
**Photograph No. 8**

American Bank & Trust Co., 1518 Hull Street Richmond VA, Photo of Asbestos Containing Materials: Brown and Tan 9"x9" Vinyl Floor Tiles with Black Mastic

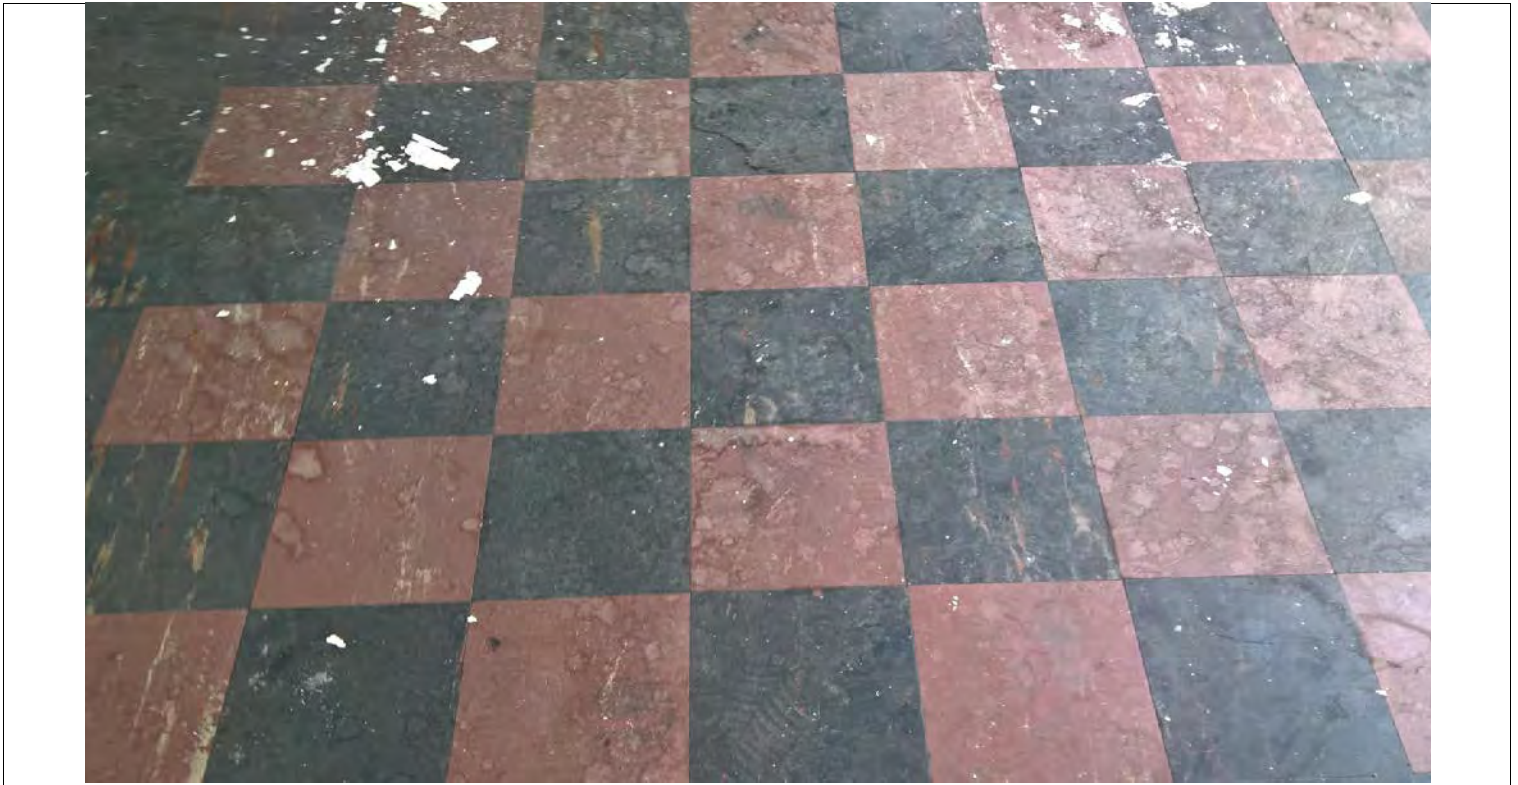
**Photograph No. 9**

American Bank & Trust Co., 1518 Hull Street Richmond VA, Photo of Asbestos Containing Materials: Black and Red 9"x9" Vinyl Floor Tiles with Black Mastic

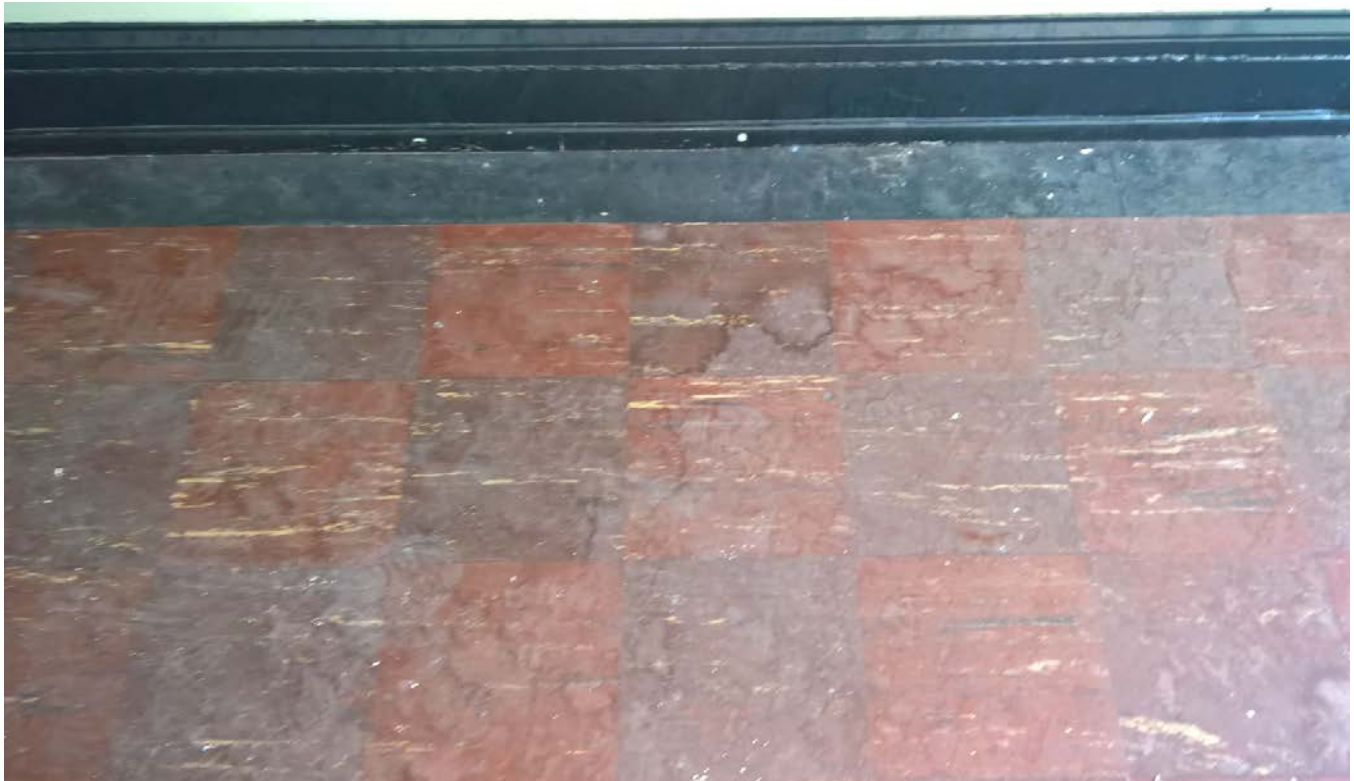
**Photograph No. 10**

American Bank & Trust Co., 1518 Hull Street Richmond VA, Photo of Asbestos Containing Materials: Brown and Red 9"x9" Vinyl Floor Tiles with Black Mastic

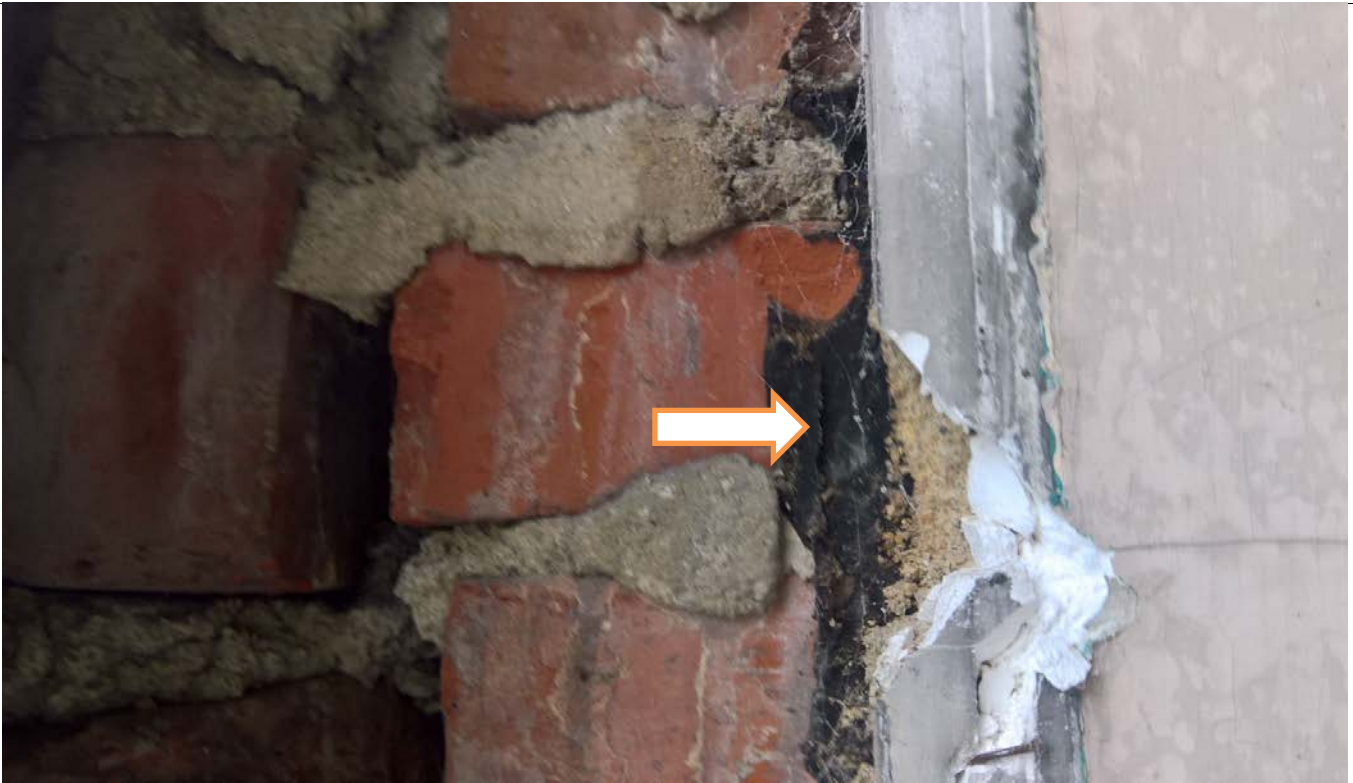
**Photograph No. 11**

MS GROUP	DESCRIPTION	ASBESTOS YES/NO	LOCATION	TOTAL QUANTITY	CATEGORY	CONDITION
R	Black Mastic on Brick	YES	West Exterior Wall behind Concrete/Plaster Facade	1,620 sq ft	Cat II	Good
S	White Pipe Penetration Caulk	NO	3 <sup>rd</sup> Floor	N/A	N/A	N/A

American Bank & Trust Co., 1518 Hull Street Richmond VA, Photo of Asbestos Containing Materials: Black Mastic on Brick (wall)

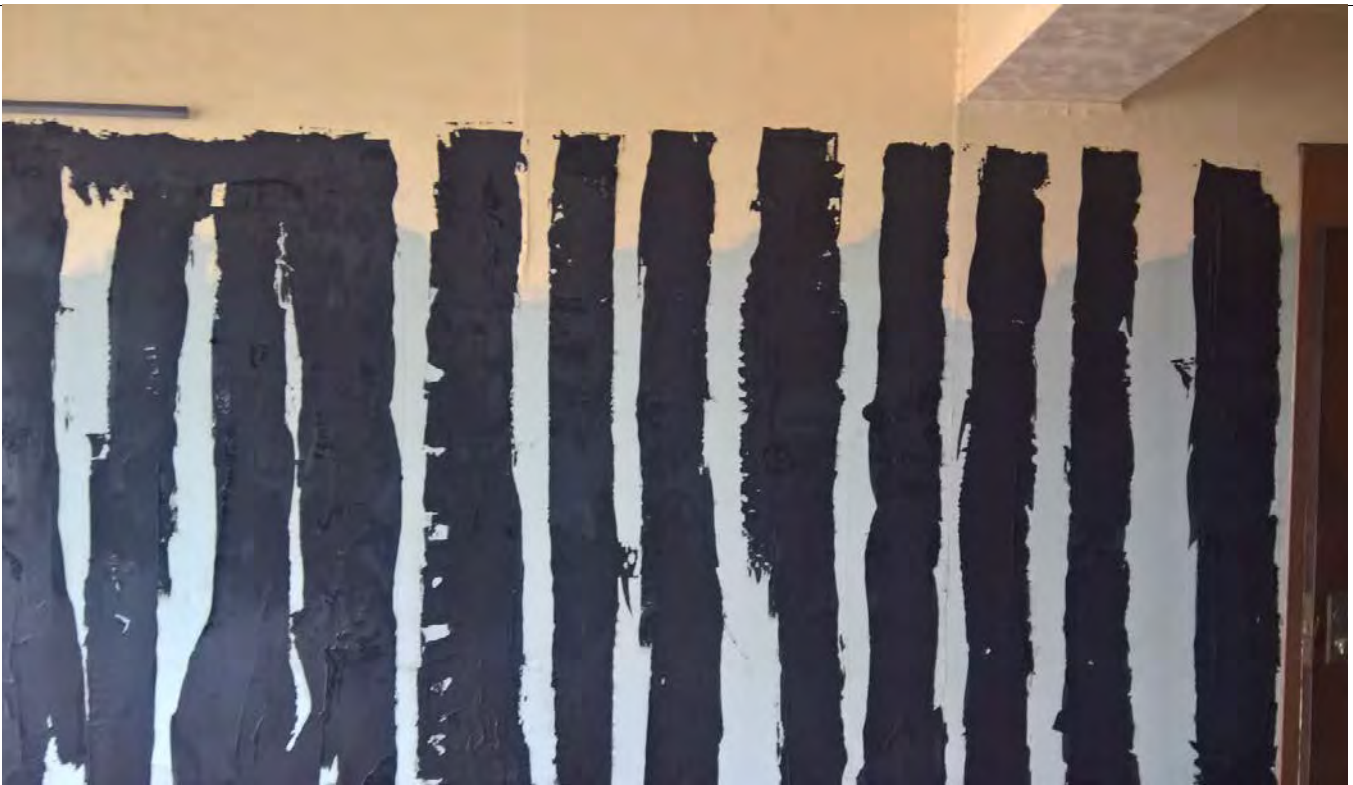
**Photograph No. 12**

American Bank & Trust Co., 1518 Hull Street Richmond VA, Photo of Asbestos Containing Materials: Black Wall Mastic

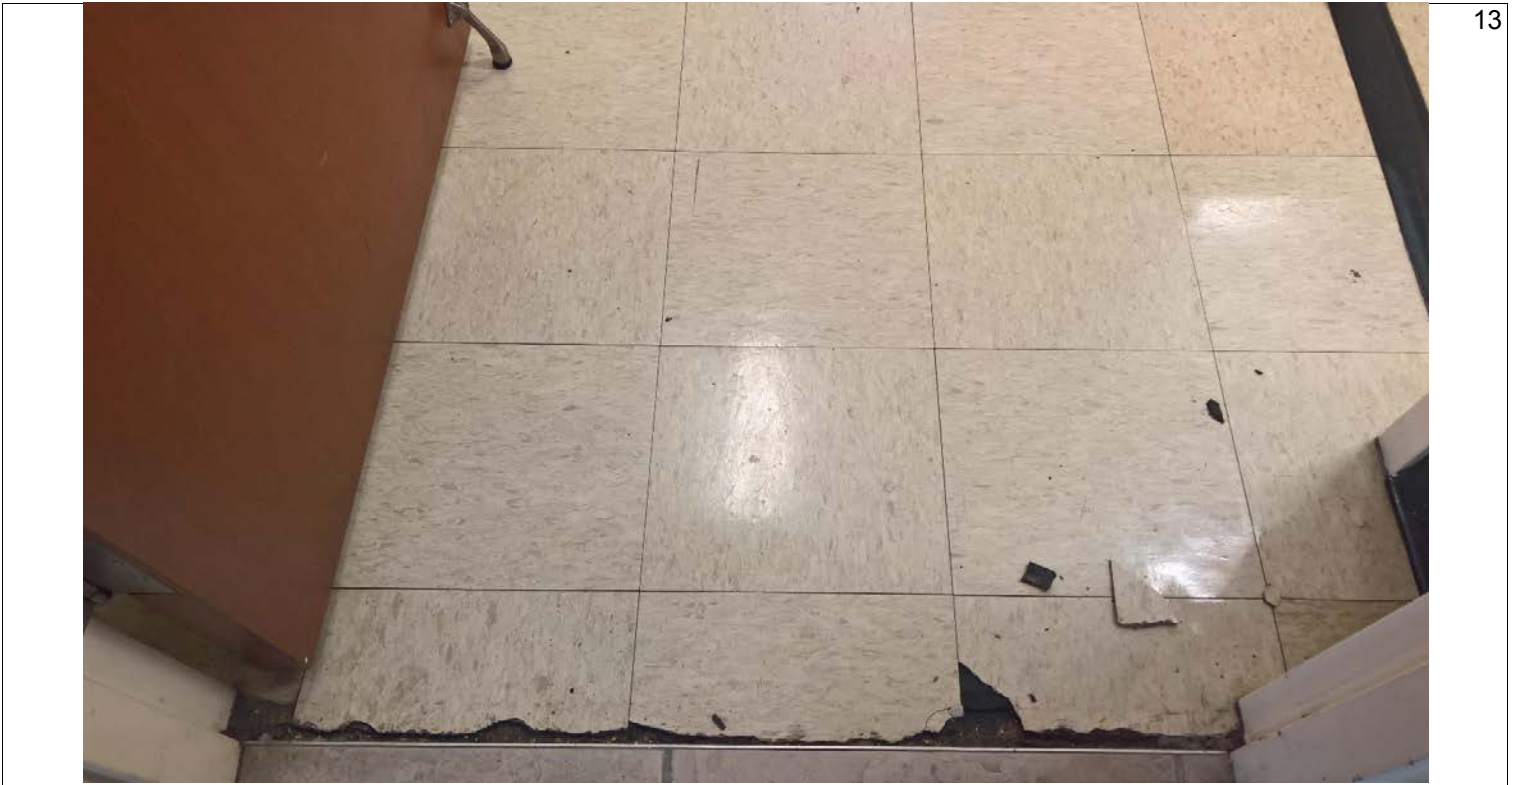
**Photograph No. 13**

American Bank & Trust Co., 1518 Hull Street Richmond VA, Photo of Asbestos Containing Materials: Dark Beige 12"x12" Vinyl Floor Tile with Black Mastic

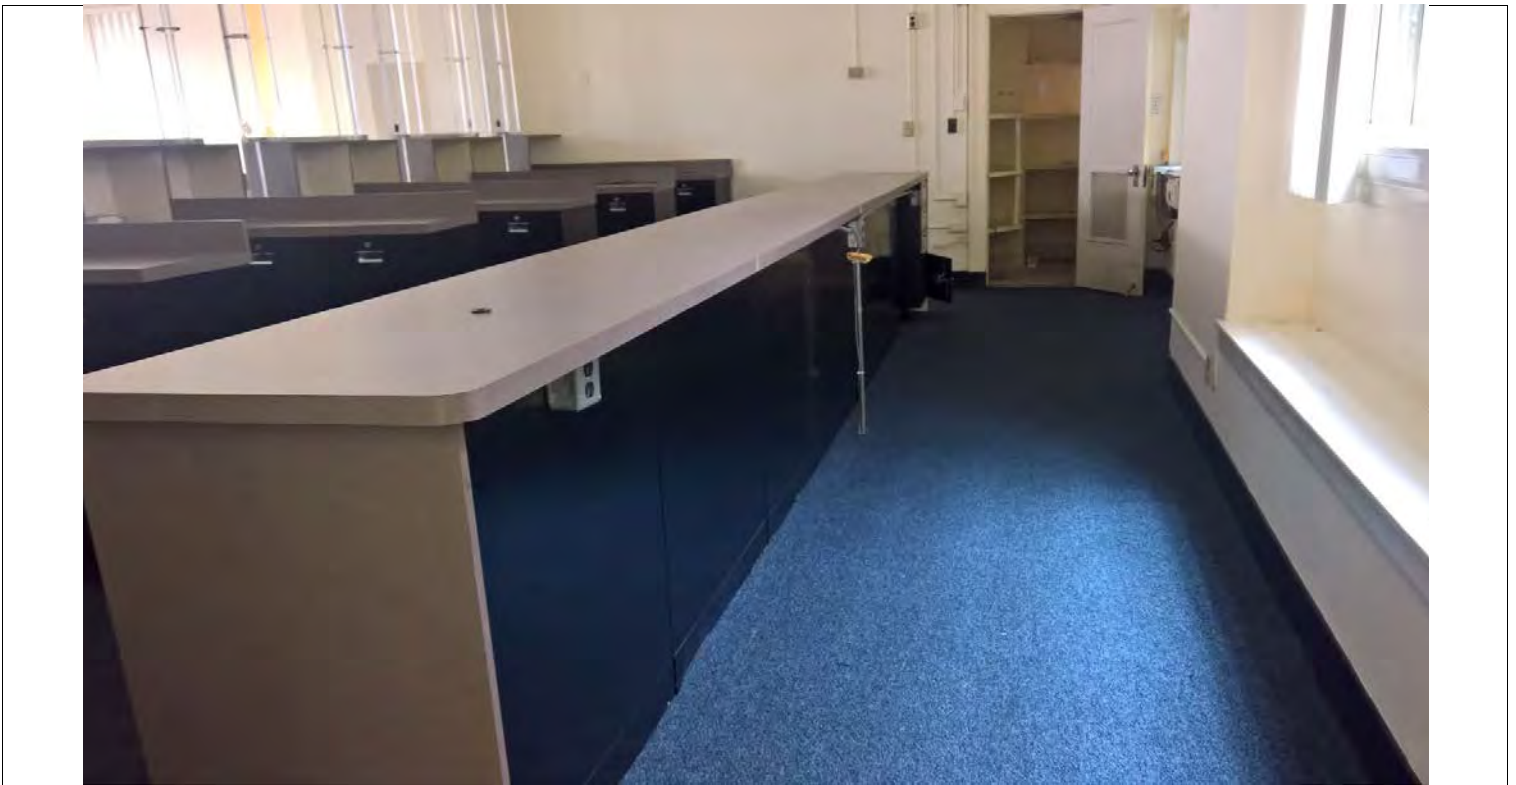
**Photograph No. 14**

American Bank & Trust Co., 1518 Hull Street Richmond VA, Photo of Asbestos Containing Materials: White Flooring (tile) with Black Mastic under carpet

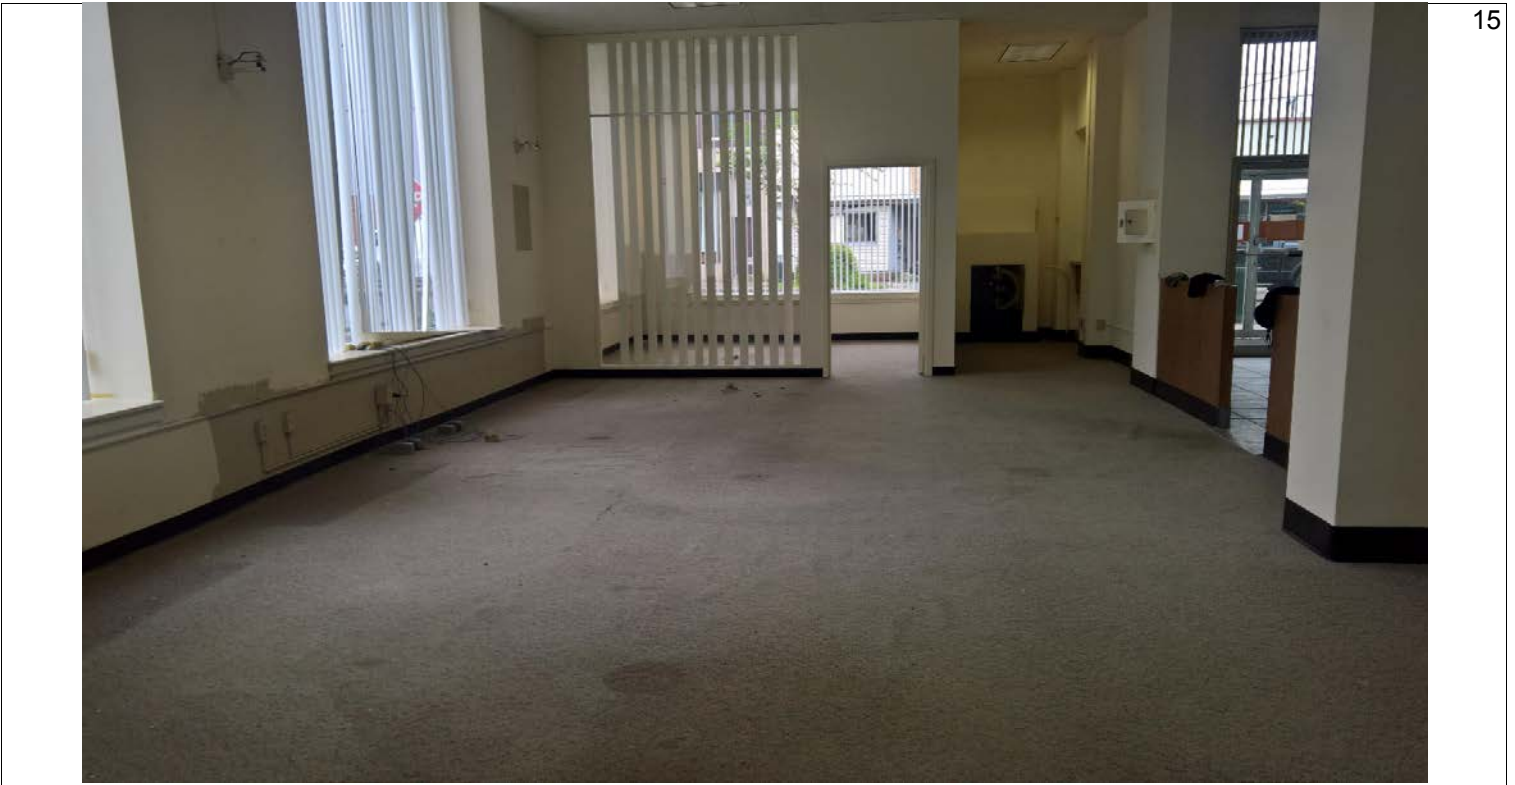
**Photograph No. 15**

American Bank & Trust Co., 1518 Hull Street Richmond VA, Photo of Asbestos Containing Materials: Thick Dark Brown Flooring under carpet and Black Mastic

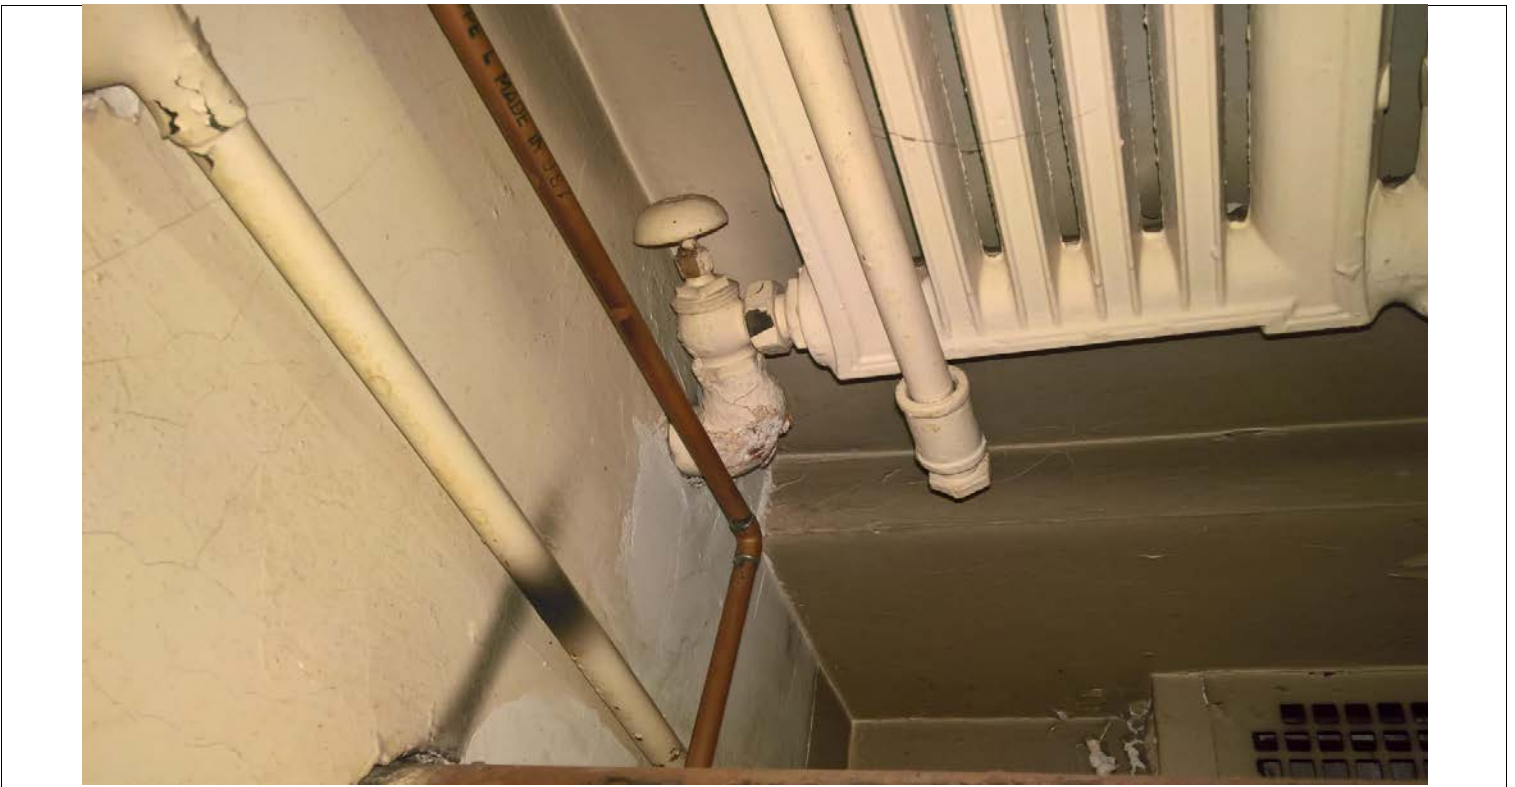
**Photograph No. 16**

MS GROUP	DESCRIPTION	ASBESTOS YES/NO	LOCATION	TOTAL QUANTITY	CATEGORY	CONDITION
3C	White 2" Elbow Mud	YES	Basement Restroom	1	RACM	DAMAGED
PR3E	3" Air Cell Pipe Insulation	Presumed	Basement Restroom Wall Cavity	unknown	RACM	Good

American Bank & Trust Co., 1518 Hull Street Richmond VA, Photo of Asbestos Containing Materials: White 2" Outer Diameter Mudded Joint Packing

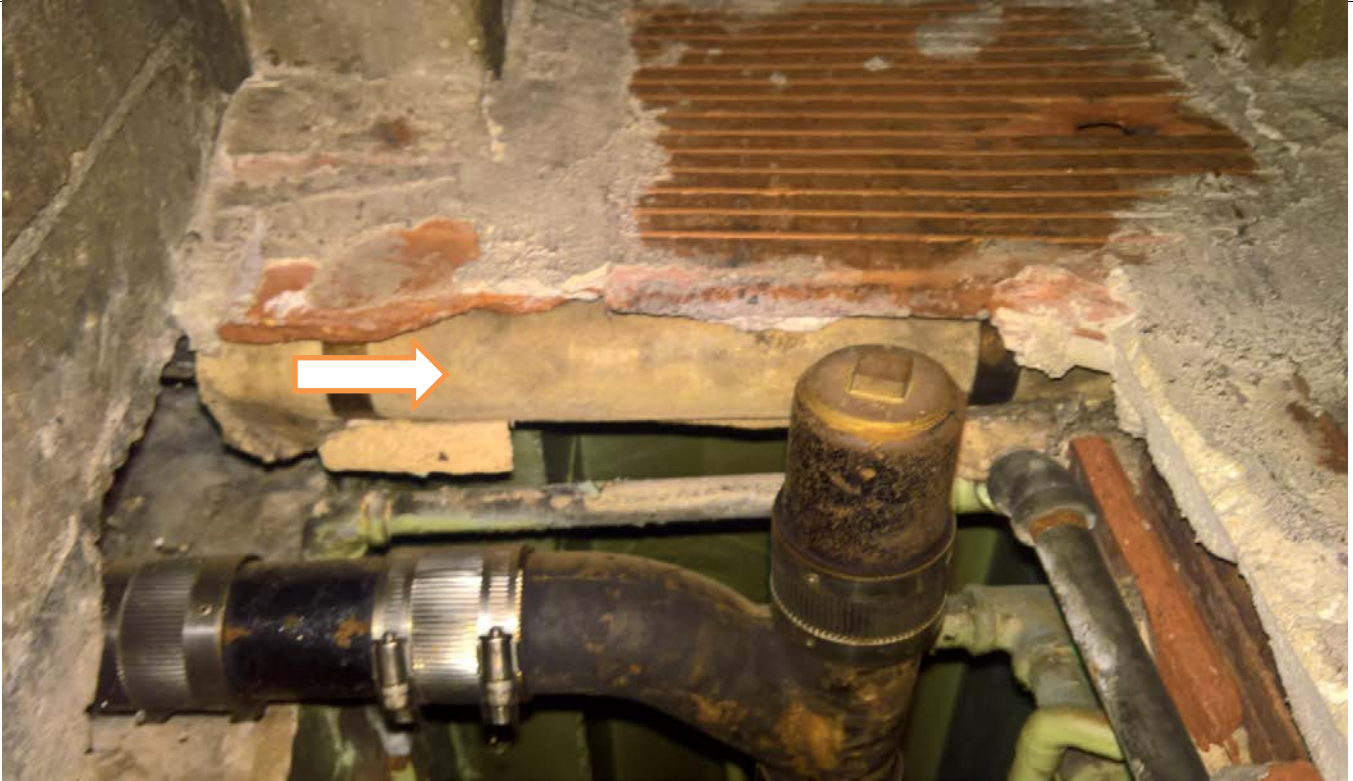
**Photograph No. 17**

American Bank & Trust Co., 1518 Hull Street Richmond VA, Photo of Presumed Asbestos Containing Materials: 3" Outer Diameter Air Cell Pipe insulation

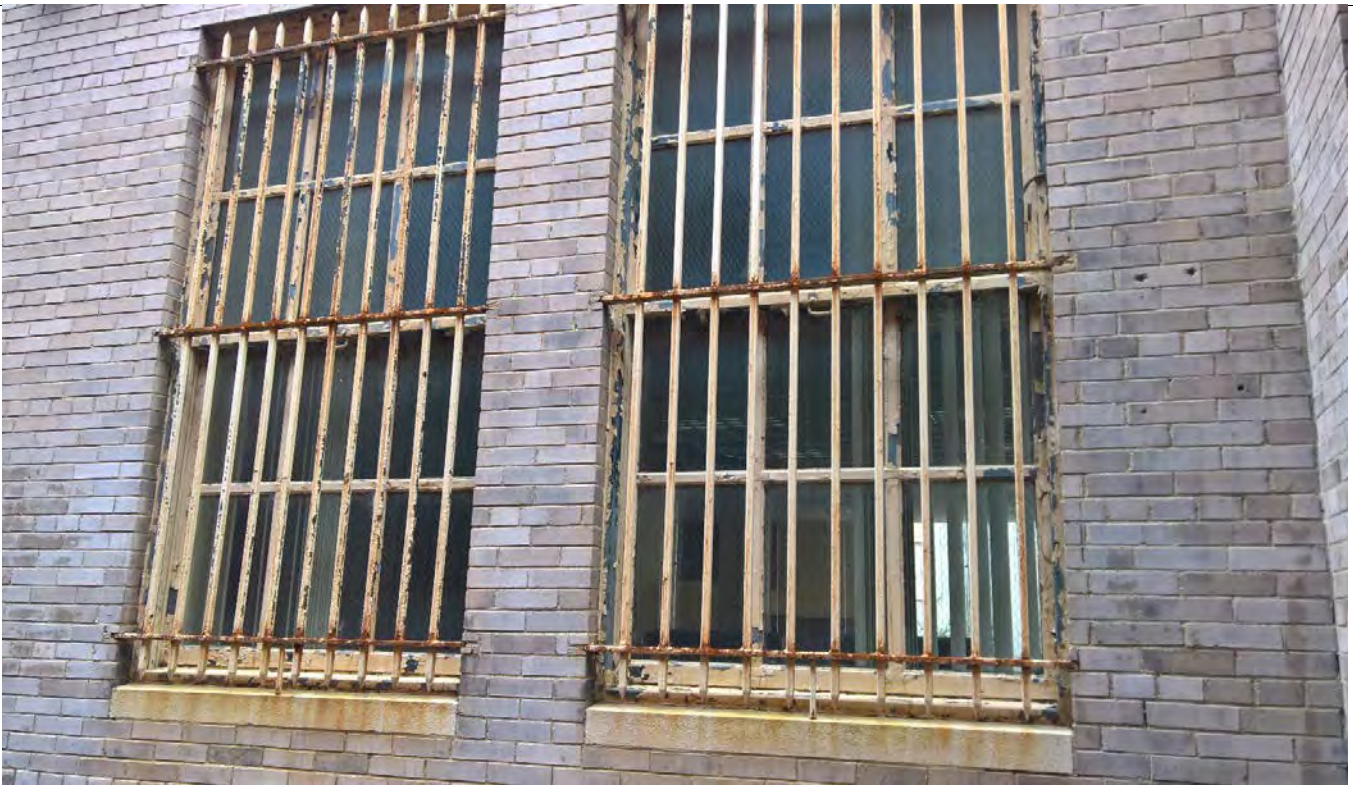
**Photograph No. 18**

American Bank & Trust Co., 1518 Hull Street Richmond VA, Photo of Asbestos Containing Materials: White Window Caulk

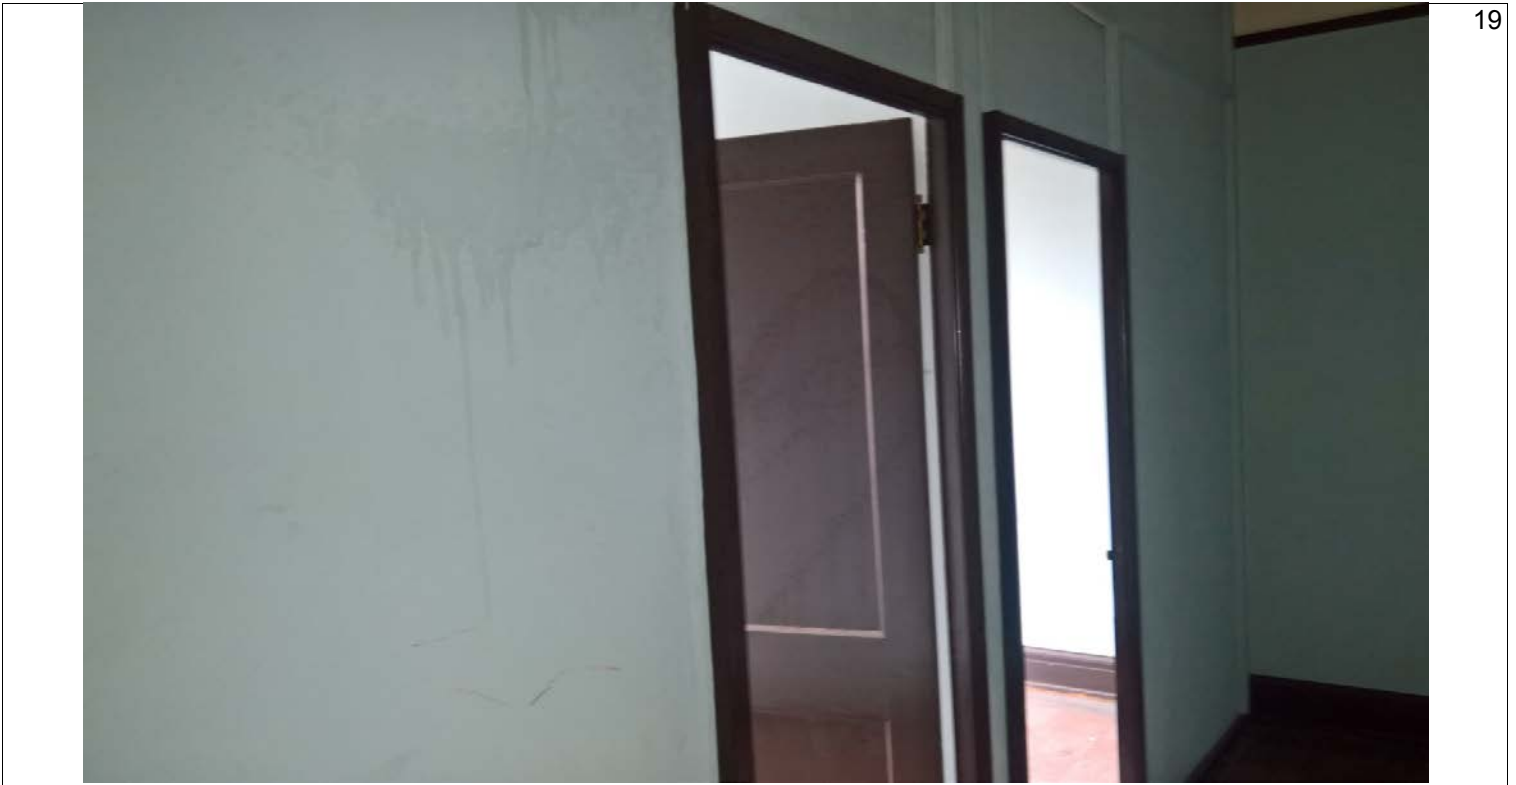
**Photograph No. 19**

OO	White Transite Wall Panel (painted blue)	YES	2 <sup>nd</sup> Floor: Suite 200	160 sq ft	Cat II	Good
PP	White Thick 2'x2' Fissure Lay-In Ceiling Tile	NO	1 <sup>st</sup> Floor Lobby	N/A	N/A	N/A
QQ	Light Grey Mortar under Ceramic Floor Tile	NO	1 <sup>st</sup> Floor Lobby	N/A	N/A	N/A
RR	Orange, Beige, and Tan Vinyl Cove Base Mastic	NO	1 <sup>st</sup> Floor Lobby	N/A	N/A	N/A

American Bank & Trust Co., 1518 Hull Street Richmond VA, Photo of Pressumed Asbestos Containing Materials: White Transite Wall Paneling
