RE: Comprehensive Asbestos Survey Report  
American Bank & Trust Company Building  
**1518 Hull Street**  
Richmond, VA 23224  
FEI Project Number: FEI-19AL171

# **ASBESTOS SURVEY REPORT**

**AMERICAN BANK & TRUST COMPANY  
1518 HULL STREET  
RICHMOND, VIRGINIA 23219**

FEI PROJECT NO. FEI-19AL171

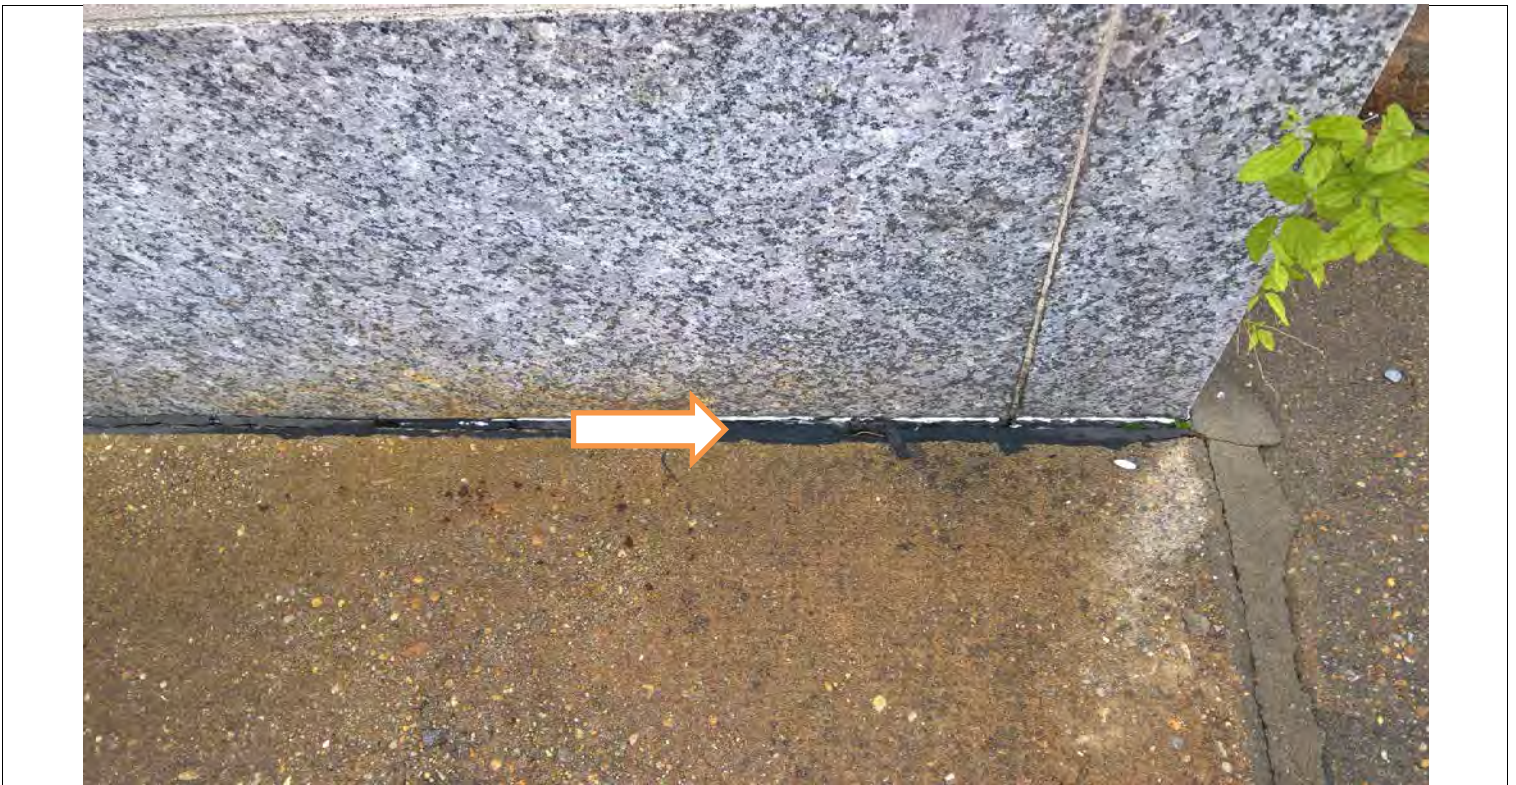
**Photograph No. 20**

American Bank & Trust Co., 1518 Hull Street Richmond VA, Photo of Pressumed Asbestos Containing Materials: Black and White Sidewalk Caulk

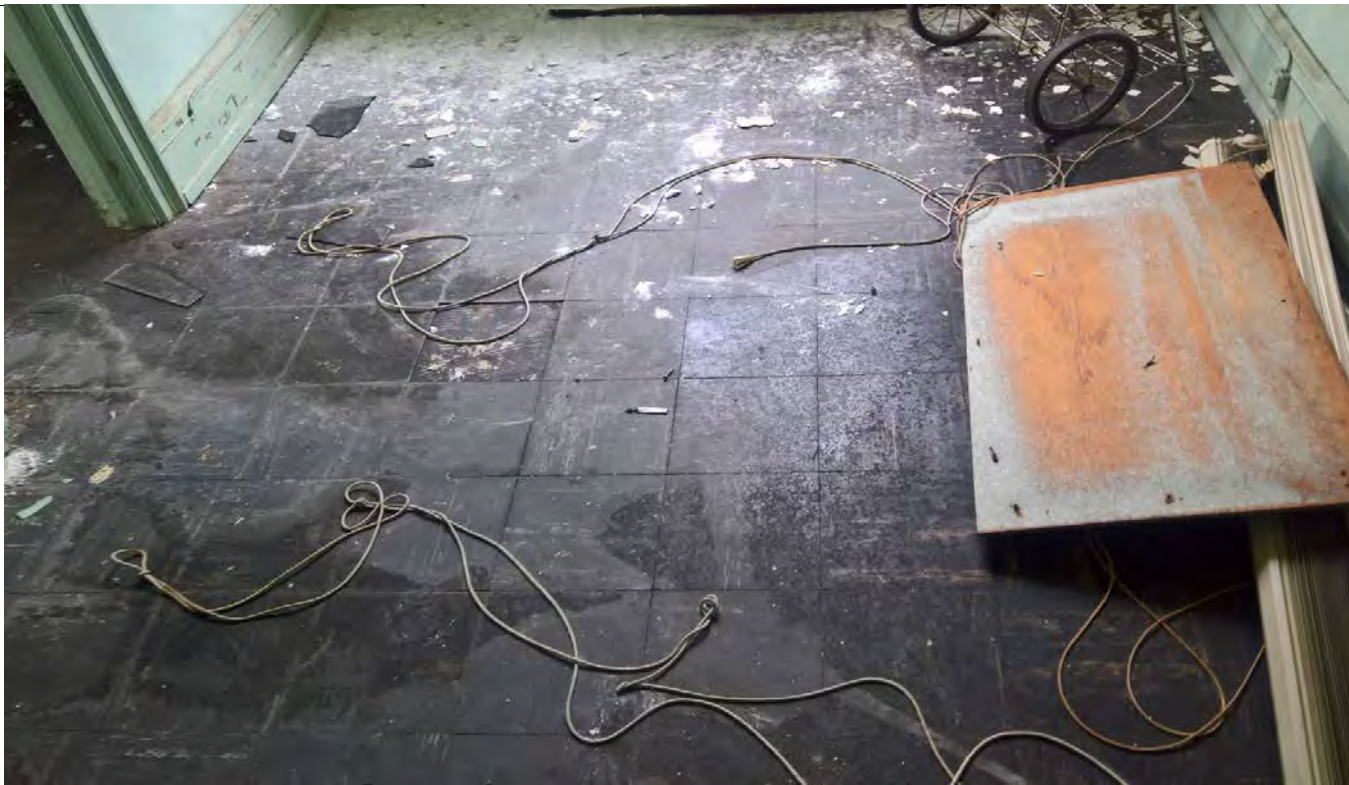
**Photograph No. 21**

American Bank & Trust Co., 1518 Hull Street Richmond VA, Photo of Pressumed Asbestos Containing Materials: Black 9"x9" Vinyl Floor Tile (with Streaks) with Black Mastic

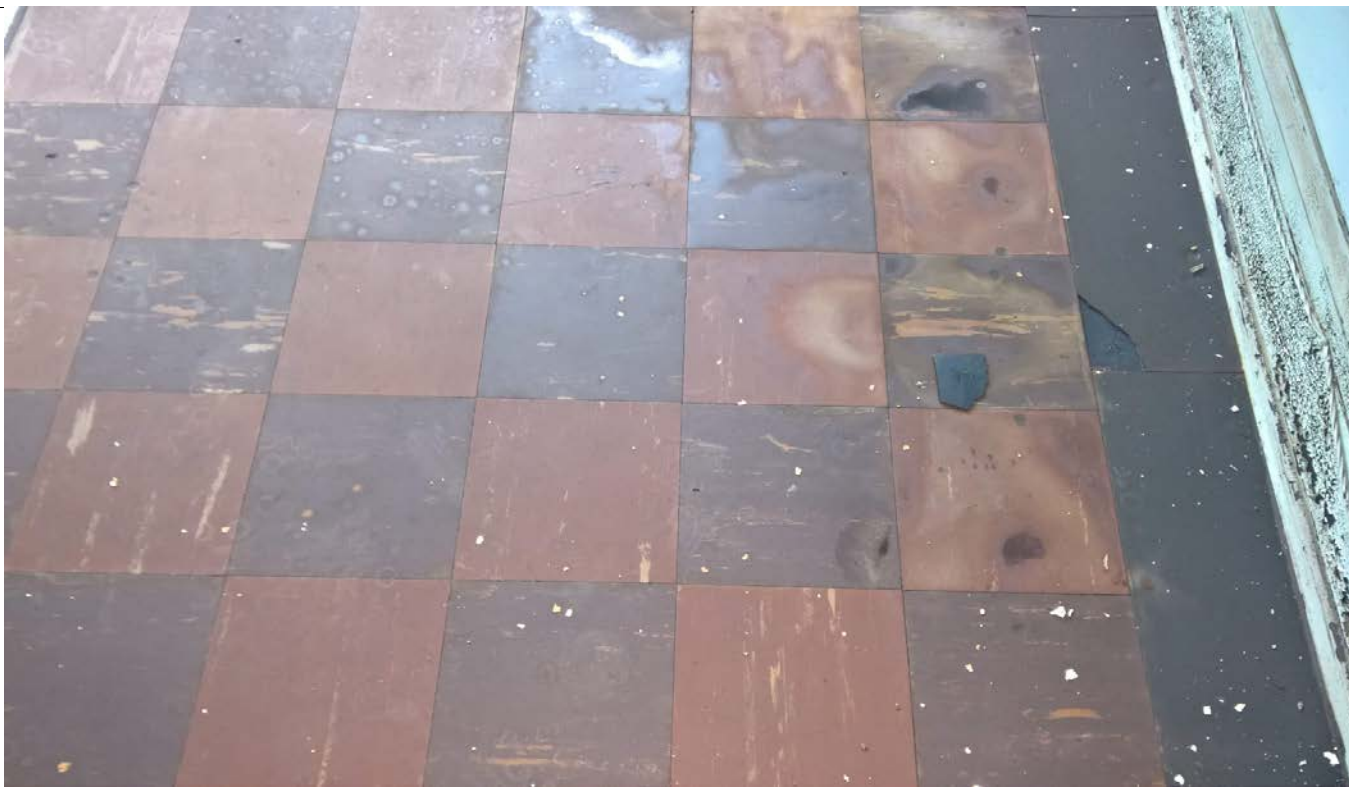
**Photograph No. 22**

American Bank & Trust Co., 1518 Hull Street Richmond VA, Photo of Pressumed Asbestos Containing Materials: Dark Brown and Red 9"x9" Vinyl Floor Tiles and Black 24"x24" Vinyl Floor Tile and Black Mastic (24" floor tile has been cut to fit for border)

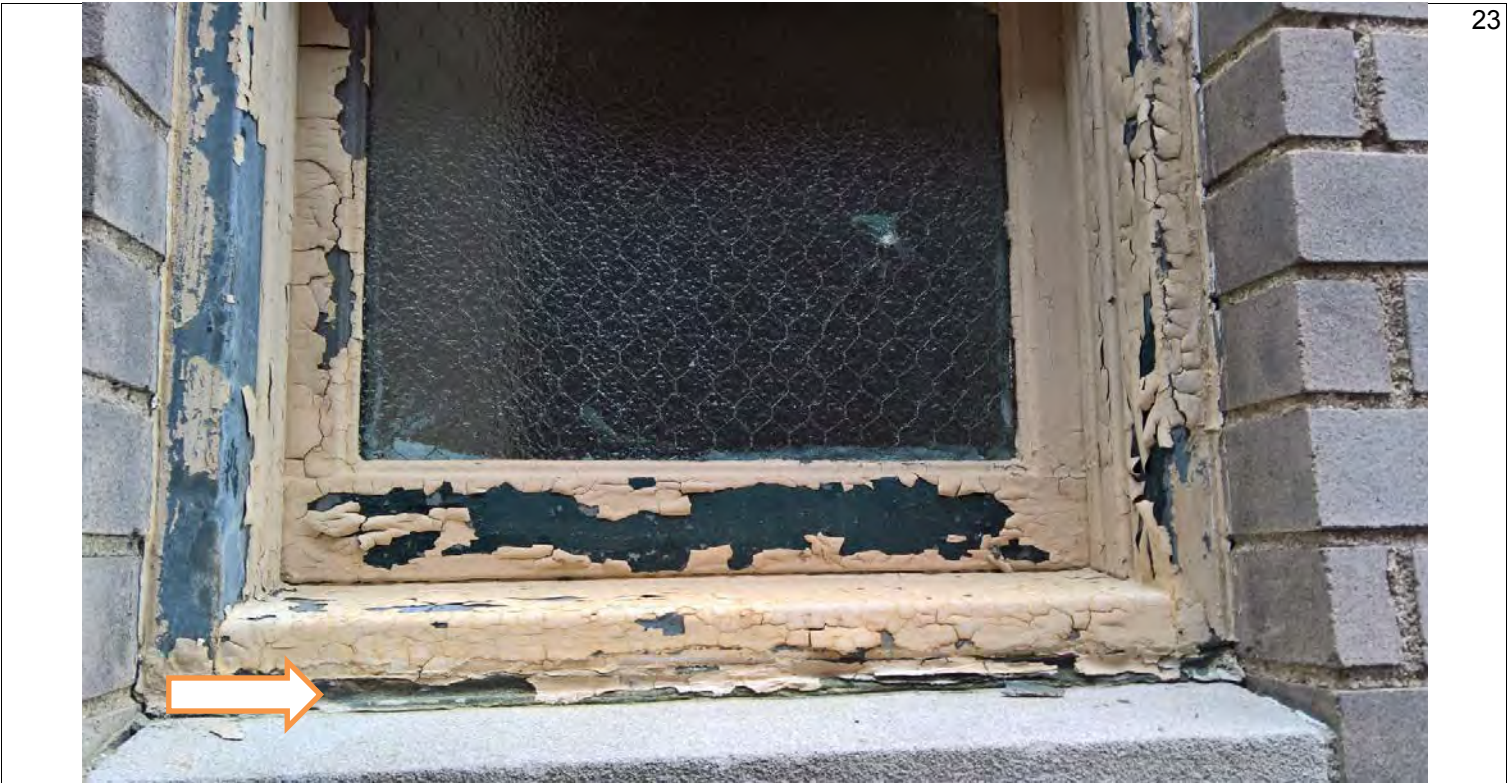
**Photograph No. 23**

American Bank & Trust Co., 1518 Hull Street Richmond VA, Photo of Presumed Asbestos Containing Materials: White Window Caulk

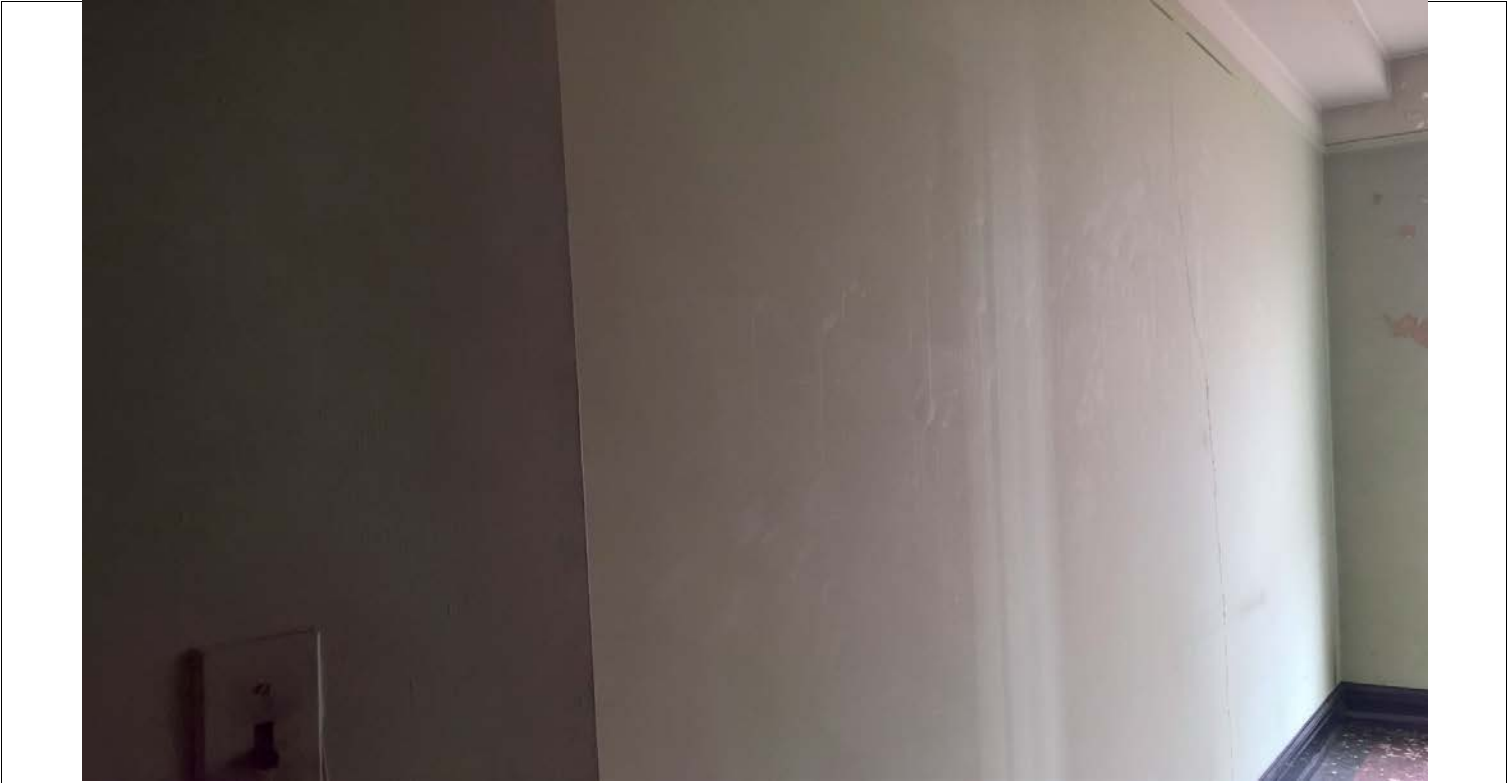
**Photograph No. 24**

American Bank & Trust Co., 1518 Hull Street Richmond VA, Photo of Presumed Asbestos Containing Materials: Pink Joint Compound associated with White Wall Drywall
