RE: Lead-Based Paint (LBP) Survey Report
American Bank & Trust Co. Building
Entire Building Renovation Project
1518 Hull Street
Richmond, Virginia 23224
FEI Project Number: FEI-19AL171

LEAD-BASED PAINT SURVEY REPORT

**AMERICAN BANK & TRUST CO.
(VACANT COMMERCIAL BUILDING)
1818 HULL STREET
RICHMOND, VIRGINIA 23224**

FEI PROJECT NO. FEI-19AL171

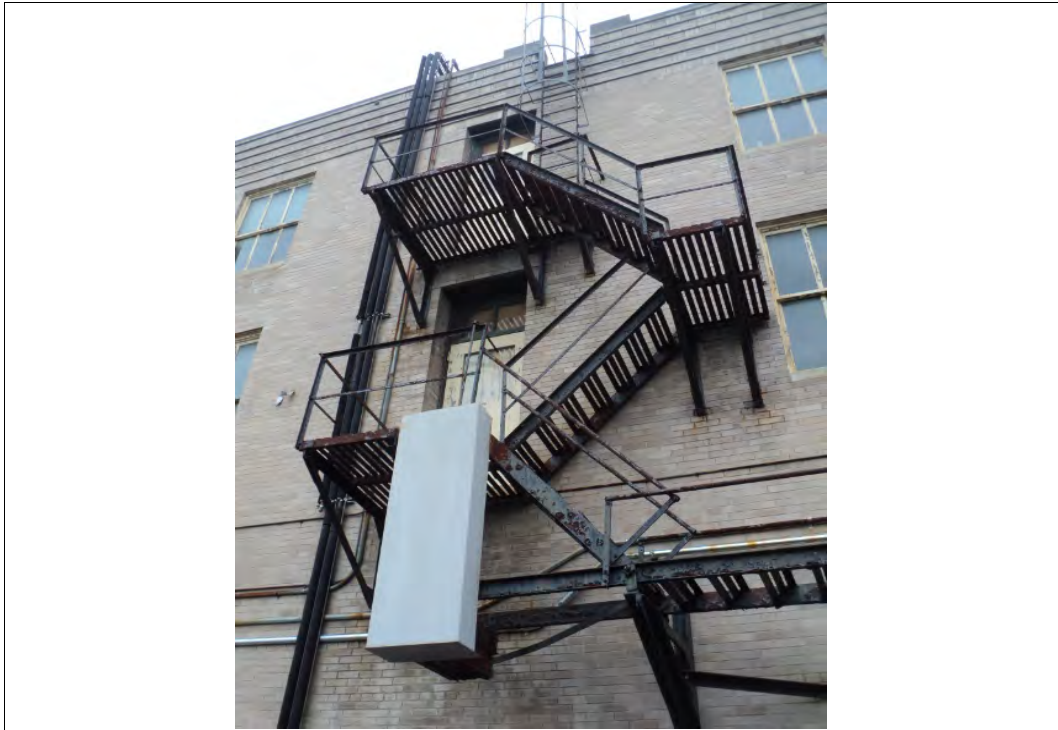
Photograph No. 1
Black Painted Metal Fire Escpae Components
(XRF Shot #'s 4-8)

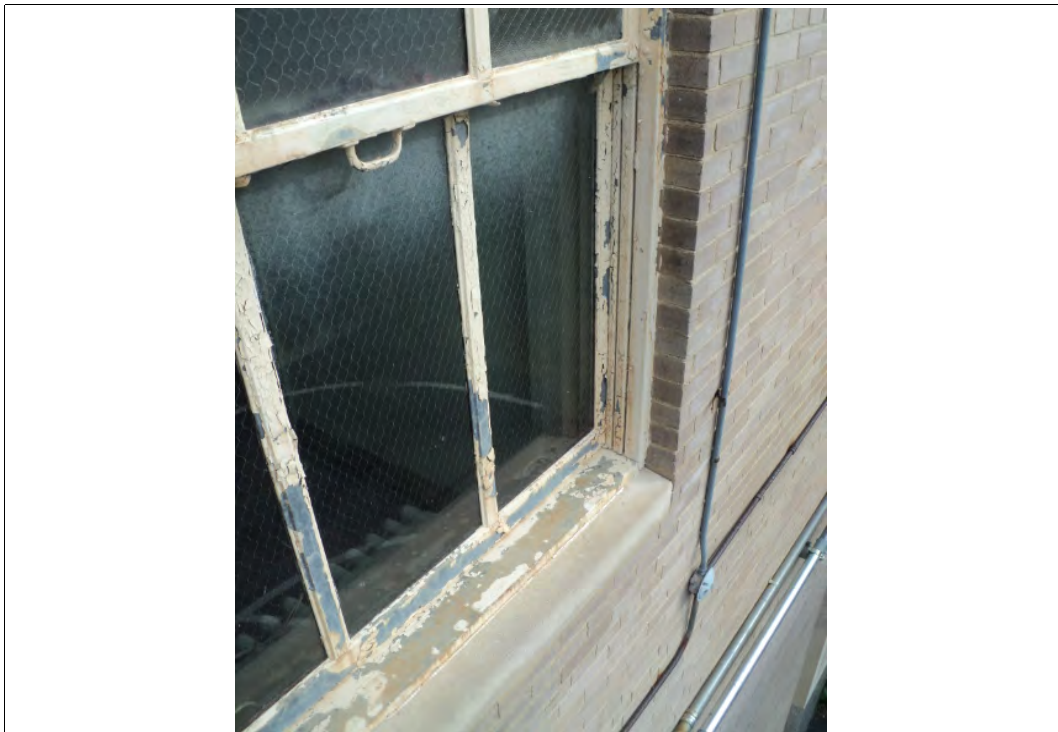
Photograph No. 2
Cream Painted Metal Exterio Window Components
(XRF Shot #'s 9-12)

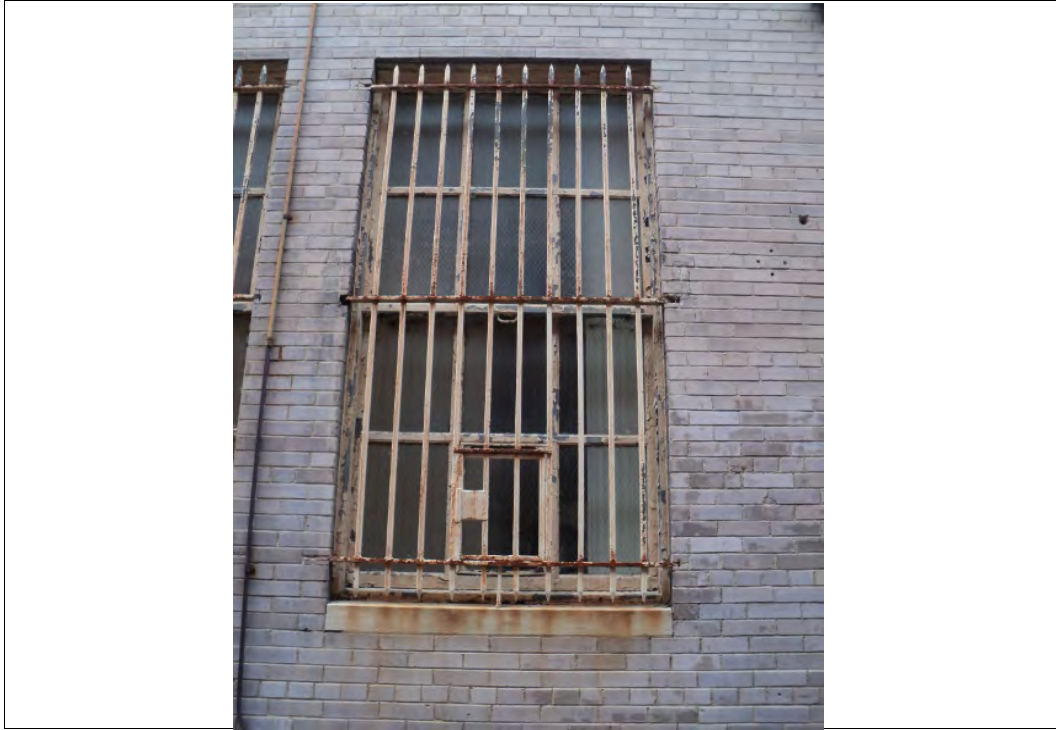
Photograph No. 3

Cream Painted Metal Exterio Window Components with Security Bars
(XRF Shot #'s 15-19)

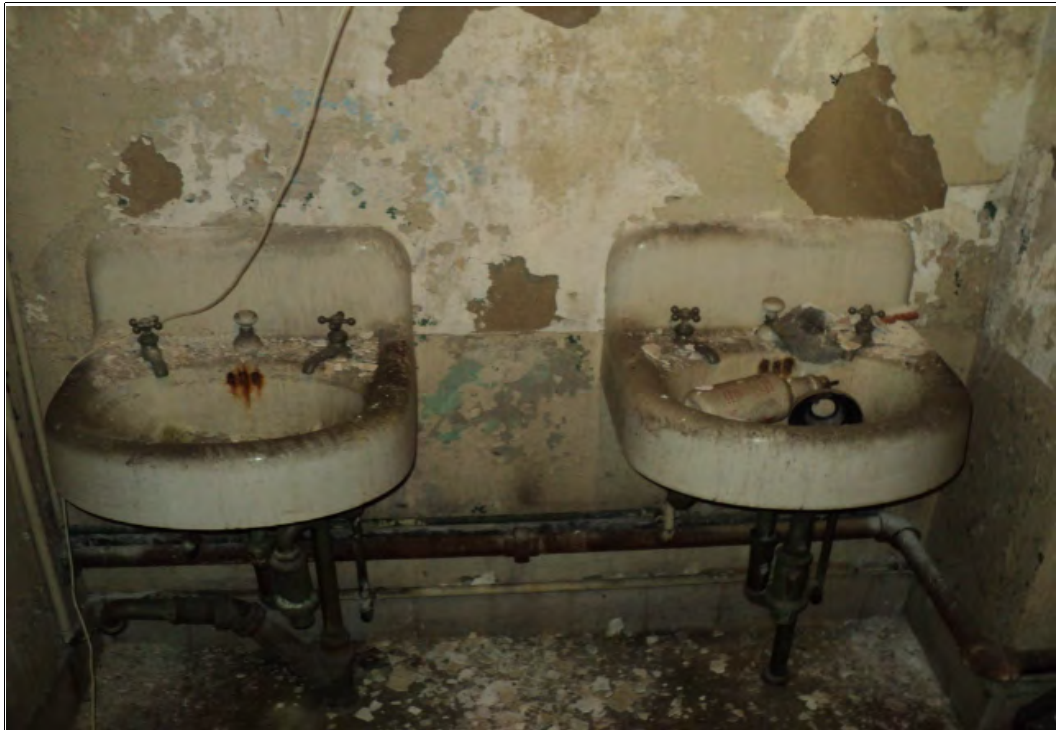
Photograph No. 4

White Ceramic Glazed Sinks (Original)
(XRF Shot #'s 27,60,98,196,201 & 224)

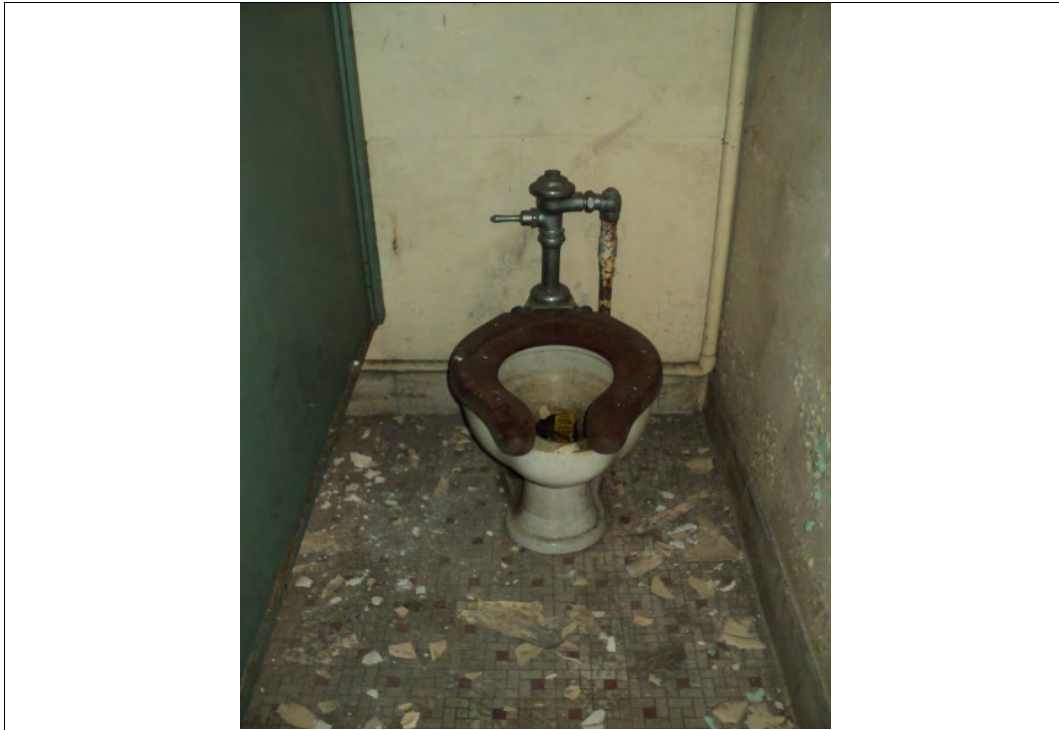
Photograph No. 5

White Ceramic Glazed Lavatory (Original)
(XRF Shot #'s 28 & 61)

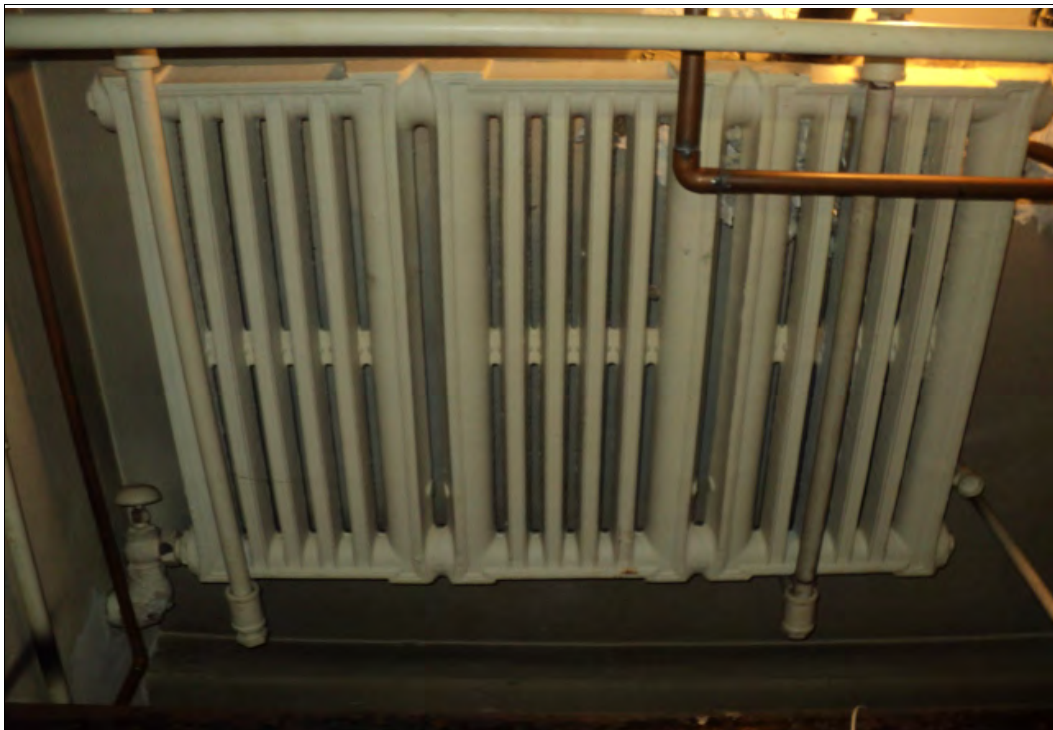
Photograph No. 6

Cream / Tan Painted Metal Radiators
(XRF Shot #'s 31, 40,214)

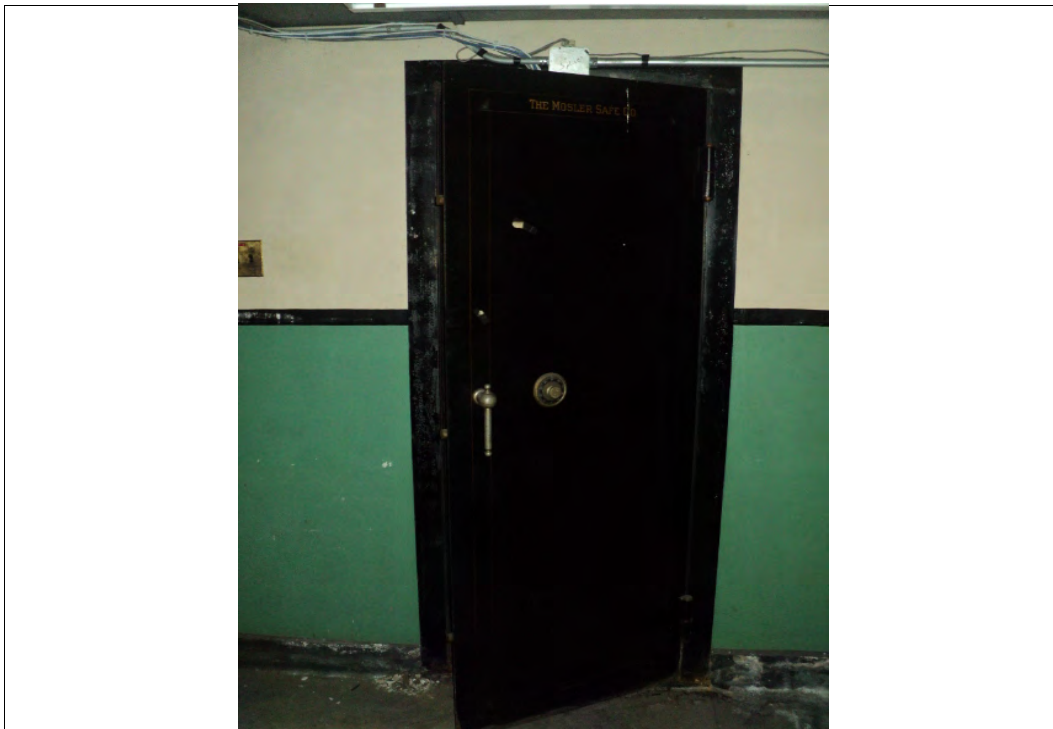
Photograph No. 7
Black Painted Metal Vault Door & Casing
(XRF Shot #'s 47 & 48)

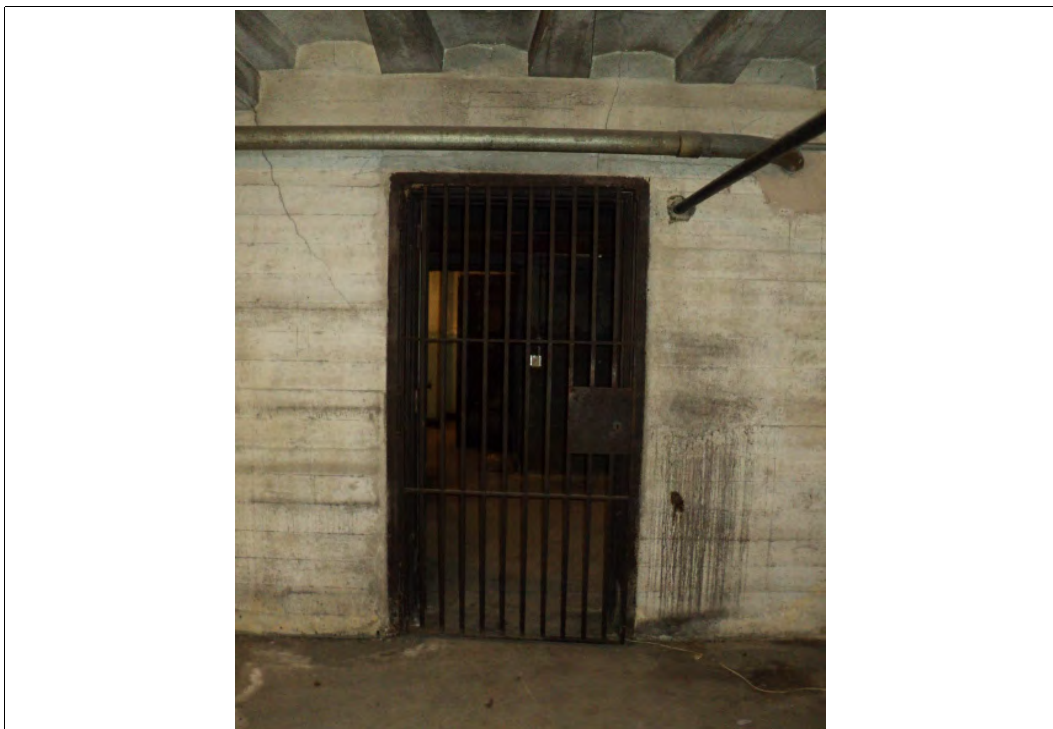
Photograph No. 8
Black Painted Metal Security Door & Casing
(XRF Shot #'s 50-51)

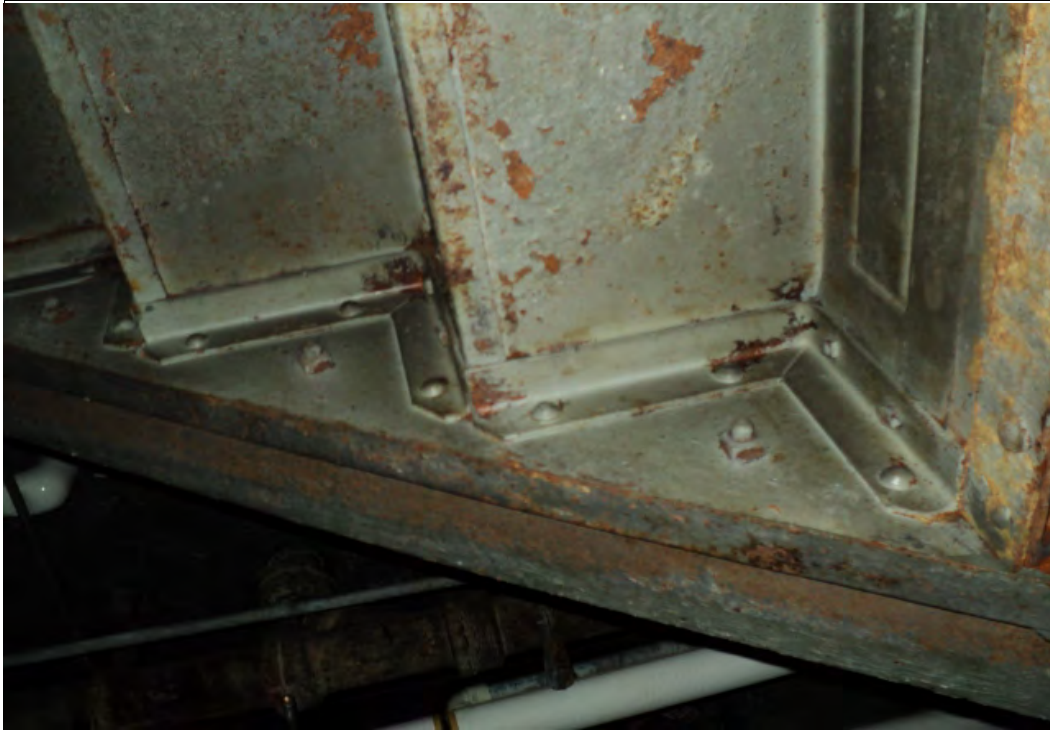
Photograph No. 9
Gray Painted Stair Components
(XRF Shot #'s 63-65)

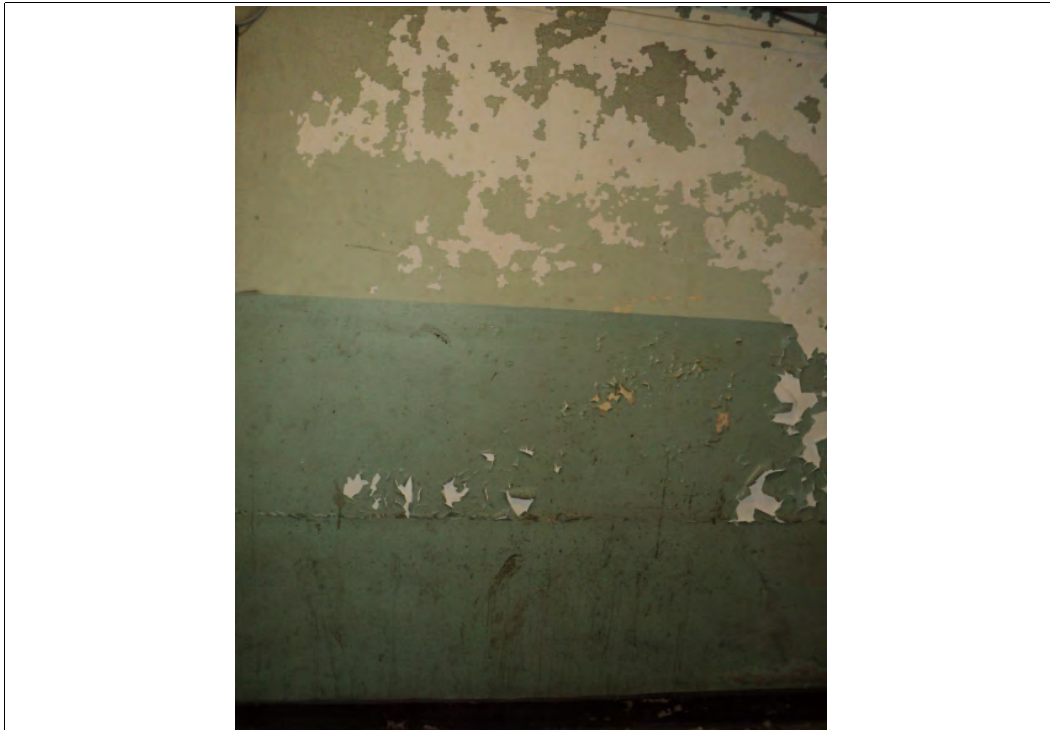
Photograph No. 10
Dark Green Painted Plaster Walls
(XRF Shot #'s 69,80,91,170 & 253)

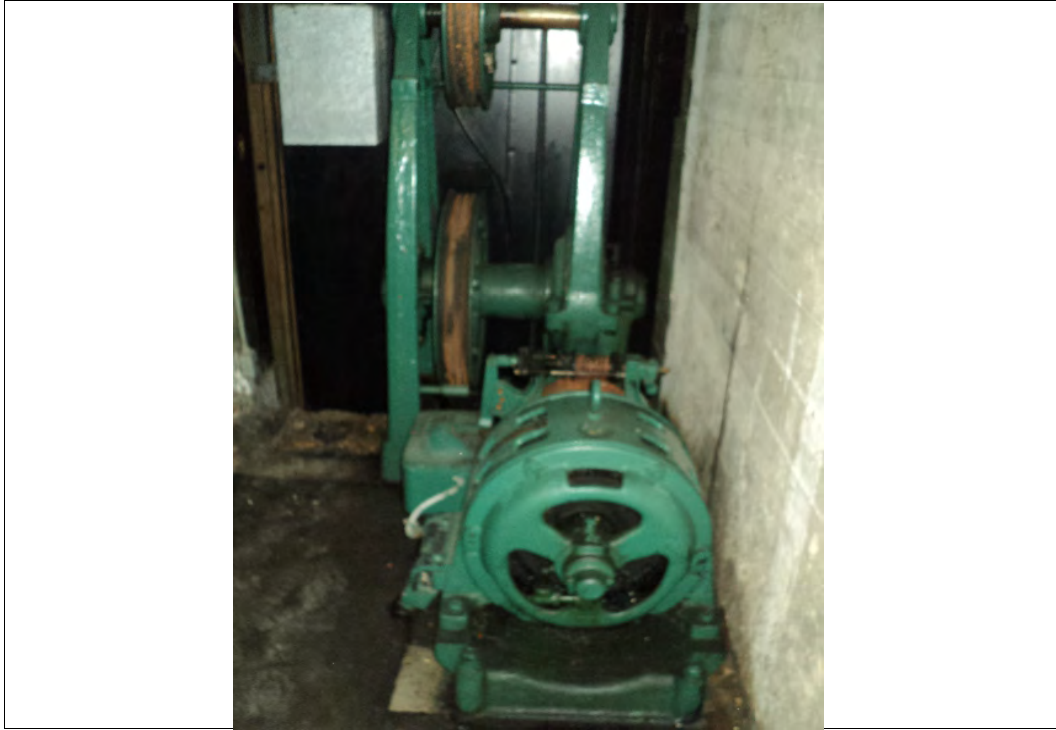
Photograph No. 11
Green Painted Metal Elevator Motor Equipment
(XRF Shot #'s 73 & 74)

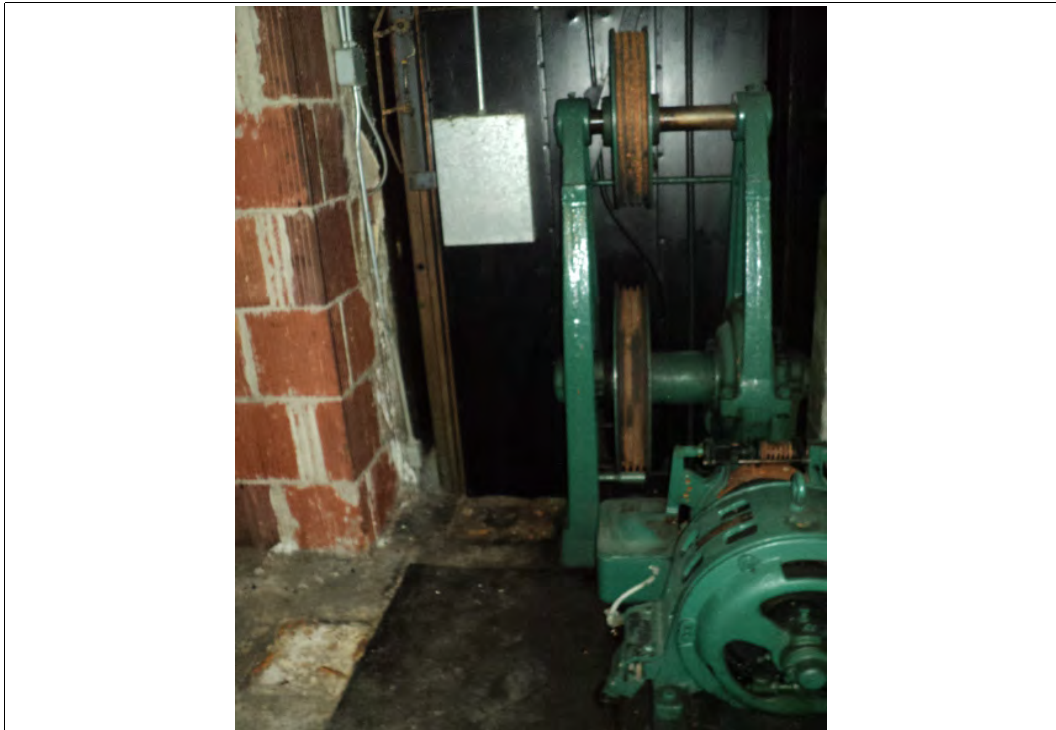
Photograph No. 12
Black Painted Elevator Car Exterior Walls
(XRF Shot # 75)

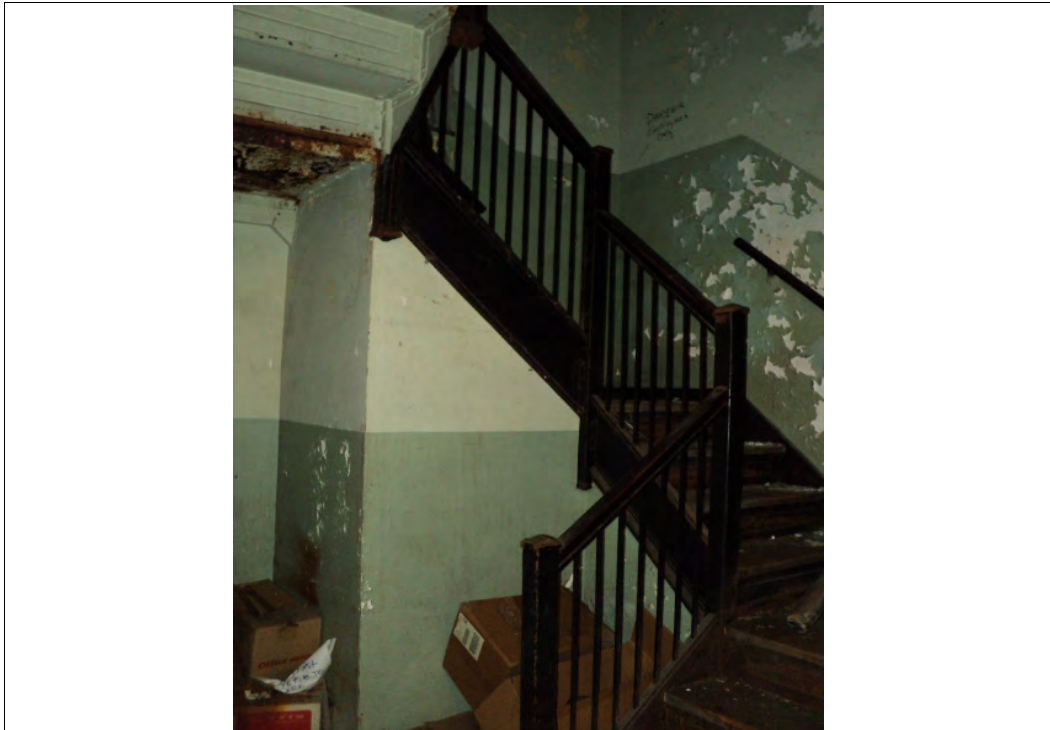
Photograph No. 13
Black Painted Metal Stair Components
(XRF Shot #'s 81,83,85,167 & 168)

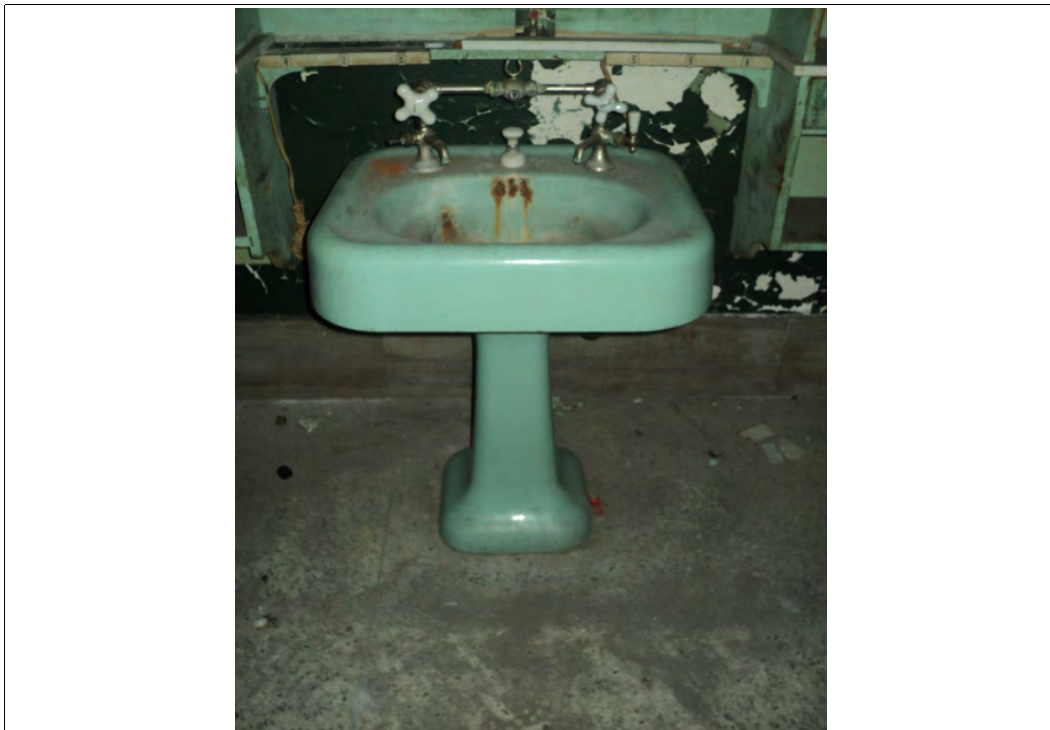
Photograph No. 14
Blu Ceramic Glazed Sinks
(XRF Shot # 86)

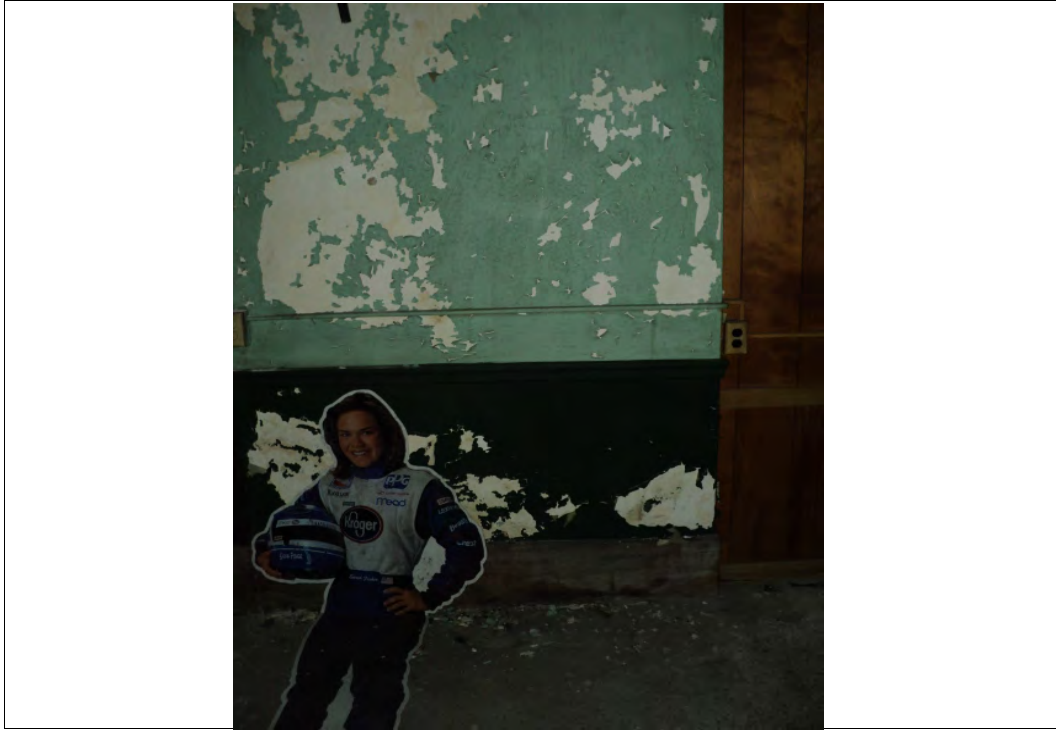
Photograph No. 15
Light Green Painted Plaster Wall
(XRF Shot # 90)

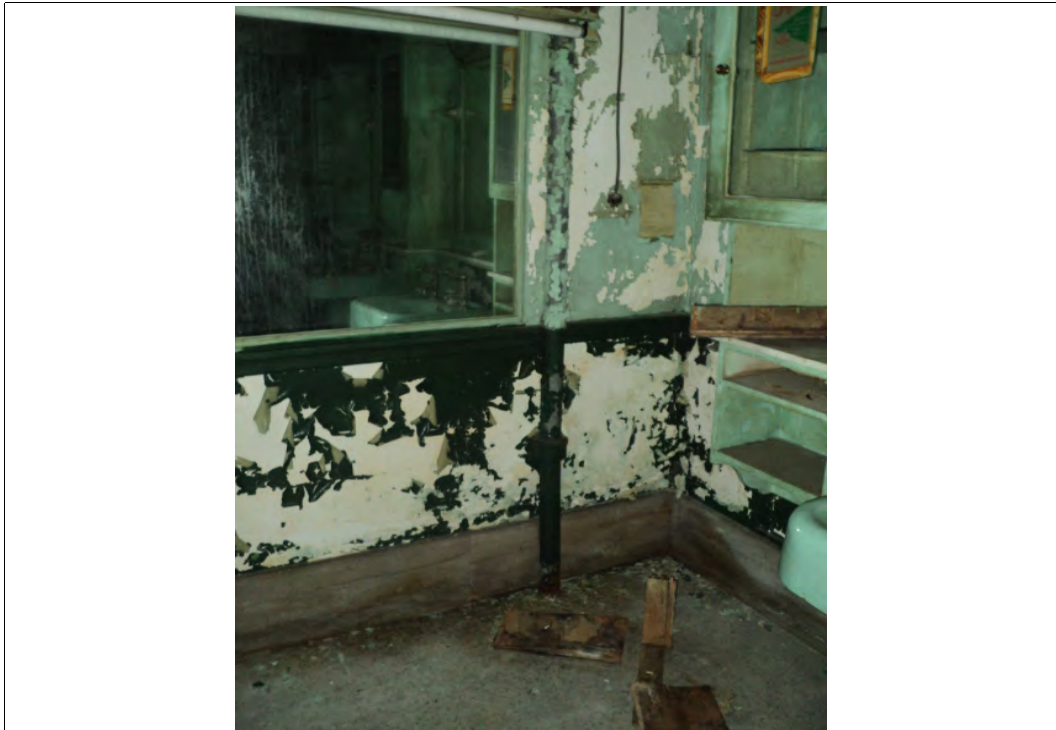
Photograph No. 16
Green Painted Metal Pipe
(XRF Shot #'s 94-94)

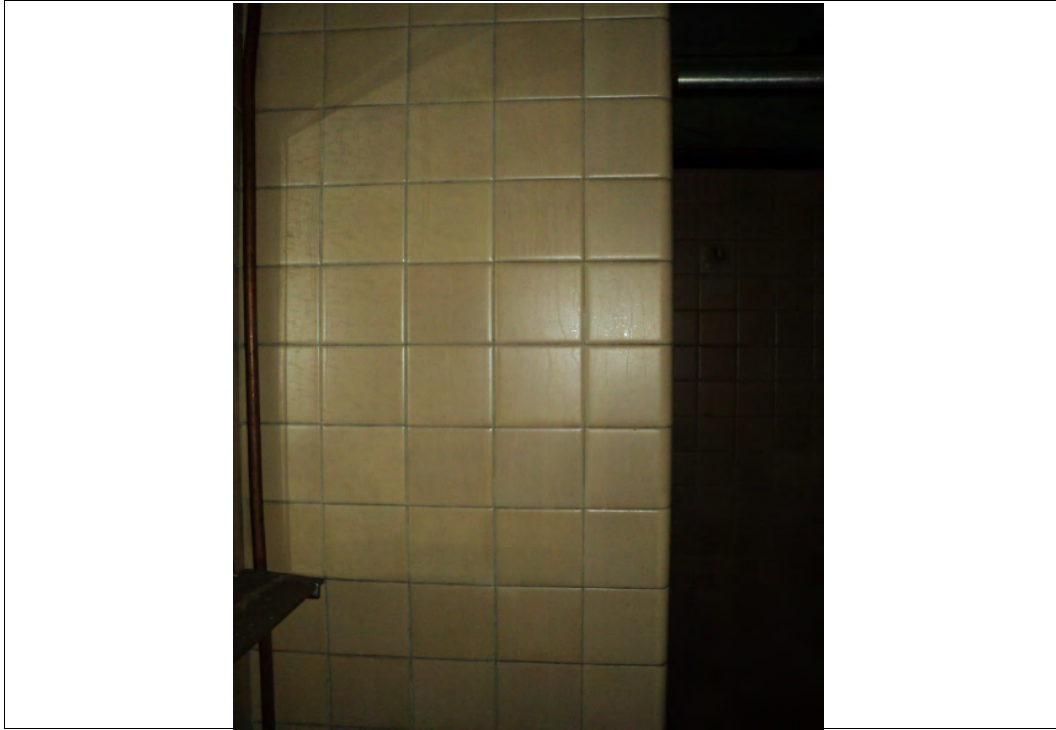
Photograph No. 17
Tan Ceramic Glazed Wall Tile
(XRF Shot # 97)

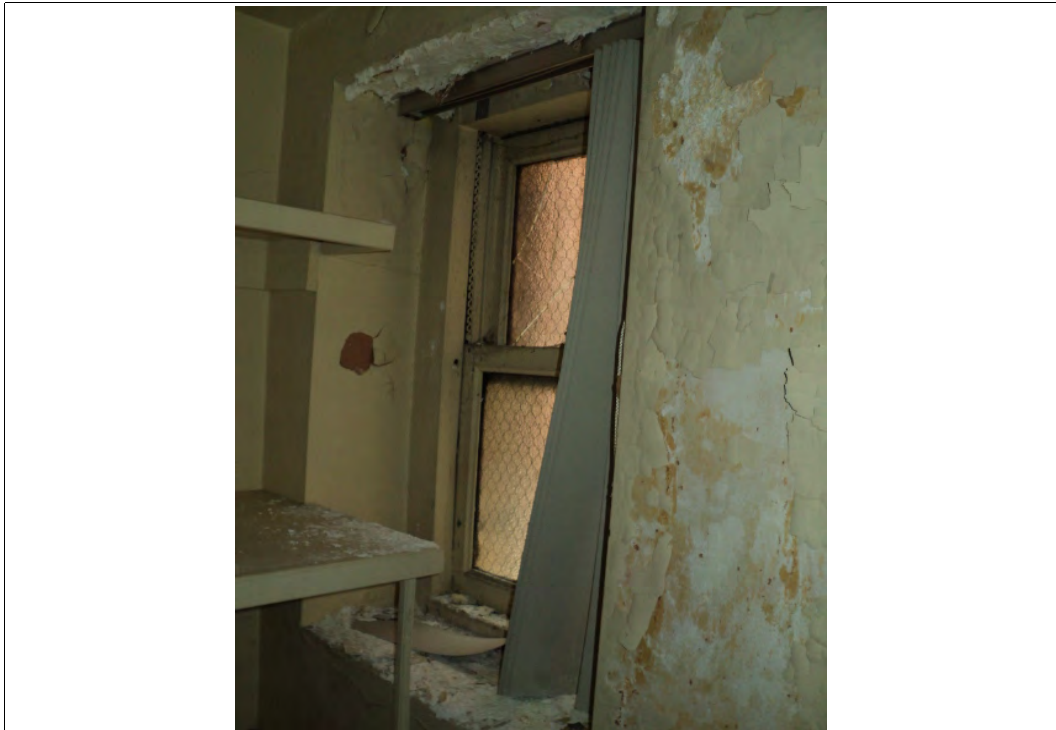
Photograph No. 18
Cream Painted Metal Window Components
(XRF Shot #'s 158-159)

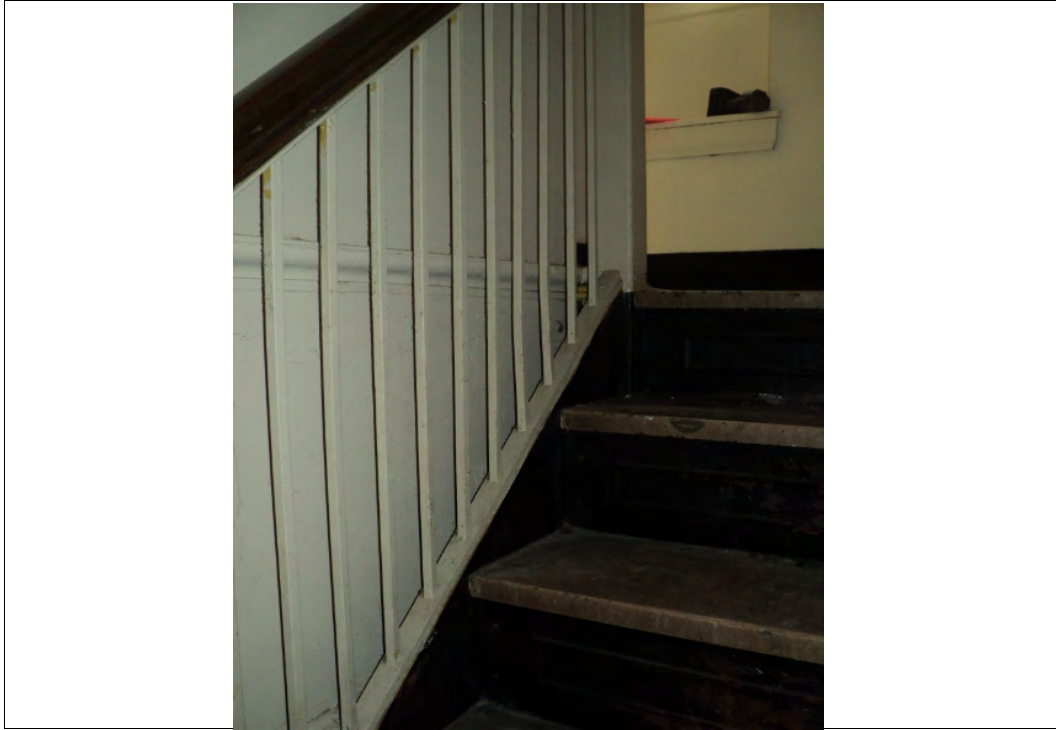
Photograph No. 19
Cream Painted Metal Stair Components
(XRF shot #'s 165-166)

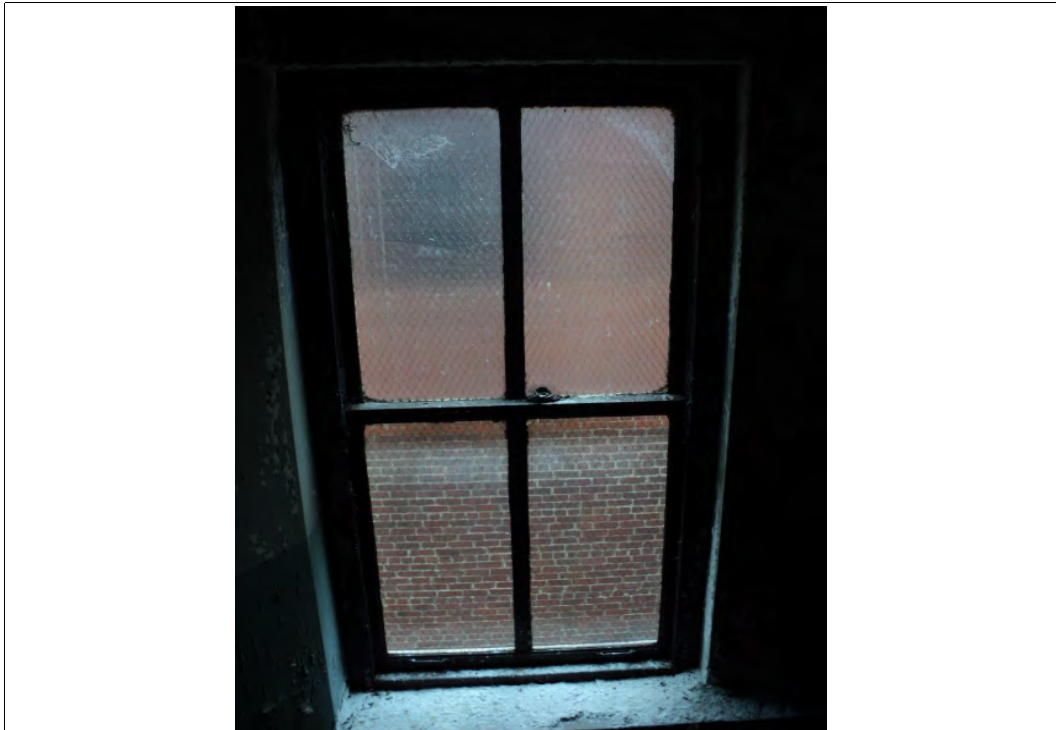
Photograph No. 20
Brown Painted Metal Window Components
(XRF Shot #'s 175-176)

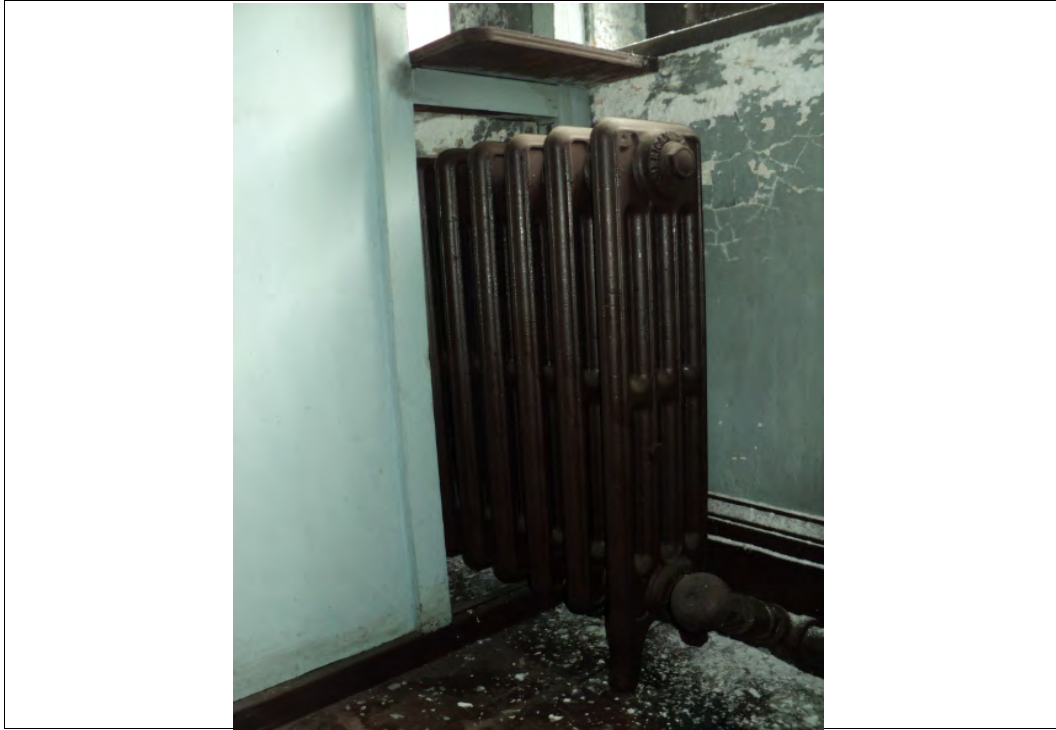
Photograph No. 21
Brown Painted Metal Radiators
(XRF shot #'s 179,197 & 238)

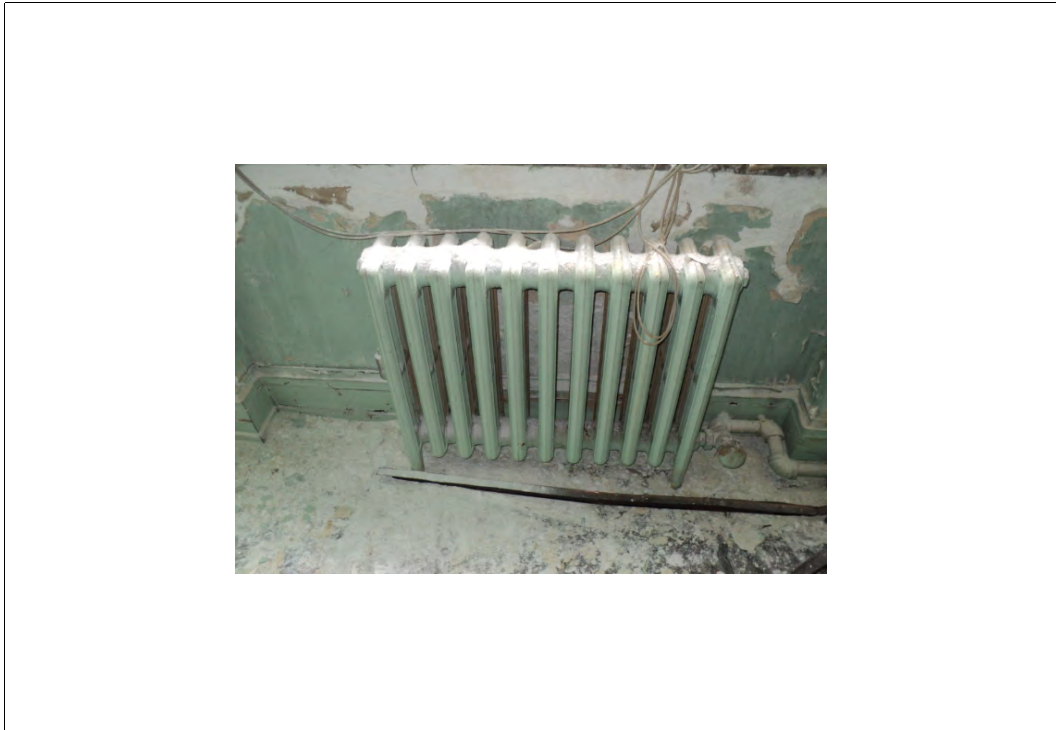
Photograph No. 22
Green Painted Metal Radiators
(XRF Shot # 184)

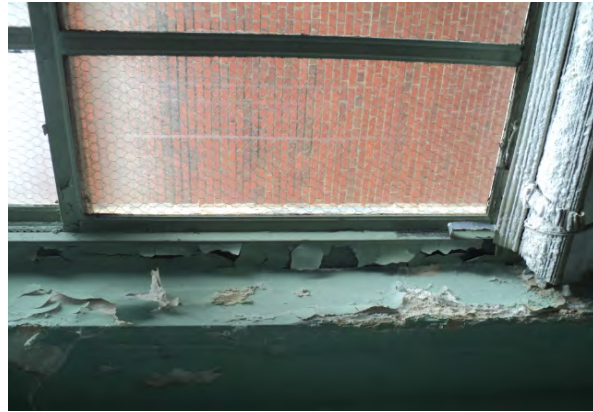
Photograph No. 23
green Painted Metal Window Components
(XRF shot #'s 185-186)

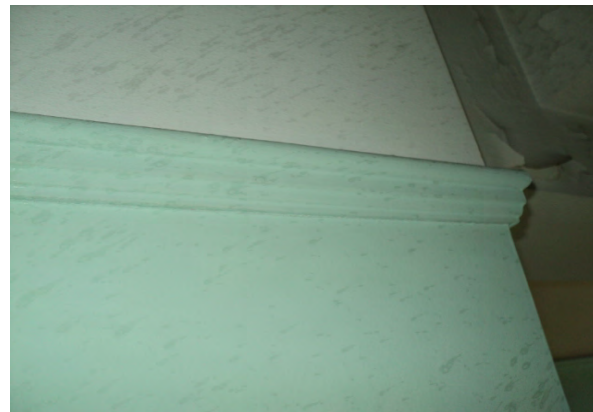
Photograph No. 24
Green Painted Wood Crown Molding
(XRF Shot #'s 187 & 192)

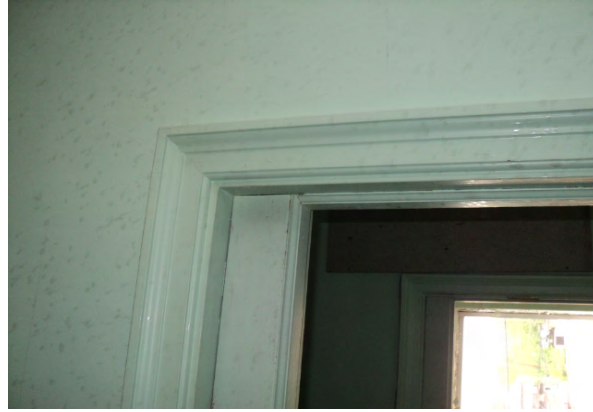
Photograph No. 25
Green Painted Metal Door Casing
(XRF shot #'s 190,193 & 230)

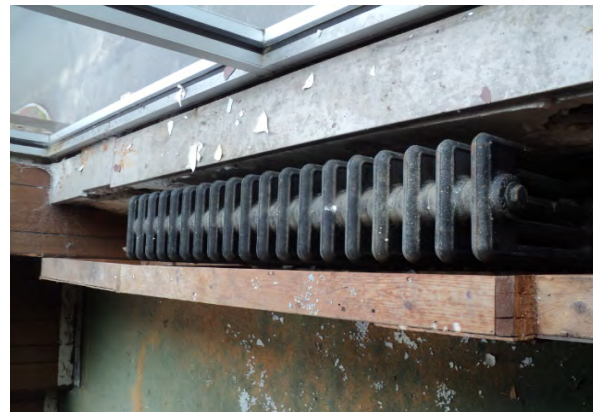
Photograph No. 26
Black Painted Metal Radiators
(XRF Shot # 199)

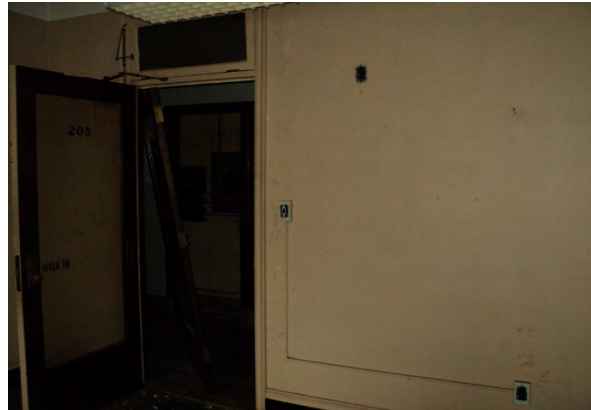
Photograph No. 27
Tan Painted Plaste Walls
(XRF shot #'s 202,239 &240)

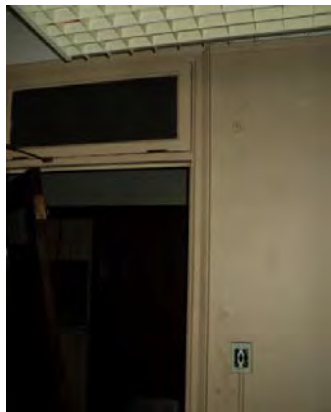
Photograph No. 28
Tan Painted Metal Door Casings
(XRF Shot #'s 204 & 244)

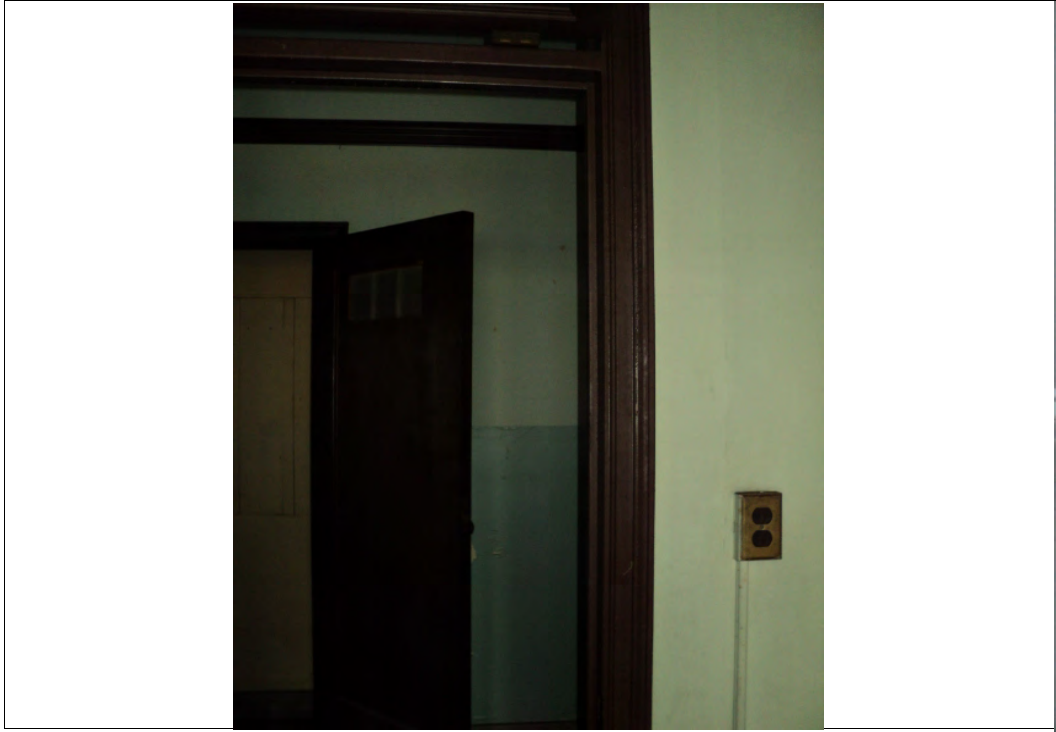
Photograph No. 29
Brown Painted Metal Door Casings
(XRF shot #'s 231,245,262-264)

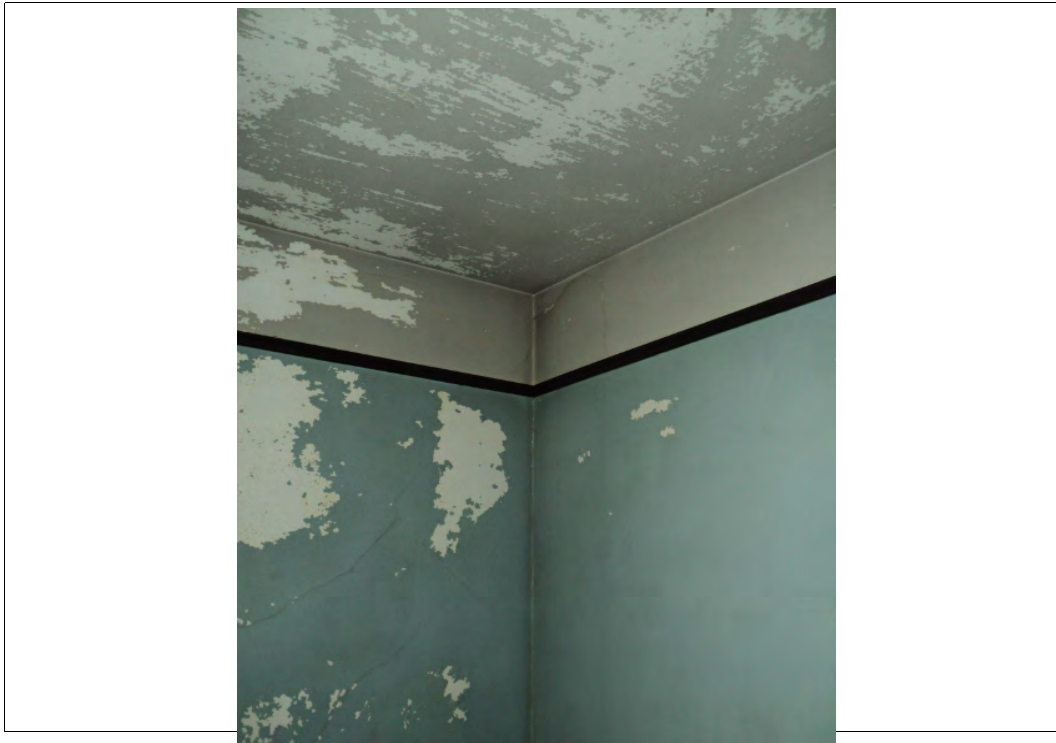
Photograph No. 30
Light Blue Painted Plaster / Drywall Walls
(XRF Shot # 232-233)

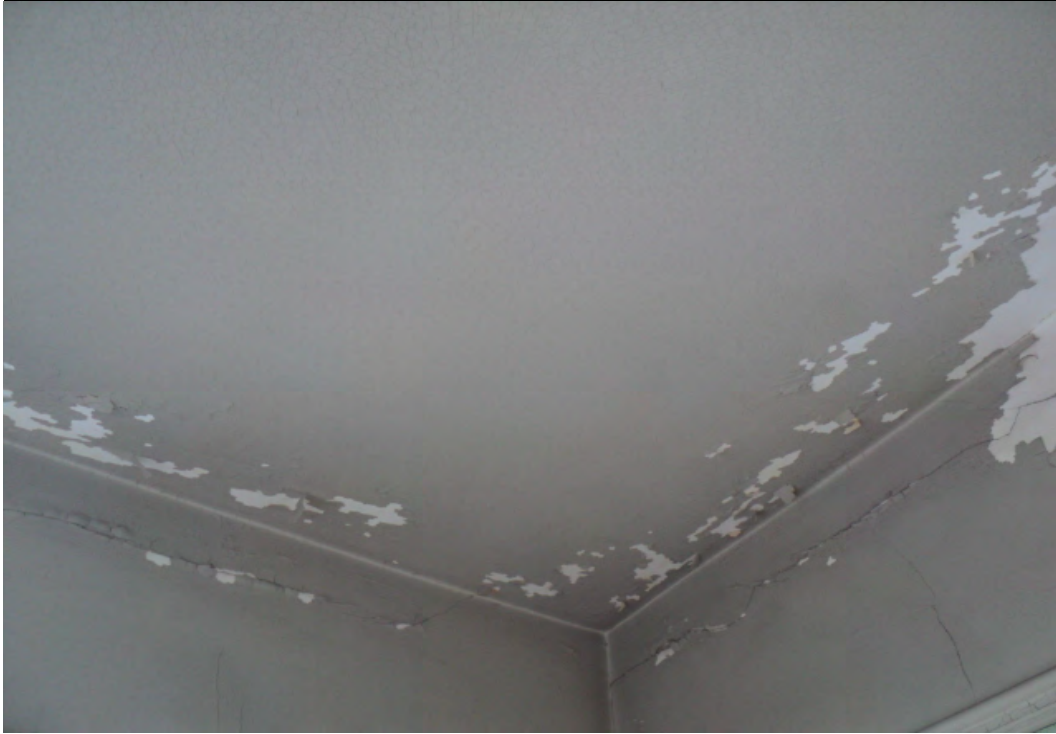
Photograph No. 31
Gray Painted Plaster Ceilings
(XRF shot #'s 234,242,249 & 276)

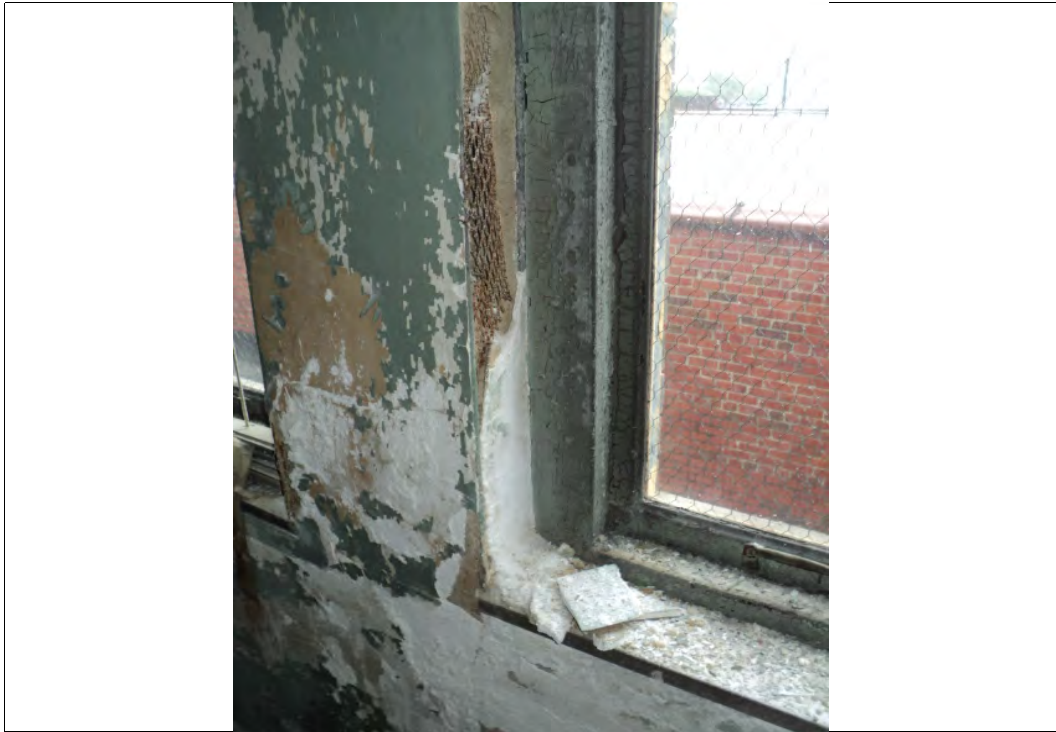
Photograph No. 32
Gray Painted Metal Window Components
(XRF Shot #'s 250-251)

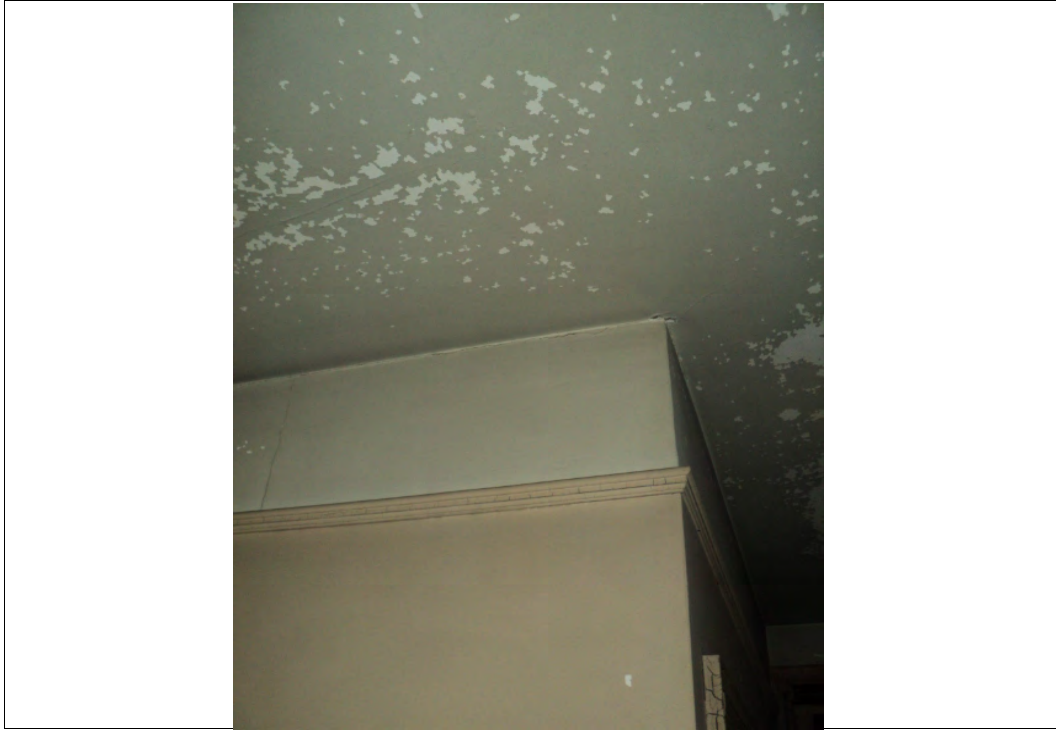
Photograph No. 33
Cream Painted Plaster Wall
(XRF shot # 265)
