RE: Lead-Based Paint (LBP) Survey Report
American Bank & Trust Co. Building
Entire Building Renovation Project
1518 Hull Street
Richmond, Virginia 23224
FEI Project Number: FEI-19AL171

LEAD-BASED PAINT SURVEY REPORT

**AMERICAN BANK & TRUST CO.
(VACANT COMMERCIAL BUILDING)
1818 HULL STREET
RICHMOND, VIRGINIA 23224**

FEI PROJECT NO. FEI-19AL171

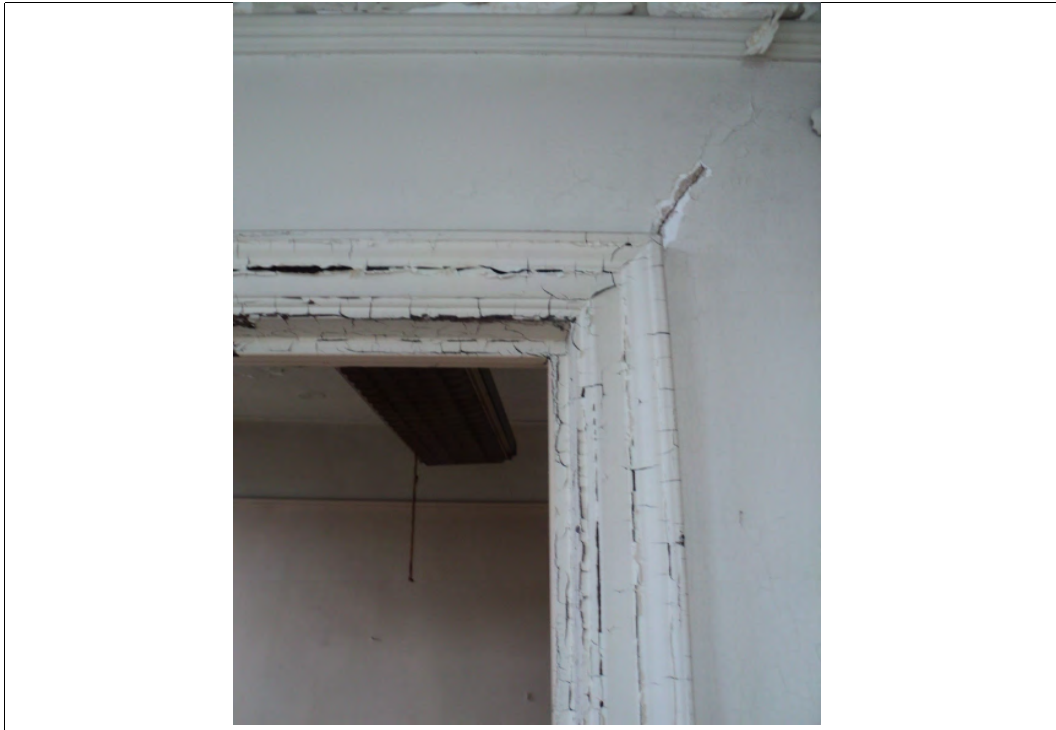
Photograph No. 34
Gray Painted Metal Door Casing
(XRF Shot # 277)
