FOCUSED PROPERTY
INSPECTIONS

20 Lady Jennifer Dr, Biddeford, Maine 04005

Inspection prepared for: Saco Biddeford Savings Bank & David Goyet

Date of Inspection: 2/17/2020 Time: 1pm

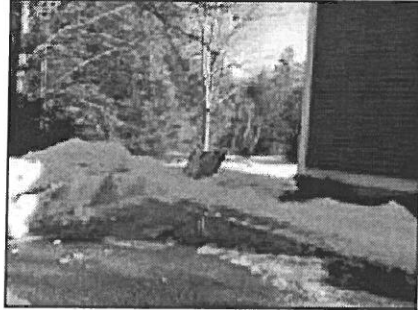
Tank location

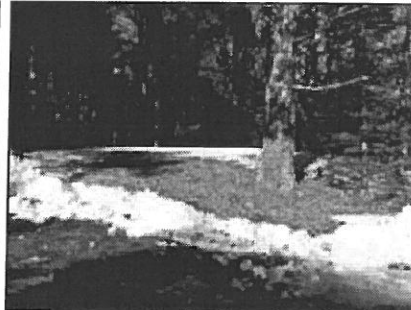
Field location

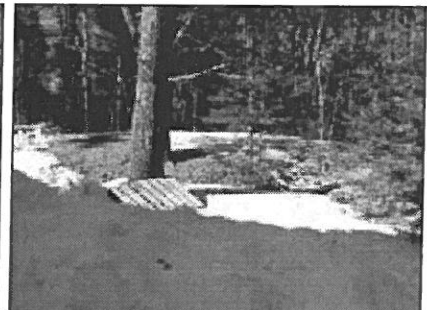
Field location

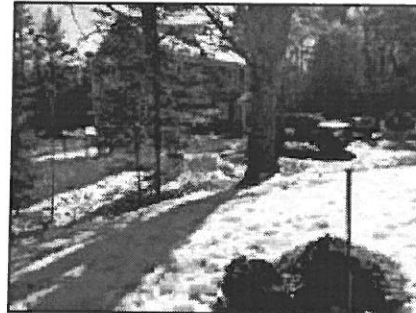
The field and tank location in relation to the house.

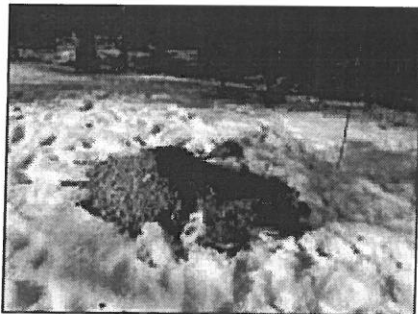
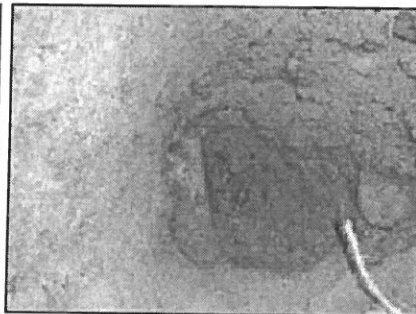
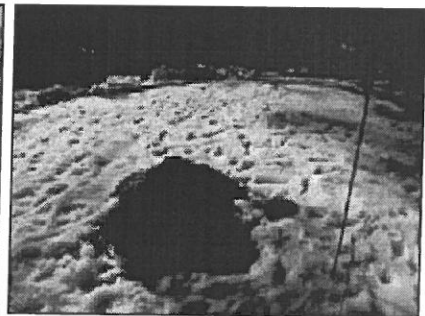
The tank and field were located. A load test was performed on the field. The field and tank showed no signs of previous backups or pressurization. The field also performed with in standards when the load test was performed at the time of inspection.
