Stucco Report

2128 N Broad Street
Lansdale, Pennsylvania 19446

20:06 November 21, 2017

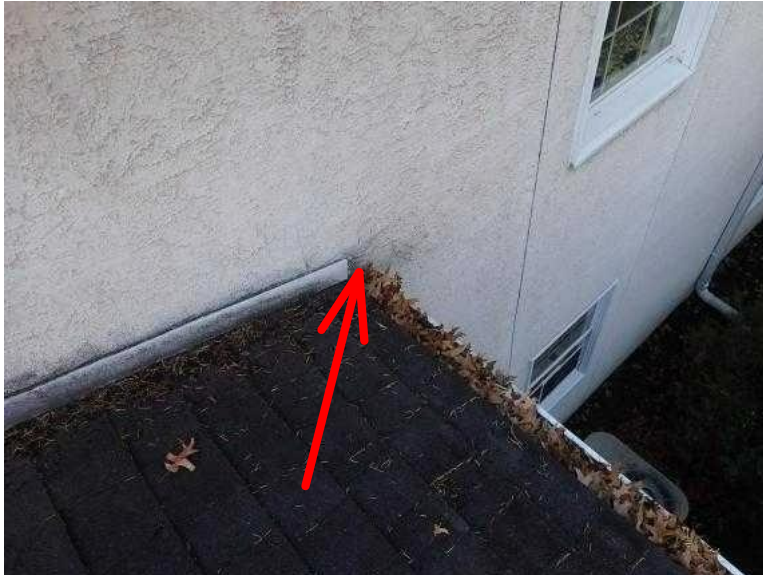
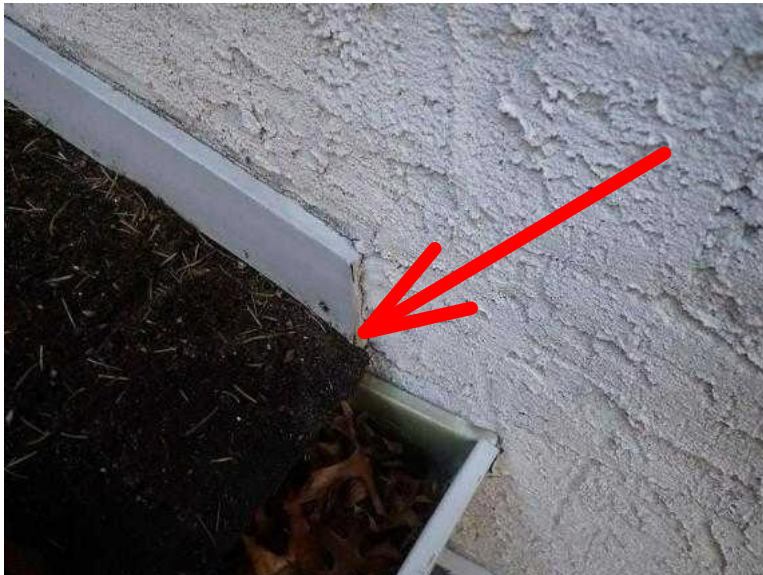
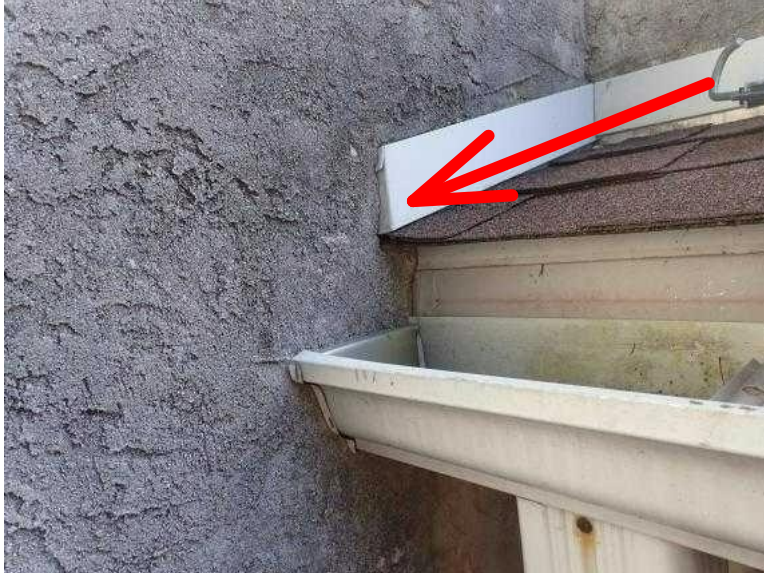
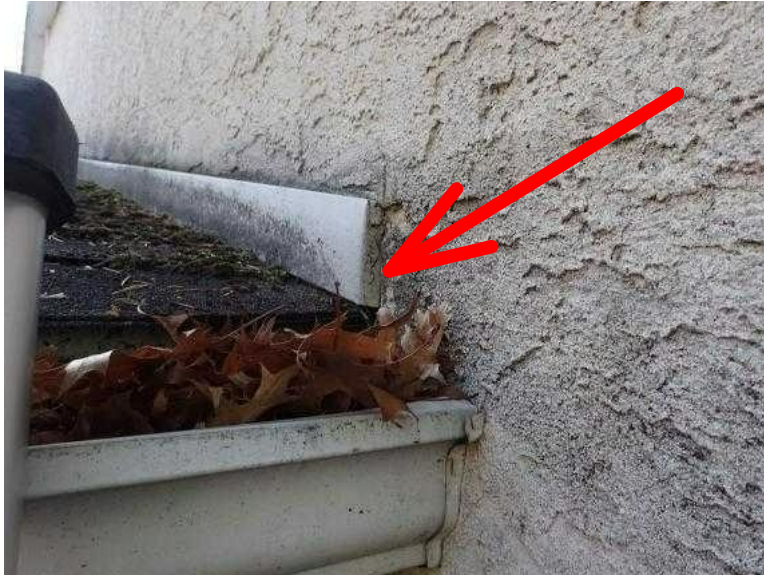
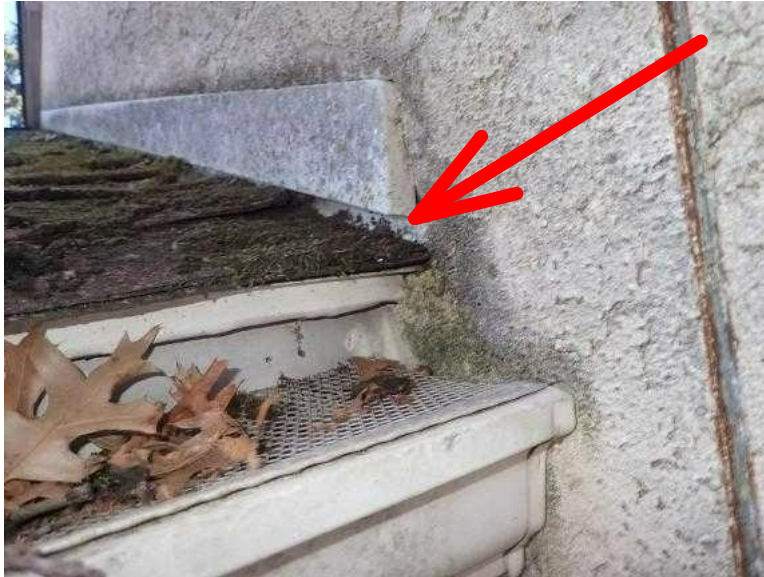
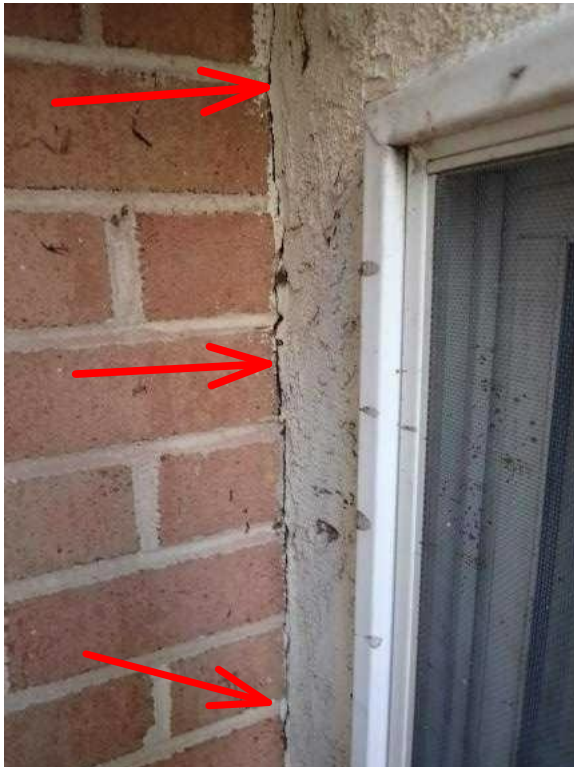
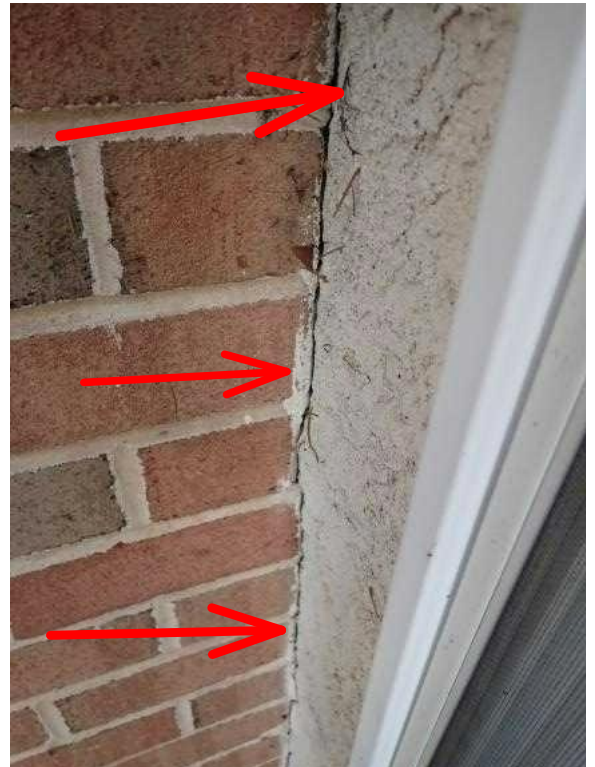
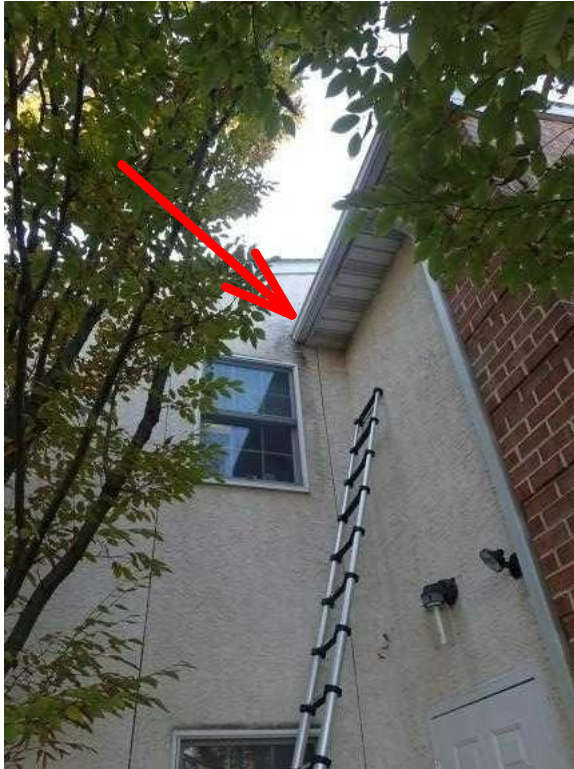
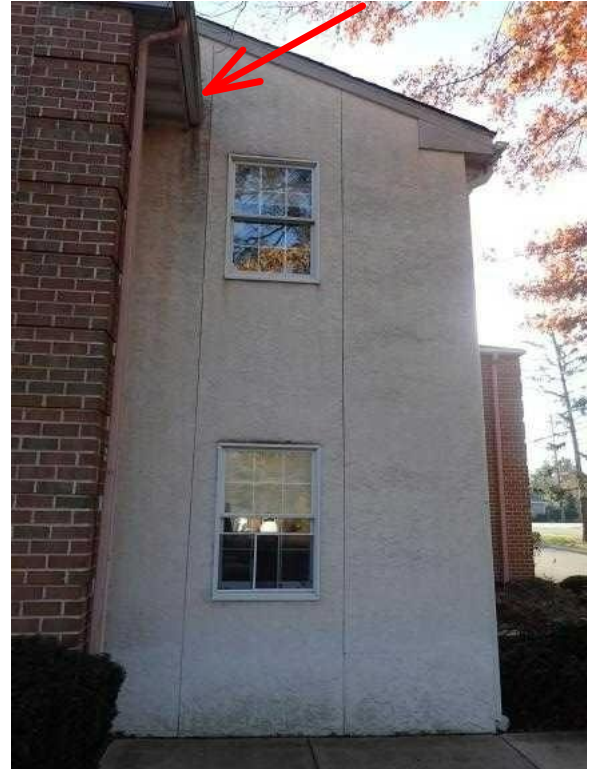
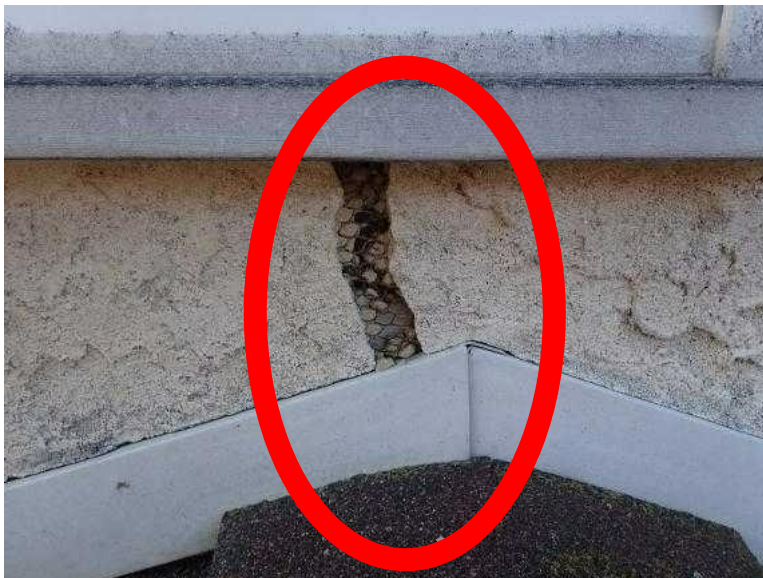
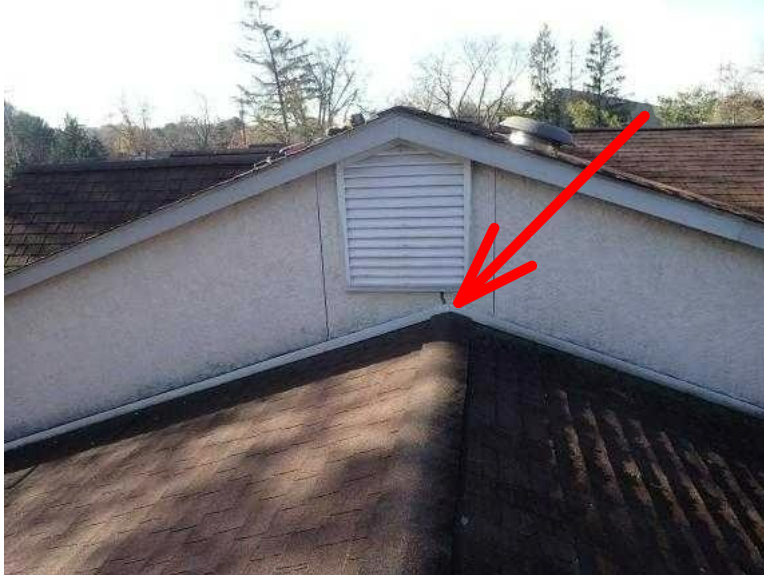
1. Method of Inspection: Sounding or tapping, visual, surface moisture reader and Infrared and moisture probe: **Missing diverter flashing where the roof ends and the wall continues throughout, recommend installation to reduce the risk of water damage.**

Gaps are not properly sealed at the transitions from brick to stucco, recommend repair.

Large gap under the right side gable vent at the left section of building, recommend repair to reduce the risk of water damage.

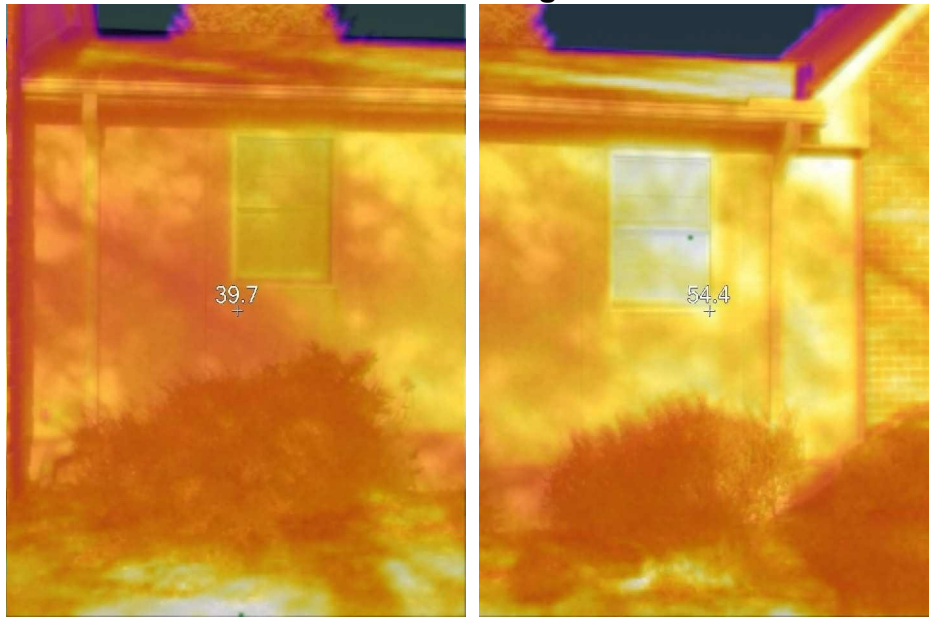
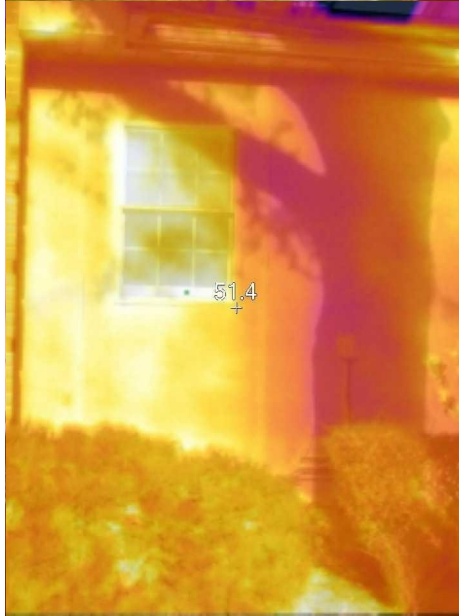
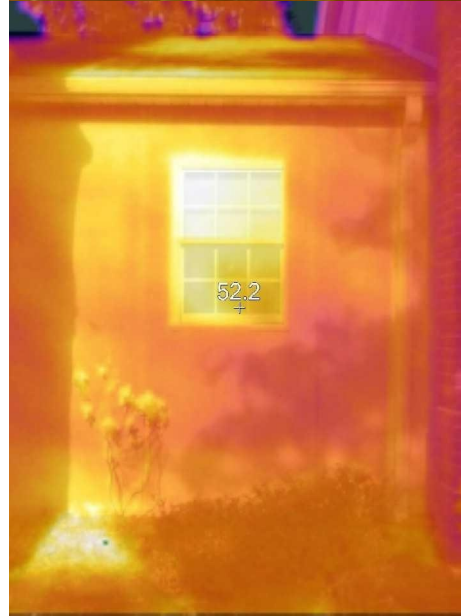
Front Non-Invasive Testing

1. Reading: **Normal**: **Thermal scan inspection is for diagnostic purposes only and does not reflect an accurate reading of moisture below the surface.**

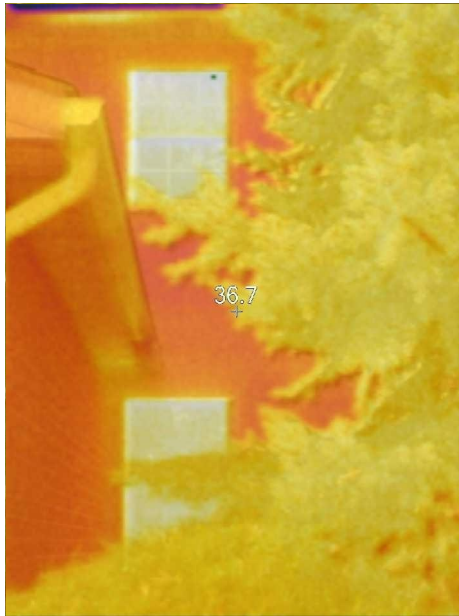
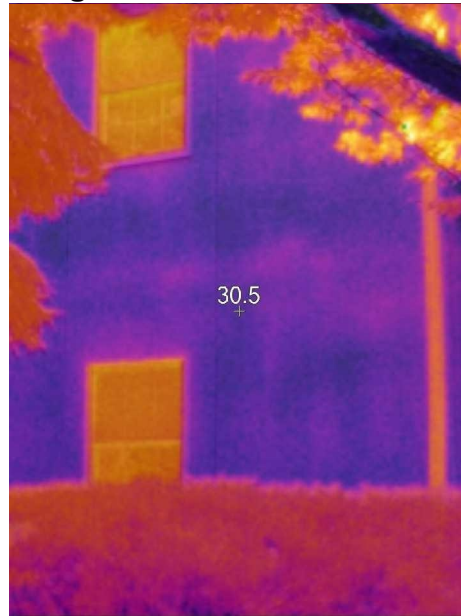
Right side Non-Invasive Testing

2. Reading: **Normal: Thermal scan inspection is for diagnostic purposes only and does not reflect an accurate reading of moisture below the surface.**

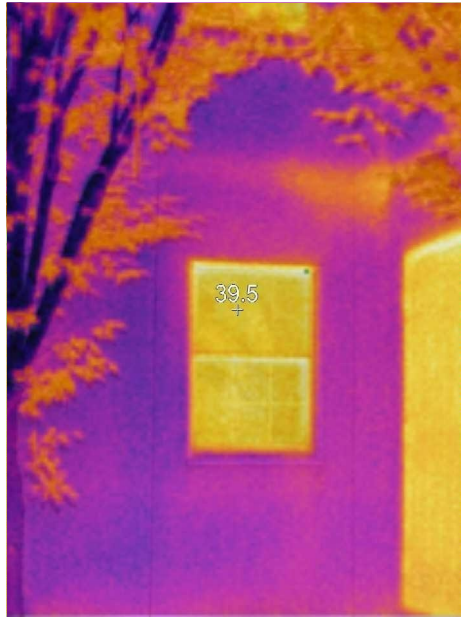
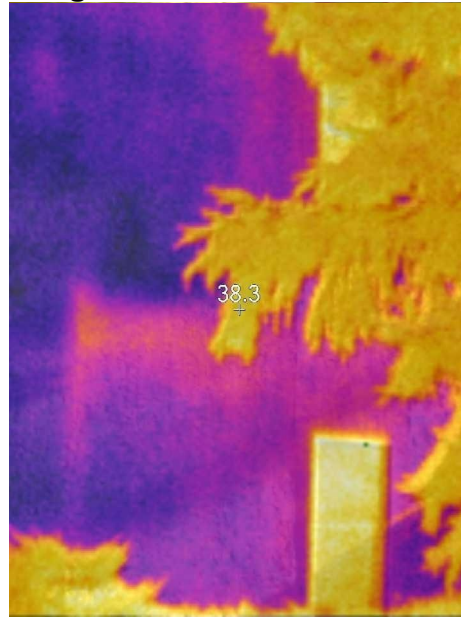
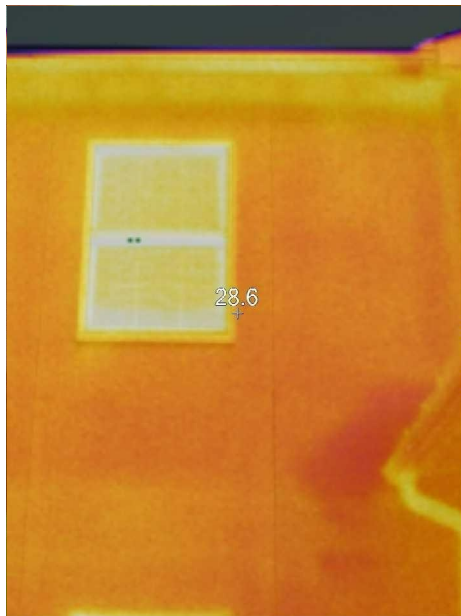
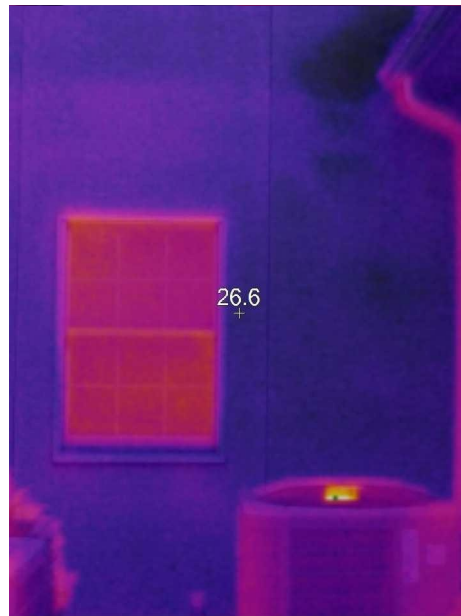
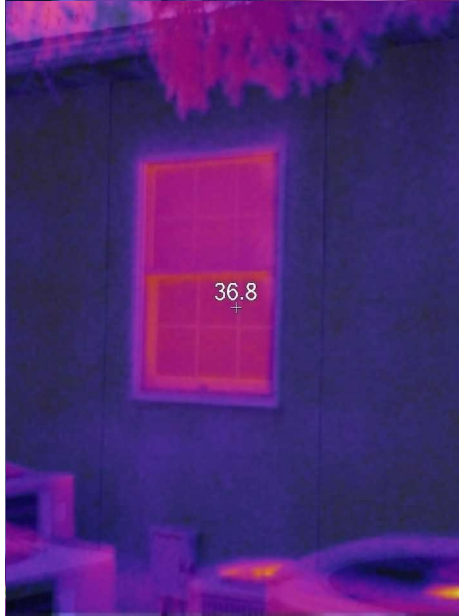
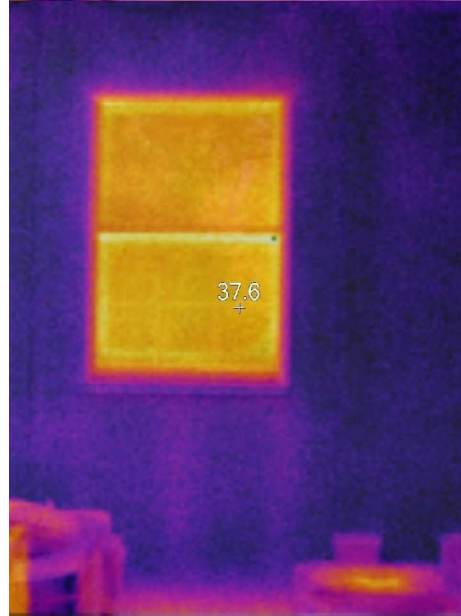
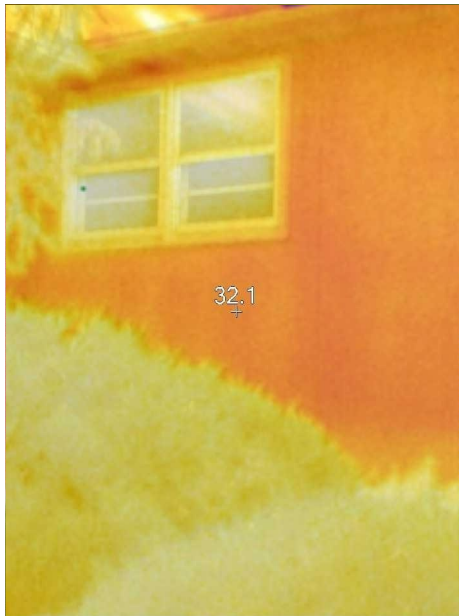
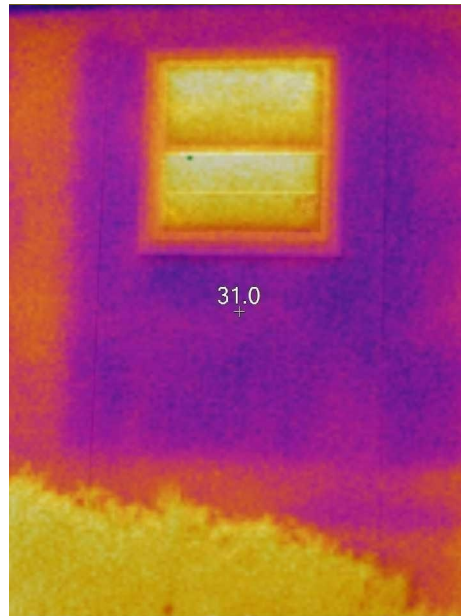
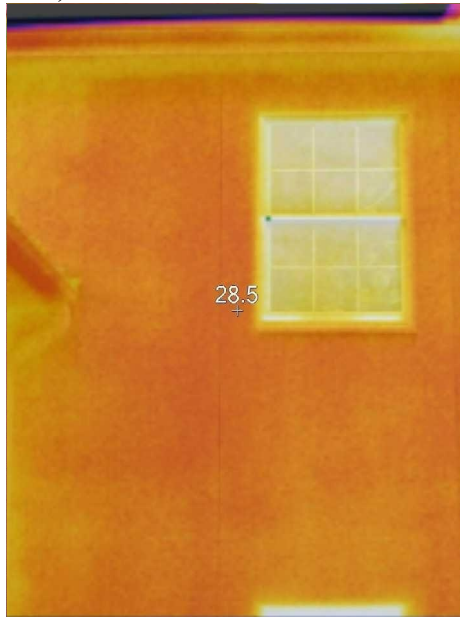
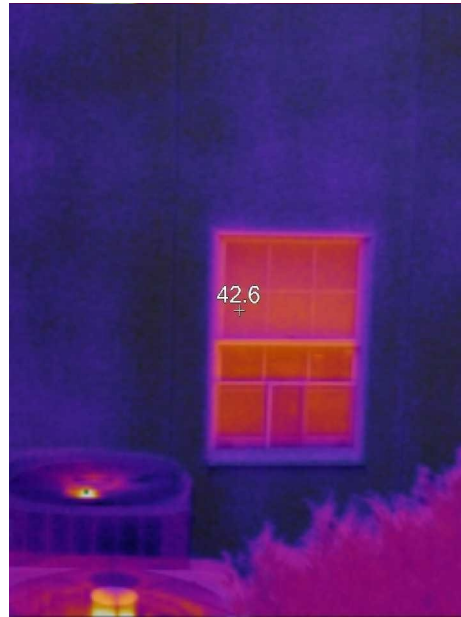
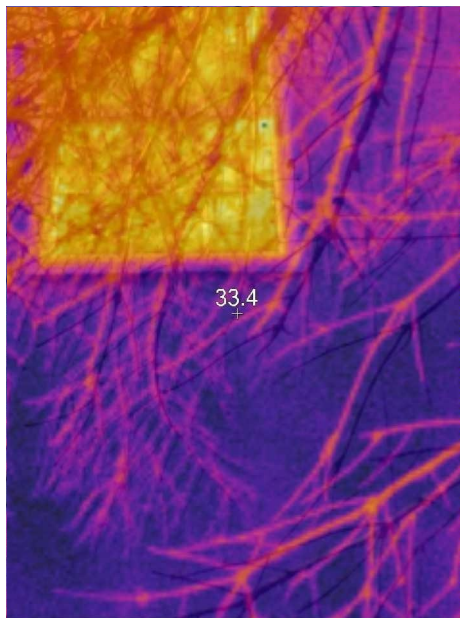
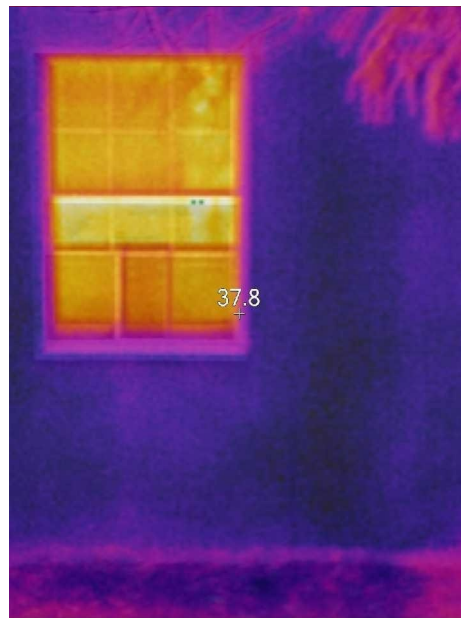
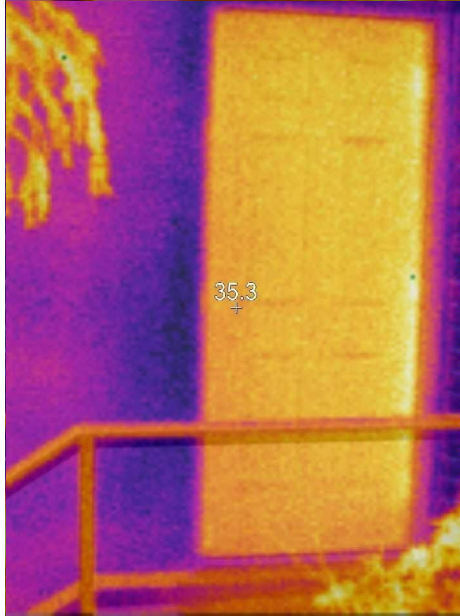
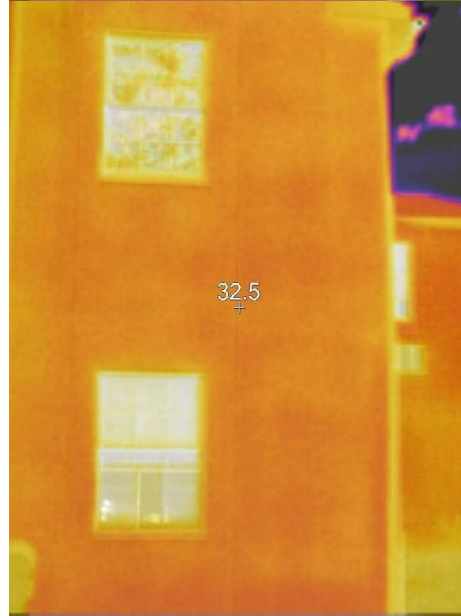
Rear Non-Invasive Testing

3. Reading: **Normal**: Thermal scan inspection is for diagnostic purposes only and does not reflect an accurate reading of moisture below the surface.

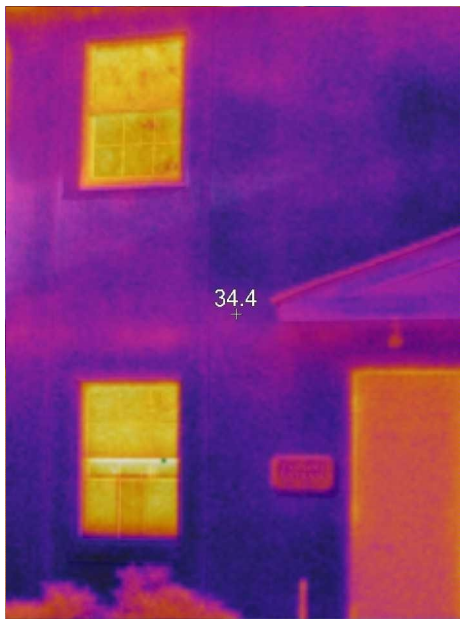
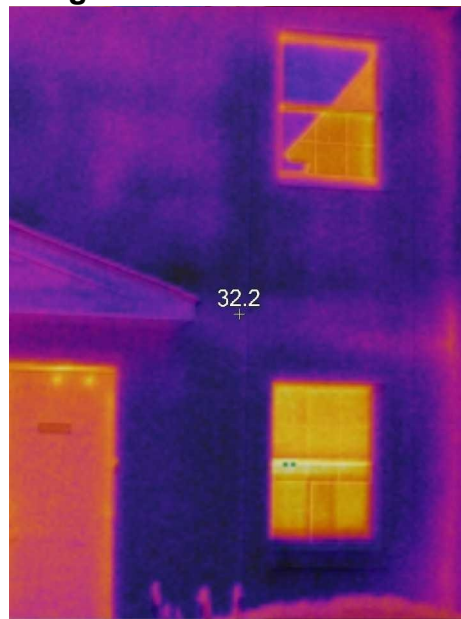
Left Side Non-Invasive Testing(Surface Scan)

4. Reading: **Normal: Thermal scan inspection is for diagnostic purposes only and does not reflect an accurate reading of moisture below the surface.**

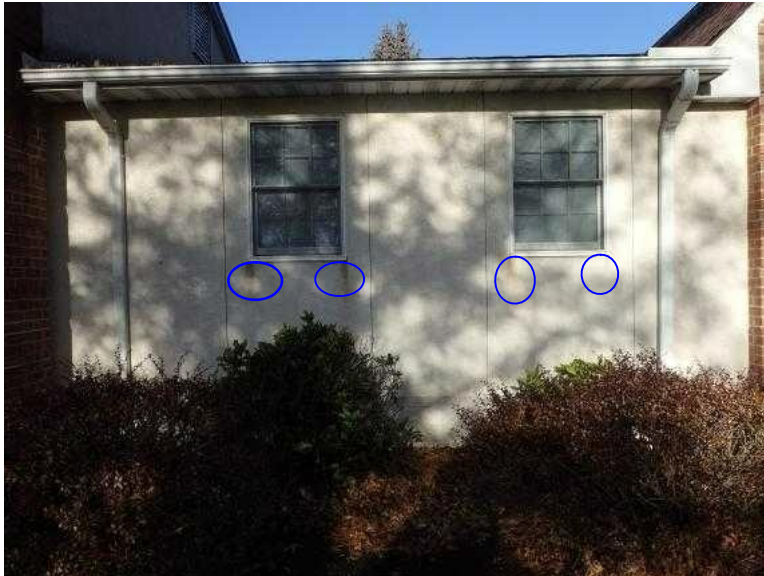
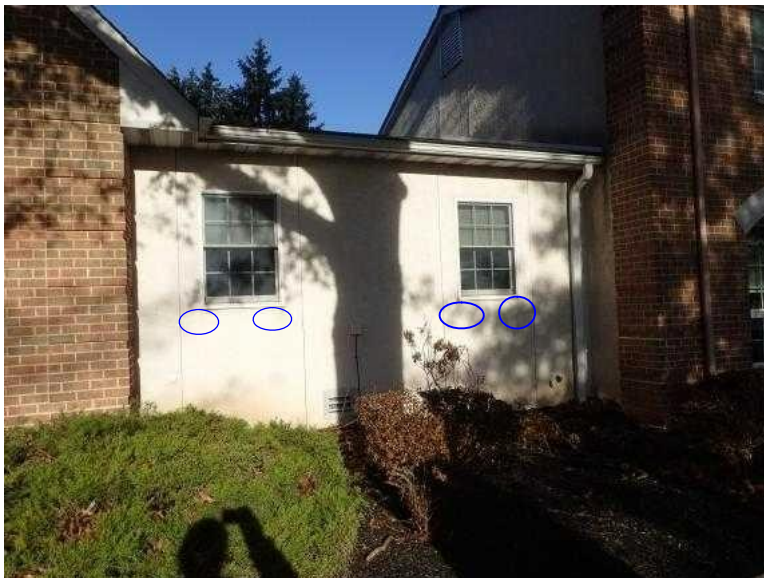
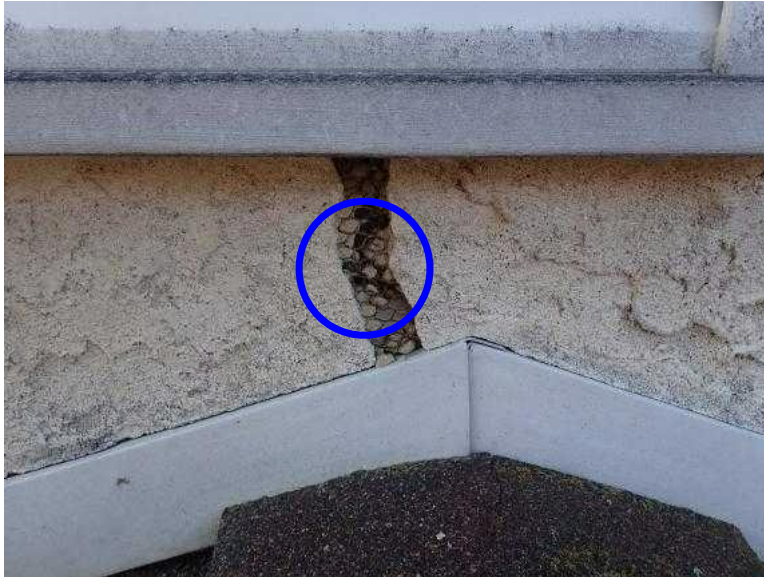
Front Invasive Testing

Reading: 6%-9%: **Blue circles stand for moisture levels being acceptable. All probes were dry with firm substrate where present, no action required at this time.**

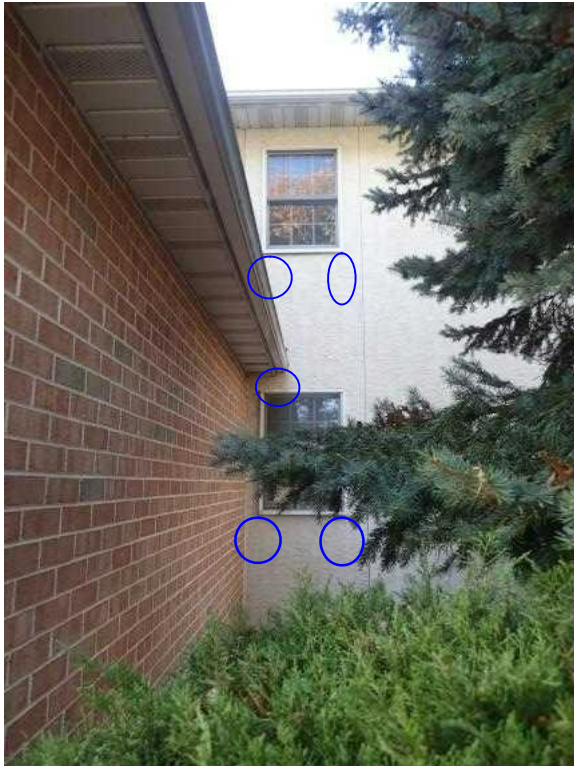
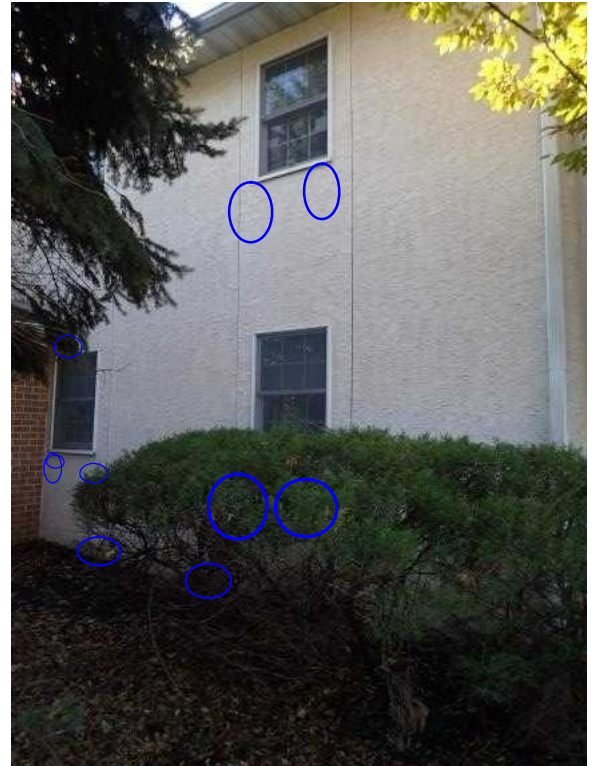
Right side Invasive Testing

Reading: 7%-10%: **Blue circles stand for moisture levels being acceptable. All probes were dry with firm substrate where present, no action required at this time.**

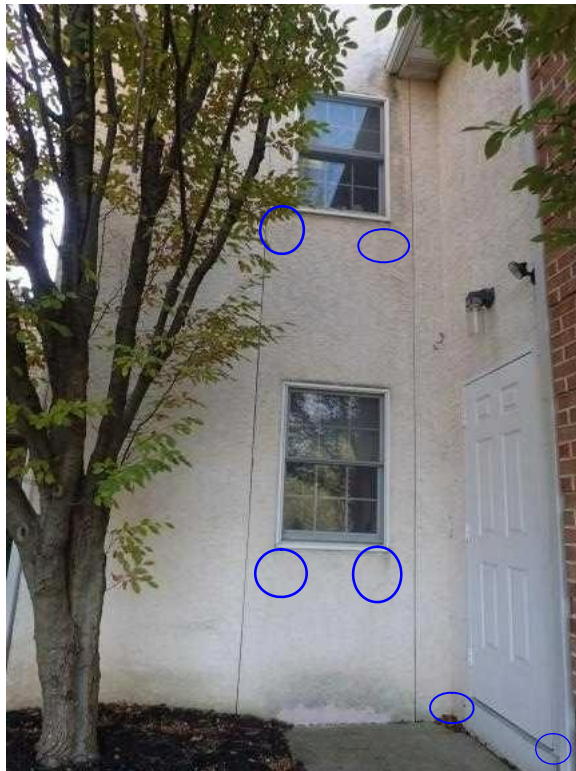
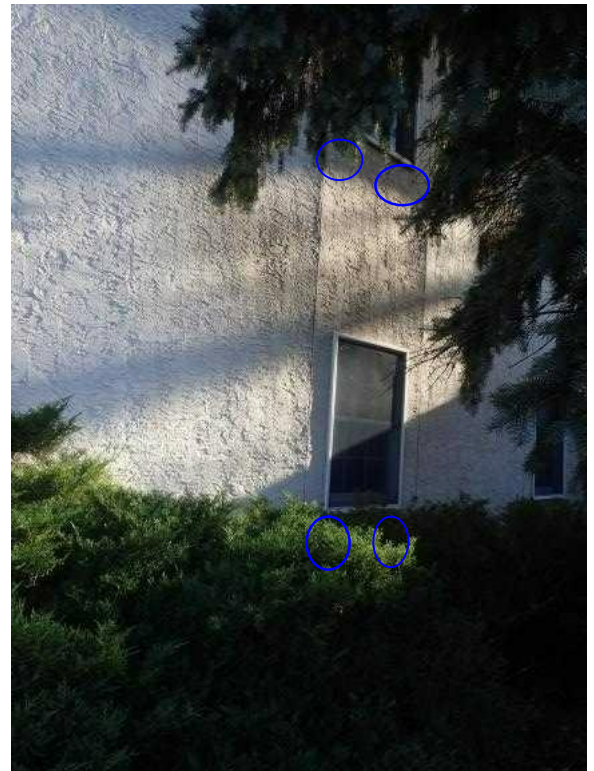
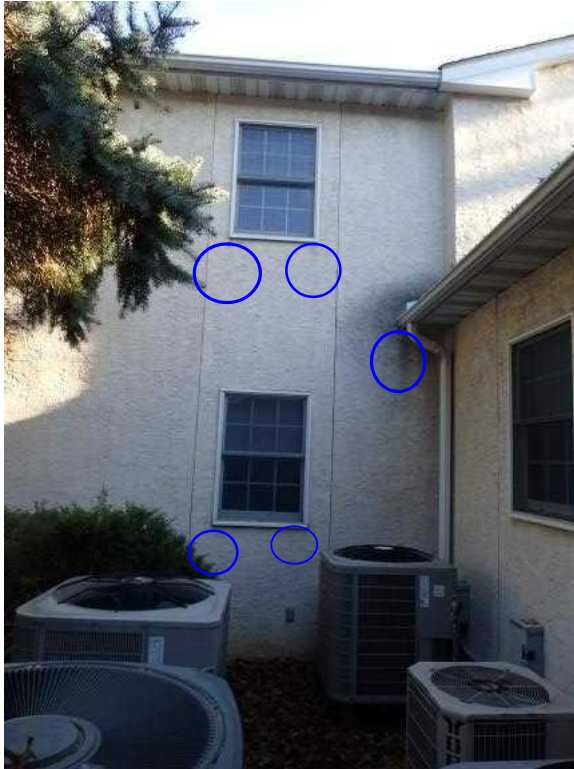
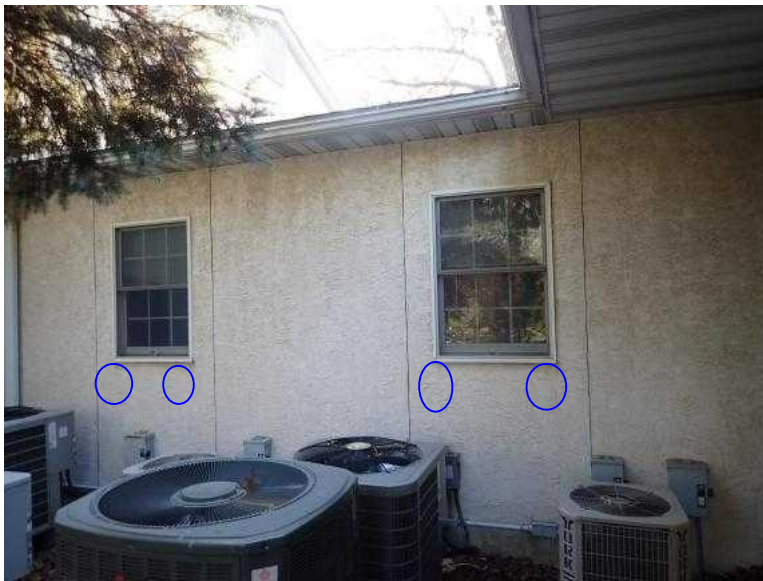
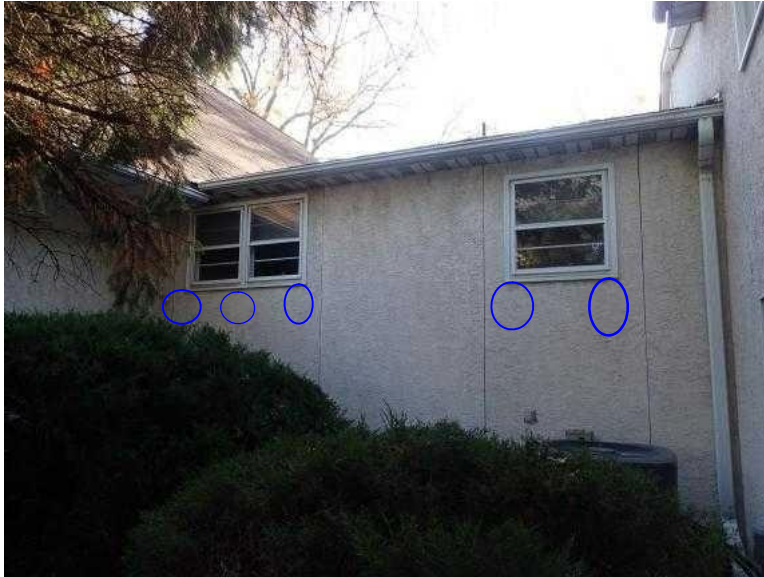
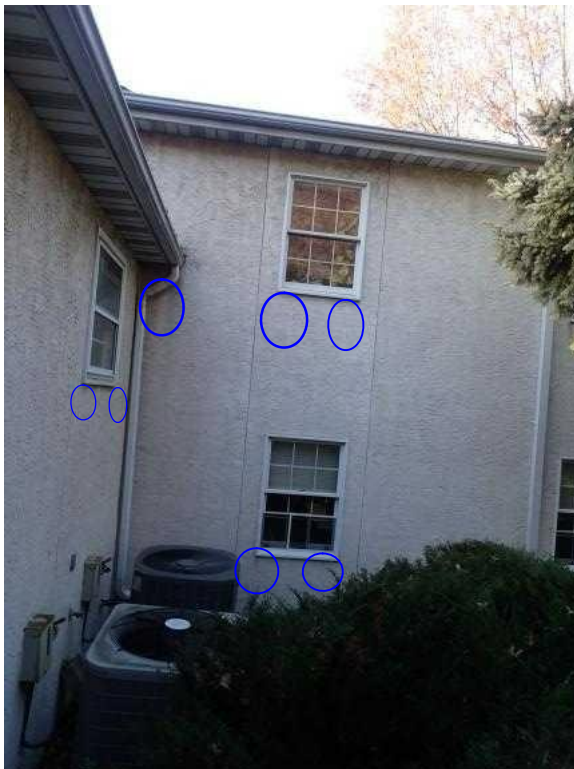
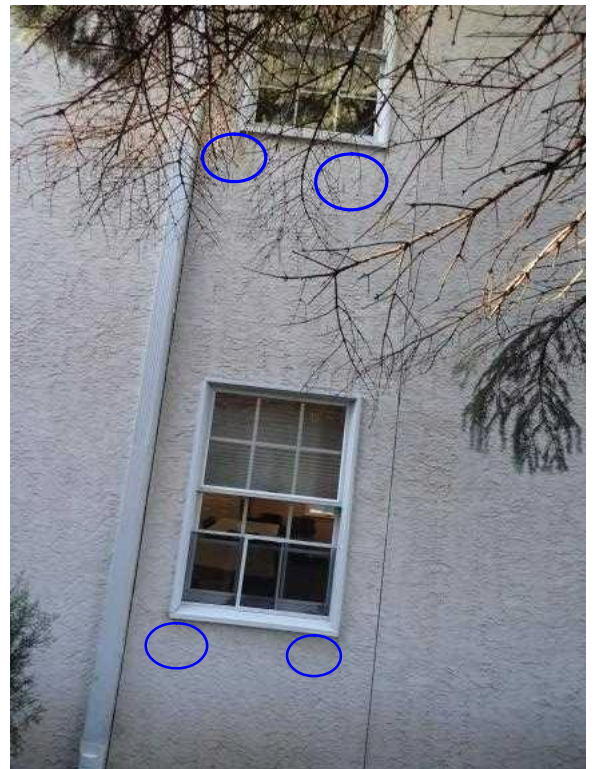
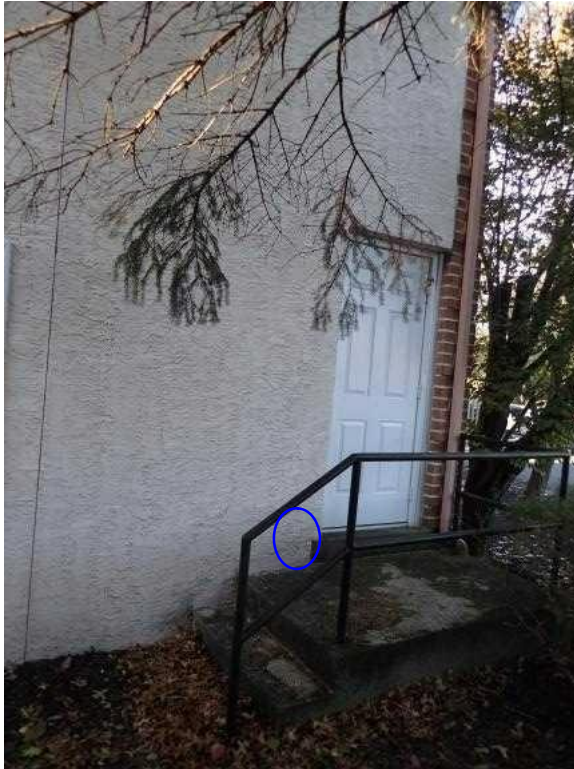
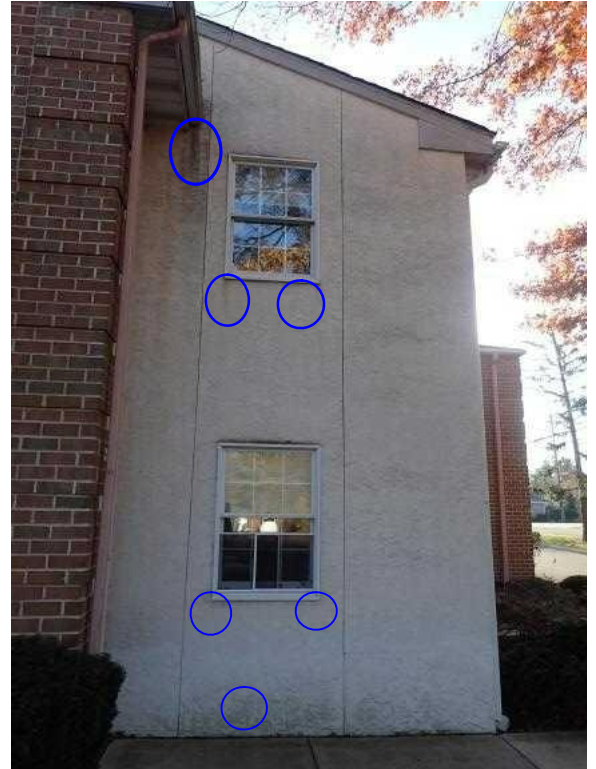
Rear Invasive Testing

Reading: 7%-12%: **Blue circles stand for moisture levels being acceptable. All probes were dry with firm substrate where present, no action required at this time.**

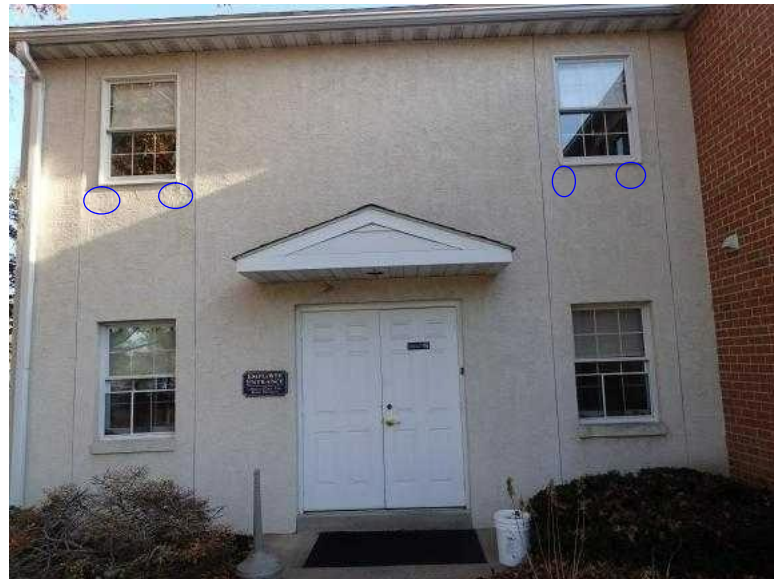
Left Side Invasive Testing(Moisture Probe)

4. Reading: 6%-7%: **Blue circles stand for moisture levels being acceptable. All probes were dry with firm substrate where present, no action required at this time.**
