PHASE I ENVIRONMENTAL SITE ASSESSMENT

**2520 Washington Avenue
Houston, Harris County, Texas 77007**

Report No. 20010096
February 10, 2010

Colliers International
1300 Post Oak Boulevard, Suite 200
Houston, Texas 77056

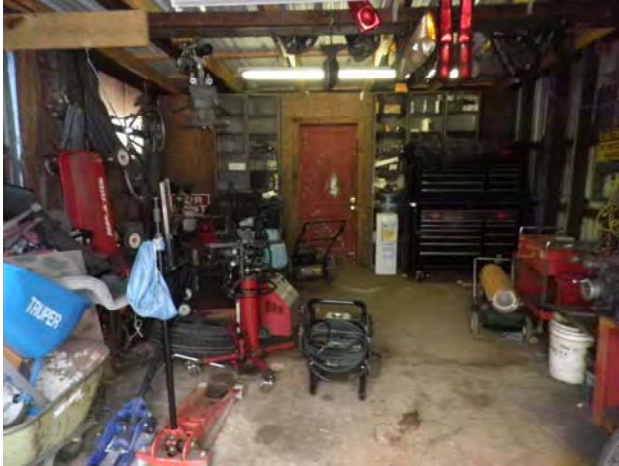
Photo 3: Interior View of Garage Storage Bldg.

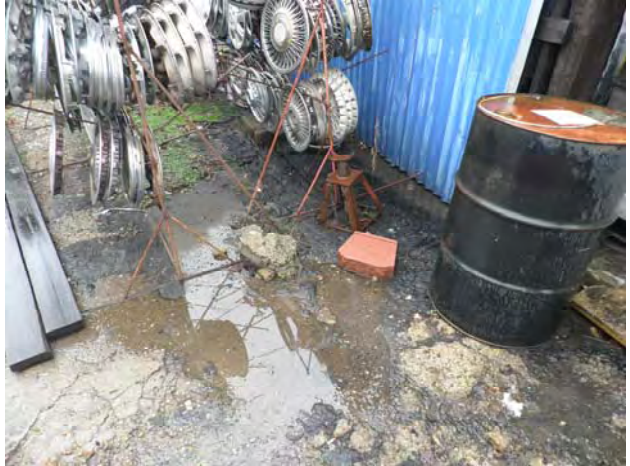
4. Multiple 55 gallon drums of oil, used oil filters and kerosene were observed at the subject property. Minor oil slab and soil staining was observed in the vicinity of the drums. The staining does not appear to be of a reportable quantity and as such is a *de minimus* condition. No recognized environmental conditions appear to exist provided the staining is cleaned up, all residue is disposed of off site and the

Photo 4: 55 Gallon Drum with Stained Soil

drums are properly stored on site to prevent future leaks in accordance with all applicable federal, state and local rules and regulations.

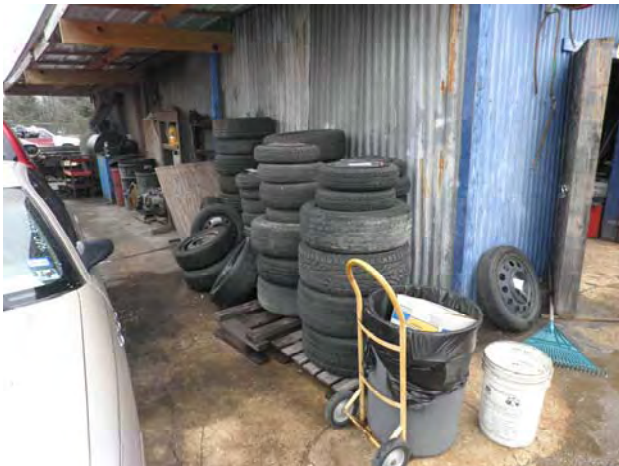
7. New and used tires are stored on site. The on site storage of new and used tires in the outside storage yards are in possible violation of the City of Houston Ordinances Article VII-Tire Storage and Tire Carriers* Section 21-182: Open storage of tires declared a nuisance and Section 21-183: Open storage of tires prohibited and Texas Health and Safety Code Section 365, 341, and 343. No recognized environmental conditions appear to exist provided new tires are stored on site and used tires are disposed of off site in accordance with all applicable federal, state and local regulations.

Photo 5: Used Tires

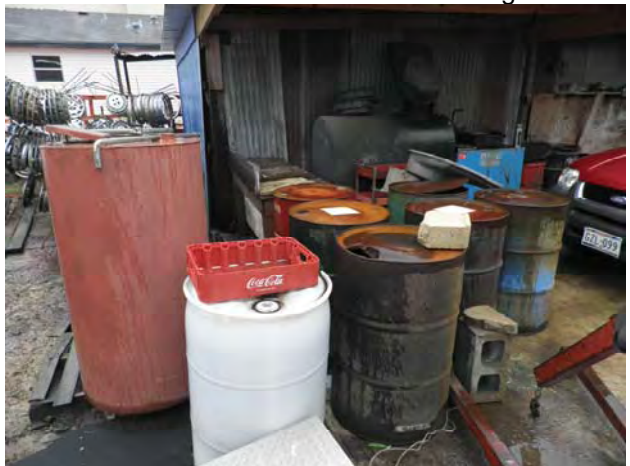
3. Aboveground storage tanks (ASTs) ranging from approximately 500 to 1000 gallons in volume each containing new oil, waste oil and coolant were observed at the subject property. ASTs with capacities greater than 1,100 gallons that contain petroleum products which could be used as a fuel for the propulsion of a motor vehicle or aircraft are required to be registered with the TCEQ. Because the ASTs are less than 1,100 gallons in volume, they are not required to be registered with the TCEQ. Minor oil slab staining was observed in the vicinity of the ASTs. The staining does not appear to be of a reportable quantity and as such is a *de minimus* condition. No recognized environmental conditions appear to exist provided the staining is cleaned up, all residue is disposed of off site and the ASTs are maintained in accordance with all applicable federal, state and local rules and regulations.

Photo 6: Drums / ASTs & Staining
