PHASE I ENVIRONMENTAL SITE ASSESSMENT of

Rush Oaks Apartments

3101 South Broadway Street

EMG Project #: 103328.12R - 001.135
Date of Report: October 10, 2012
On Site Date: September 25, 2012

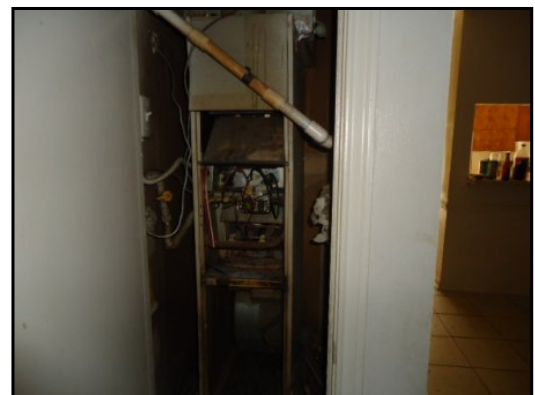
12 : Furnace contained in each unit

- Heat and air-conditioning are supplied to the Project from split systems with pad-mounted condensing units and gas-fired furnace/air handling units. Conditioned air is distributed via thermostatically controlled, ducted supply and return systems. EMG observed that all of the condensers have been stolen.

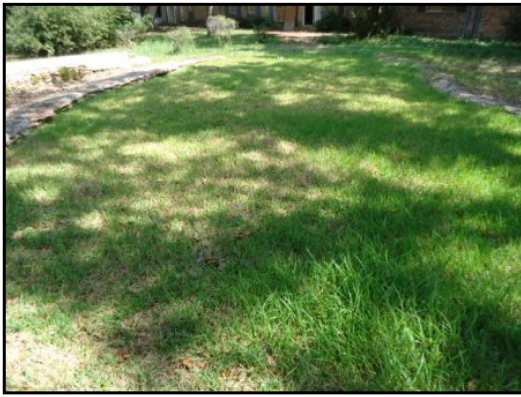
13 : Former swimming pool

No environmentally significant miscellaneous systems/equipment were identified at the Project. EMG observed that the swimming pool was apparently filled in with dirt. Grass was observed on the surface of the former pool area. The concrete coping was observed as well. According to the POC, the complex will be sold 'as is' and it will be up to the buyer if the swimming pool will be filled in or if the swimming pool will be used.

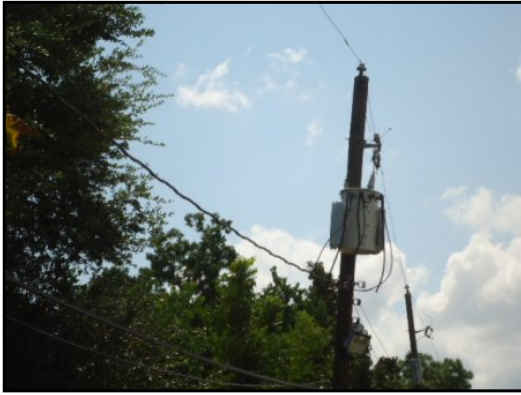
19 : Pole-mounted transformer

EMG identified utility-owned electrical transformer equipment at the Project. This equipment appeared to be in good condition with no evidence of leaks. The transformer is designated as the property of the public utility and is labeled as "Non-PCB." The utility is the financially responsible party for maintenance of this equipment. No further action or investigation is recommended regarding the transformer equipment.

The Project is supplied with overhead secondary electrical service from one pole-mounted electrical transformer. The transformer is designated as the property of Reliant Energy, the public utility, and is labeled as "Non-PCB." The unit should be periodically inspected for leakage. If leakage is visible, the Project owner/manager should contact the public utility, which will remediate the situation. Should the unit have to be replaced, the utility is responsible, provided the cause is equipment failure, not customer misuse. No leakage of the transformer was observed at the time of the assessment.

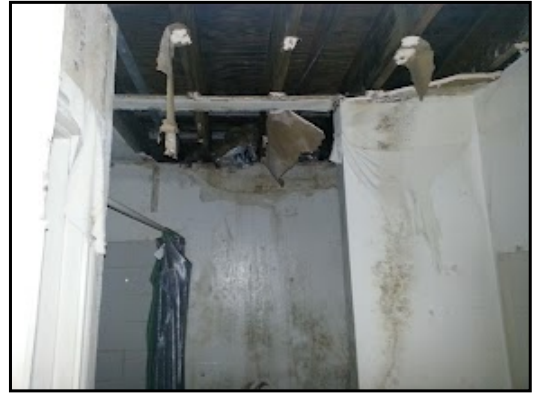
20 : Unit 3126 mold bathroom

EMG performed a limited visual assessment for the presence of mold, conditions conducive to mold, and evidence of moisture in readily accessible interior areas of the Project. Suspect mold was observed in the following unit:

- Unit 3126. The area affected by the moisture was approximately 200 square feet in size.

Suspect non-friable ACM, in the form of roofing materials, vinyl floor tile, wallboard/joint compound and various mastics, were identified. These materials were observed to be in good overall condition. Unit 3126 had a plumbing leak that resulted in the removal of a portion of the ceiling in the bathroom.

Additional information about the source of the moisture is included in EMGs Property Condition Assessment (PCA) report (EMG Project Number 103328.12R-001.042).

Additional information about the suspect mold and source of the moisture is included in EMGs Property Condition Assessment (PCA) report (EMG Project Number 103328.12R-001.042).

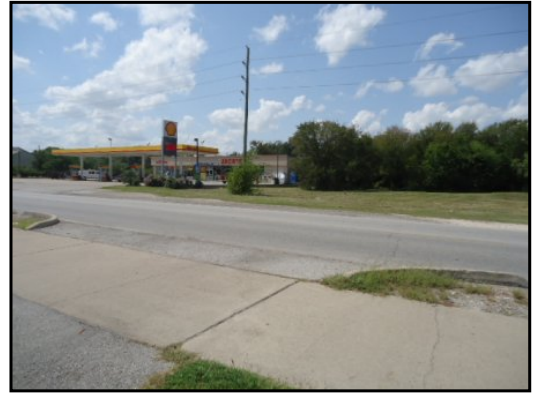
The adjacent property use to the west was identified on the LPST and UST databases. More information regarding this site is included in the **Regulatory Review** discussion (Section 9.2.). The remaining adjacent property uses are not anticipated to adversely impact the environmental integrity of the Project.

26 : Adjacent property west, South Broadway Street (Old State Highway 146), Jacks Super Mart Shell Gasoline Station and grassy land
