Doc #: 123631 Inspector: Inspection Associates

Dwelling Address: 45485 Westmeath Way G24

Great Mills, MD 20634

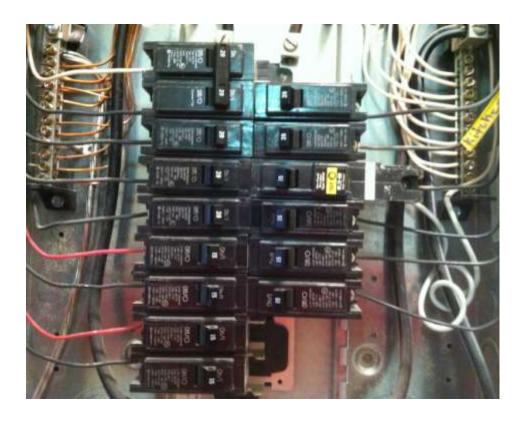
1803. Main Electrical Panel & Location

Serviceable: Typical sub-panel for condos; kitchen

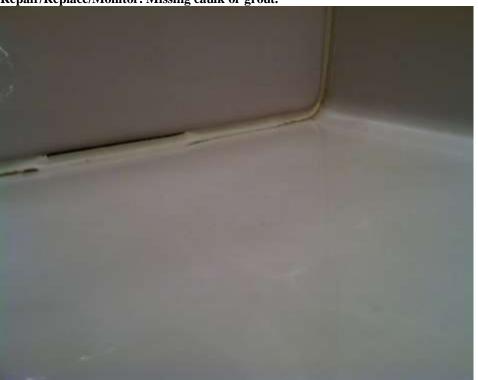
2302. Sinks Repair/Replace/Monitor. Missing caulk or grout.

2302. Sinks Repair/Replace/Monitor. Missing caulk or grout.

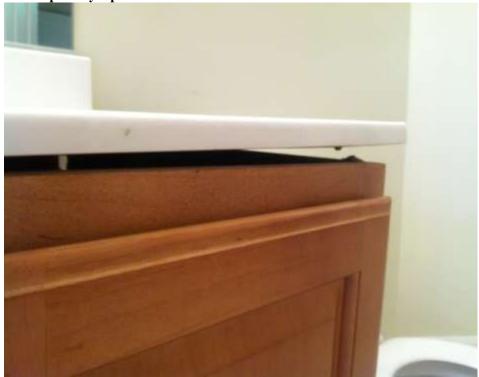
Lifted up vanity top/loose

Lifted up vanity top/loose

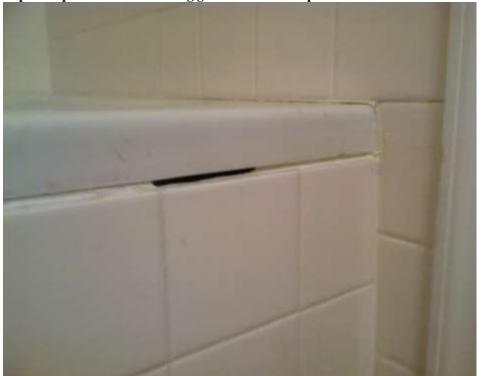
2303. Bathtub Repair/Replace/Monitor. Missing grout at side and top of tub.

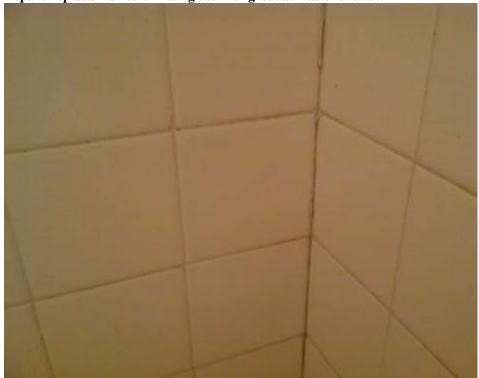
Repair/Replace/Monitor. Missing caulk or grout at master shower.

2304. Shower Repair/Replace/Monitor. Missing caulk or grout at master shower.

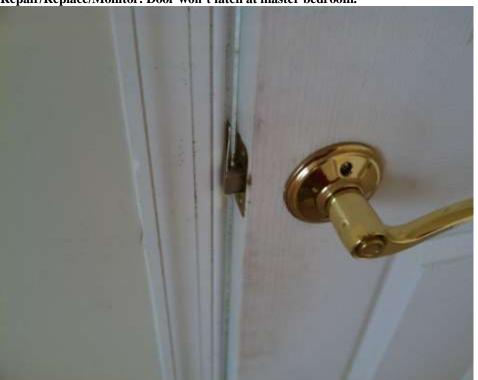
2401. Doors Repair/Replace/Monitor. Door won't latch at master bedroom.

2401. Doors Repair/Replace/Monitor. Door won't latch at master bedroom.

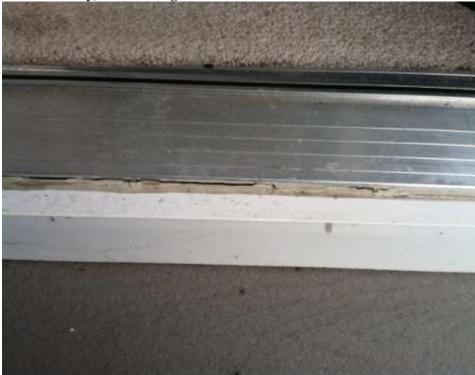
Door to balcony, caulk missing

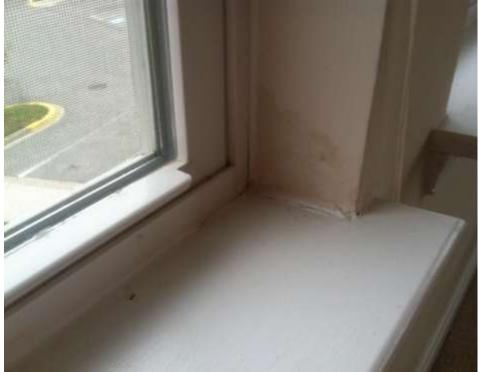
2402. Windows Repair/Replace/Monitor. Single Hung. Water stain.

2402. Windows Repair/Replace/Monitor. Water stain.

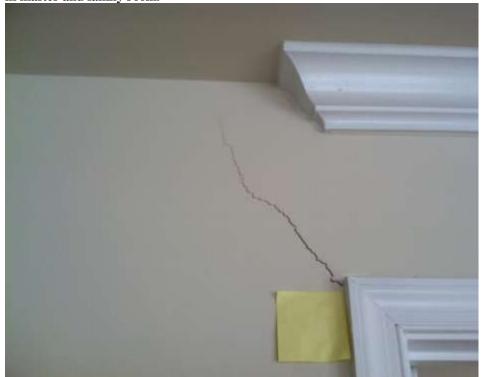
2403. Walls Repair/Replace/Monitor. Drywall. Cracking observed in drywall/plaster. Noted in master and family room.

2403. Walls Repair/Replace/Monitor. Cracking observed in drywall/plaster. Noted

in master and family room.

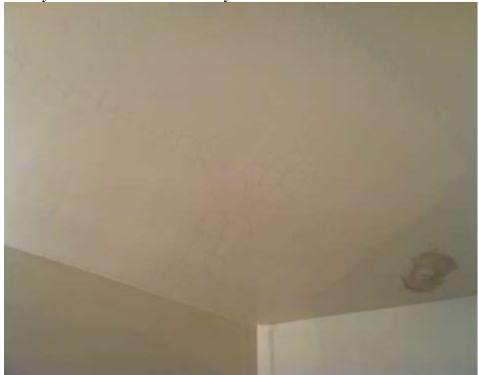
Repair/Replace/Monitor. Drywall. Moisture damage/ repair work noted at hallway bathroom. Possible water entry from condo unit above.

2404. Ceilings Repair/Replace/Monitor. Moisture damage/ repair work noted at

hallway bathroom. Possible water entry from condo unit above.

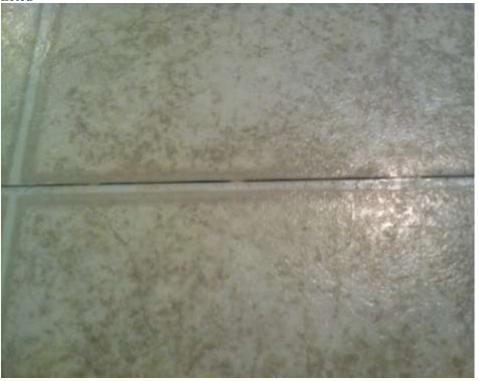
Repair/Replace/Monitor. Carpet; Ceramic tile; Linoleum. Crack in kitchen floor noted

2405. Floors Repair/Replace/Monitor. Crack in kitchen floor noted
