PRESENT CONDITIONS REPORT

Bel Air

Prince William County

DHR Easement File No. 076-0001_ep

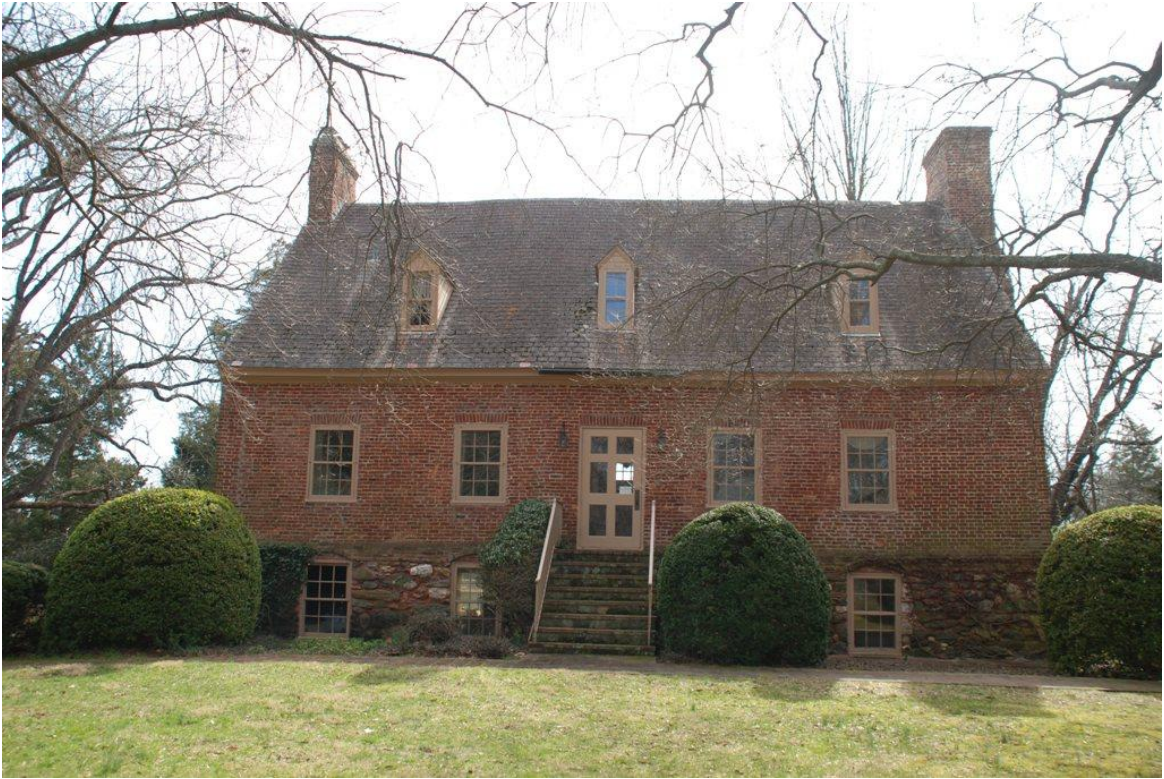
Photo 1: West elevation, Main House, Bel Air, 03/07/2012

Existing Exterior and Interior Architectural Features of the Main Historic Resource:		
<p>Roof: Gable roof covered with asbestos shingles. Minor replacement of individual shingles with slate tiles. There is minor moss growth present. There are three smaller dormers on each side of the gable. The dormers are sided in clapboard; each contains a four-over-four double hung window. The flashing appears to be well-seated and no signs of deterioration were reported or observed.</p>		
<p>Exterior: The house fenestration pattern is asymmetrical. The construction material is brick laid in Flemish bond and it is in excellent condition. Some vine and ivy growth on the masonry was observed.</p>

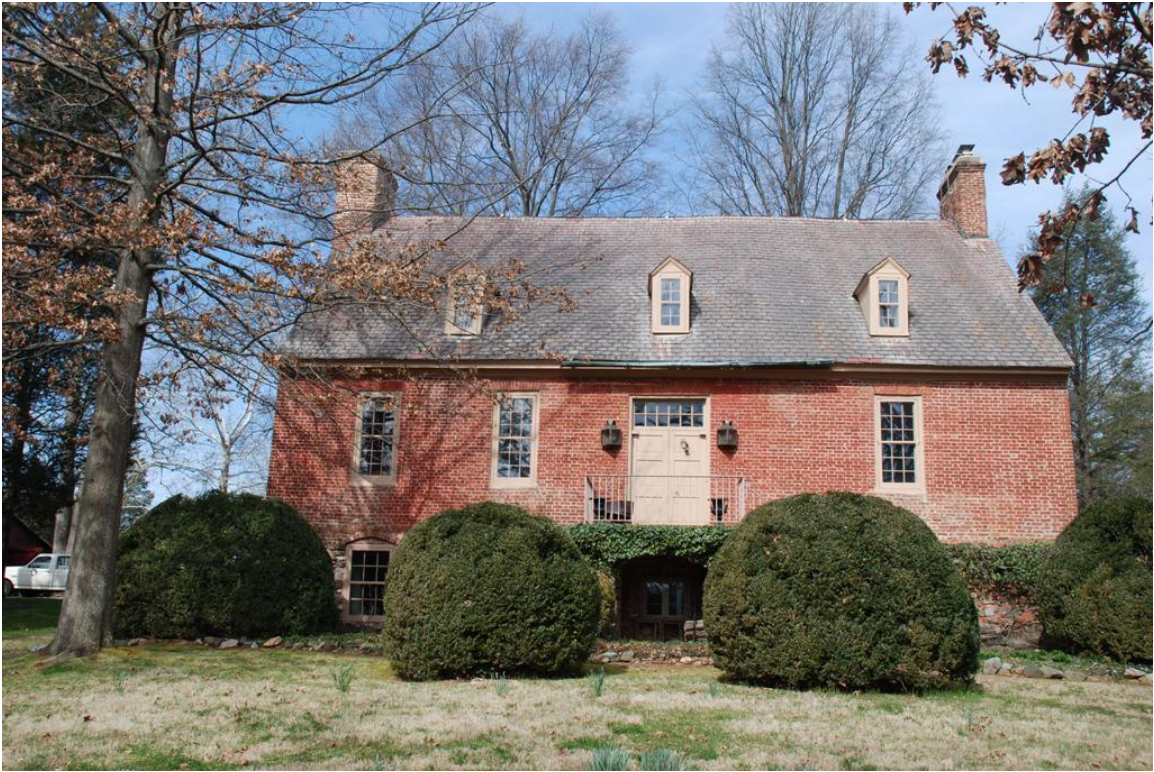
Photo 3: East elevation, Main House, Bel Air, 03/07/2012

<p>Windows/Window Frames/Shutters: Window placement is asymmetrical on the elevations. On the east elevation, there are two to the south end of the entry and one to the north. They are double-hung, nine-over-nine wooden sash windows. On the west elevation, the main level windows are also not evenly-spaced from one side of the entry to the other. The glass lights in the windows remain intact and in the appropriate configuration. The sashes are screwed shut for security purposes. No warped or split wood was observed. The dormers were added to the rear of the house in the 1940s-50s to provide more natural light to the second level.</p>
<p>Doors and Door Frames: Main entrance on the east elevation is a paired wooden door, with a rectangular twelve-light transom. The entry on the west elevation is a single six-light wood door. The interior doors are largely wood panel doors. The exception is in the basement, where the exterior doors are vertical board with Z-bracing on the interior. There is a twelve-light transom over the interior door between the Red Room and Guest Bedroom. All of the doors are properly hung and operable with historic hardware remaining throughout the property.</p>

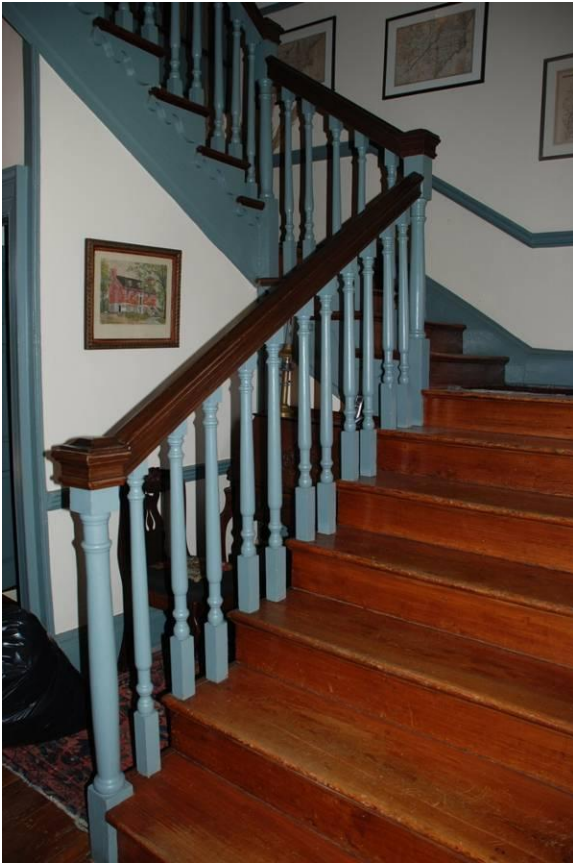
Photo 7: Main Stair, Bel Air, 03/07/2012

<p>Stairs/Staircases: Main stair between the main and second level is a wood stair with scrollwork, turned balusters and a turned newel post. There are two balusters per tread. The handrail is not believed to be the original due to inconsistencies in the design (as related to the construction period of the house), but is, nonetheless historic. Both the stair and railing appear sound, with no instabilities observed. A second stair is found underneath the main stair and provides access to the basement level. This stair is carpeted and enclosed with walls. A third stair, the historic service stair, is extremely steep and connects the dining room with the basement.</p>
<p>Mantels and Fireplaces: Wood mantels are in place at all fireplace locations. The eight fireplaces are unused, as some require liners to function safely. All remain uncapped.</p>
<p>Basement: Rough fieldstone construction with red-tinted mortar. The entire level is almost completely above ground. The flooring is brick and ceramic tile. No signs of water infiltrations were observed or reported.</p>

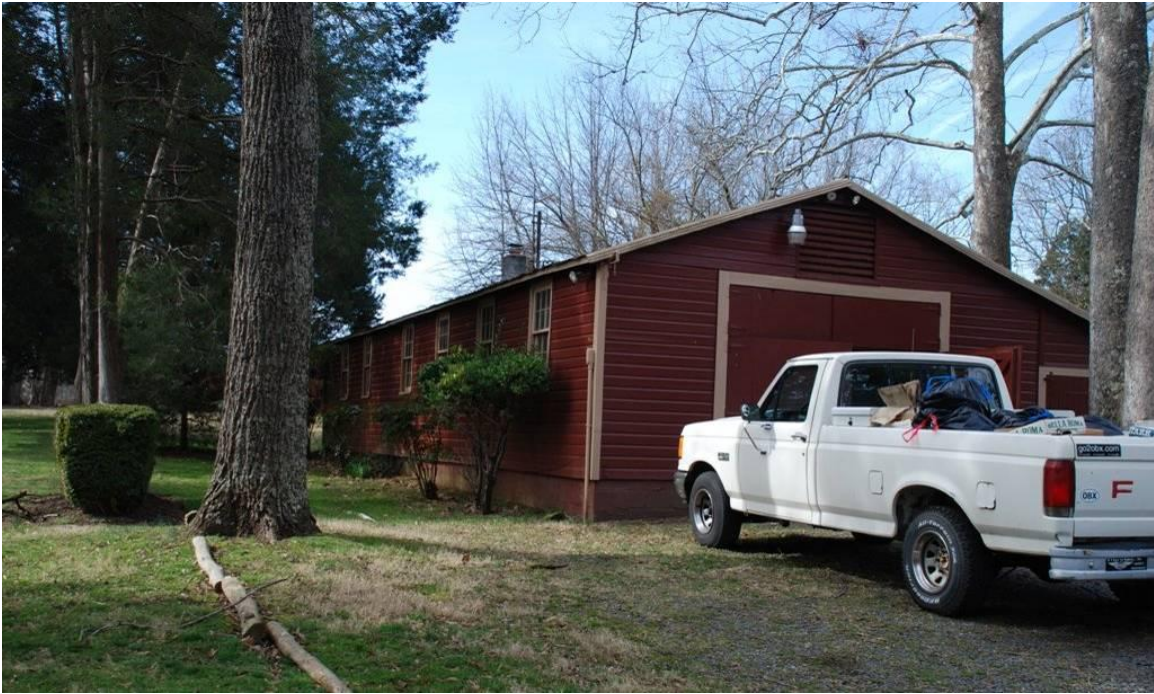
Photo 25: Garage/ storage/ office building, north elevation, Bel Air, 03/07/2012

This building is a former World War II barrack that was cut in half and relocated her, where it was placed atop its concrete block foundation. It features painted horizontal wood siding and six-over-six double-hung windows spaced at regular intervals along its length. The windows on the south side are covered in siding from the exterior, but remain in place and are visible from the interior. The building is currently used as a garage and workshop.		
Pole Barn #1 (Cattle Barn) and Pole Barn #2 (Hay Barn)		
Outbuildings both constructed of vertical wood board siding, which is painted. The roof is 5v metal corrugated. Both are in very good condition.		
Family cemetery		
The family cemetery is located north of the main house. The headstones were stealthily removed in the 1930s at the direction of the then-listing realtor. The current owner's family attempted to locate the headstones to have them reinstalled to no avail. The unmarked stones currently in place mark locations that are believed to be graves, based on ground undulations. The cemetery is still in use by the family.
