Property Condition Assessment

Sykes Realty Call Centers – Pikeville, Kentucky

55 Sykes Boulevard
Pikeville, KY 41501

RE: PROPERTY CONDITION ASSESSMENT
Sykes Realty Call Centers – Pikeville, Kentucky
55 Sykes Boulevard
Pikeville, KY 41501
Vannoy & Associates Project No. V285-001

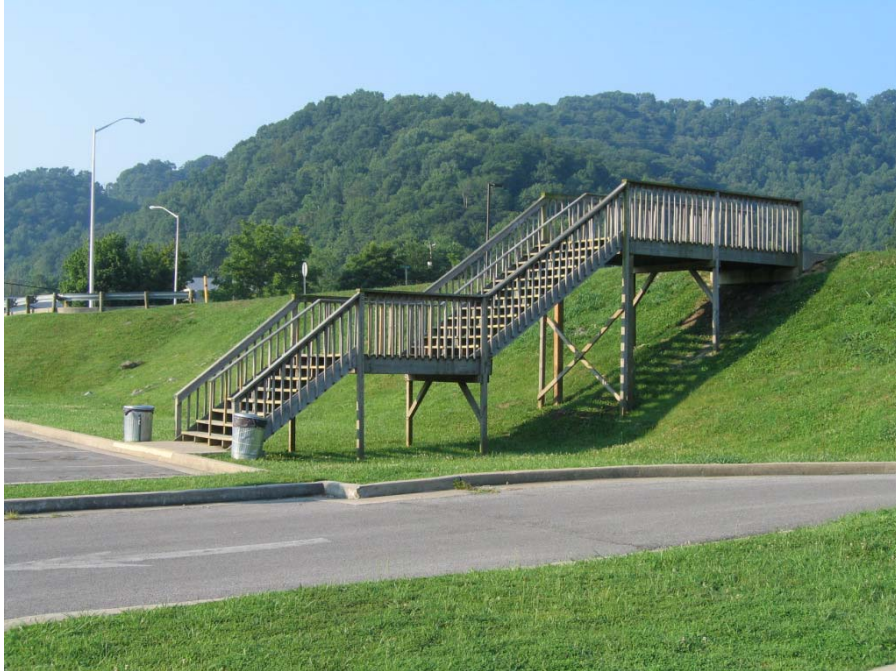
Photograph 39

38. View of deteriorated sealant for the masonry expansion joints.
39. Overall view of the wood staircase that leads from the lower parking lot to Sykes Boulevard.

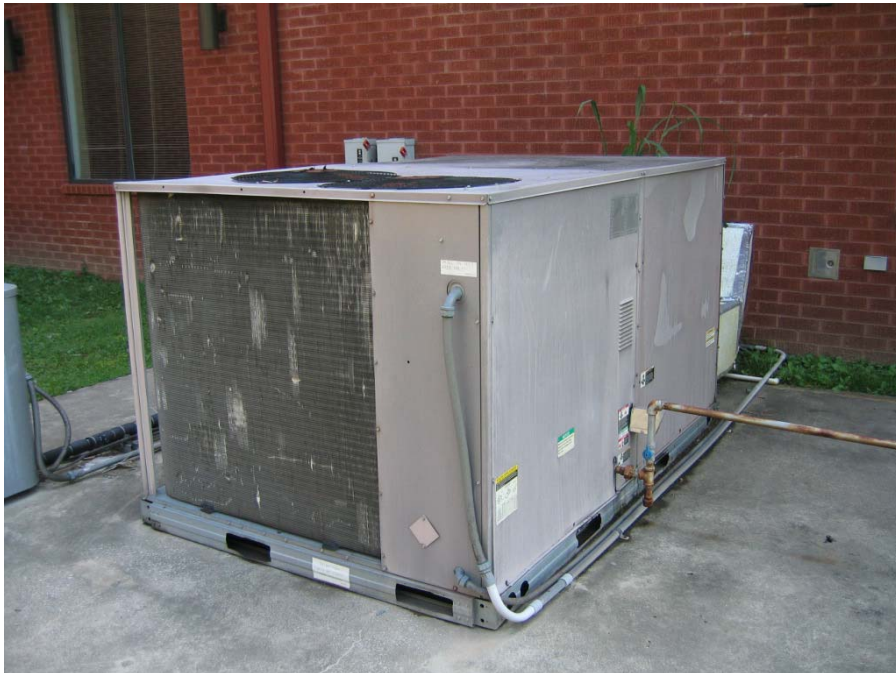
Photograph 40

40. View of a Carrier pad mounted packaged air condition unit.
41. View of a Comfort Commercial pad mounted packaged air condition unit.
42. View of the ground mounted Liebert condensing unit.
