Daybreak Home Inspections, Inc.  
534 Derstine Avenue  
Lansdale, Pennsylvania 19446  
Joe Kovatch  
ASHI Certified Inspector #207821

# Building Inspection

2128 N Broad Street  
Lansdale, Pennsylvania 19446

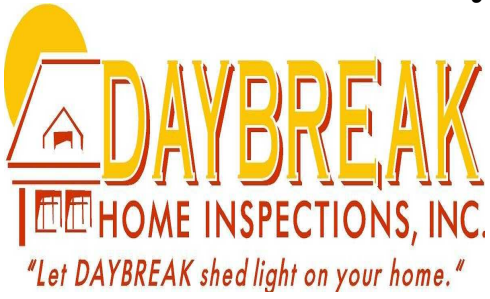
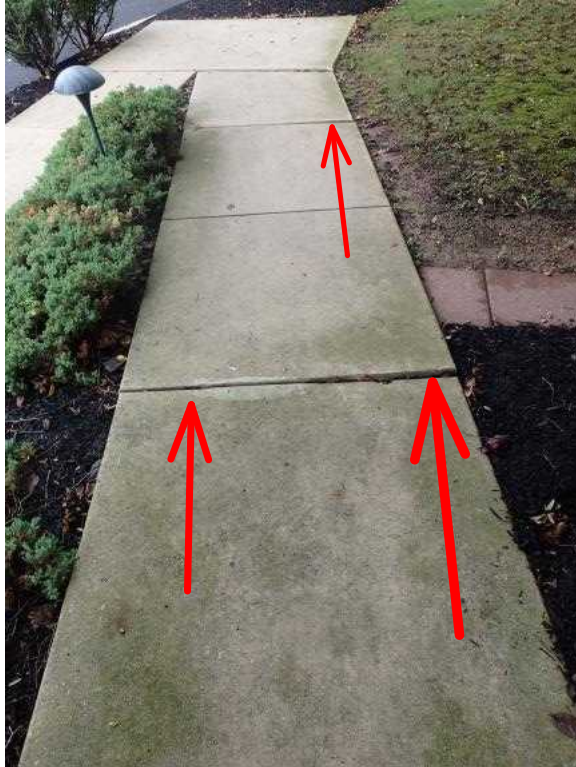
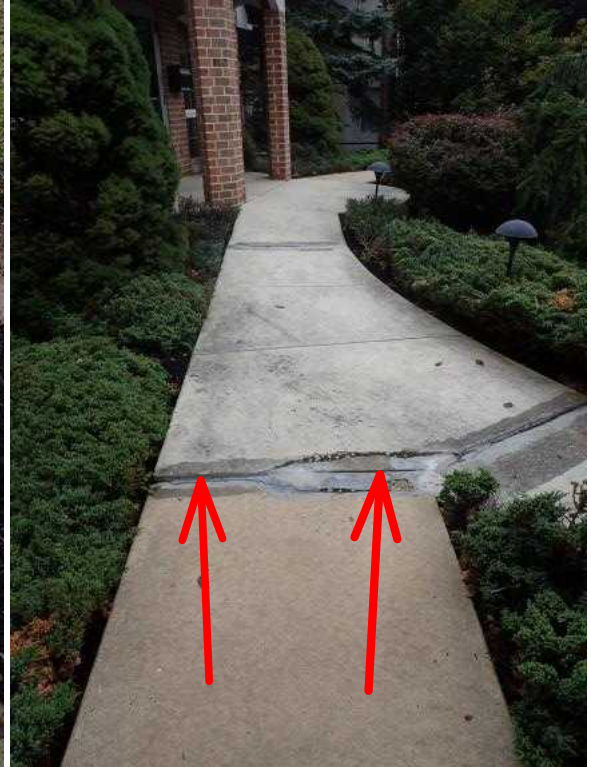
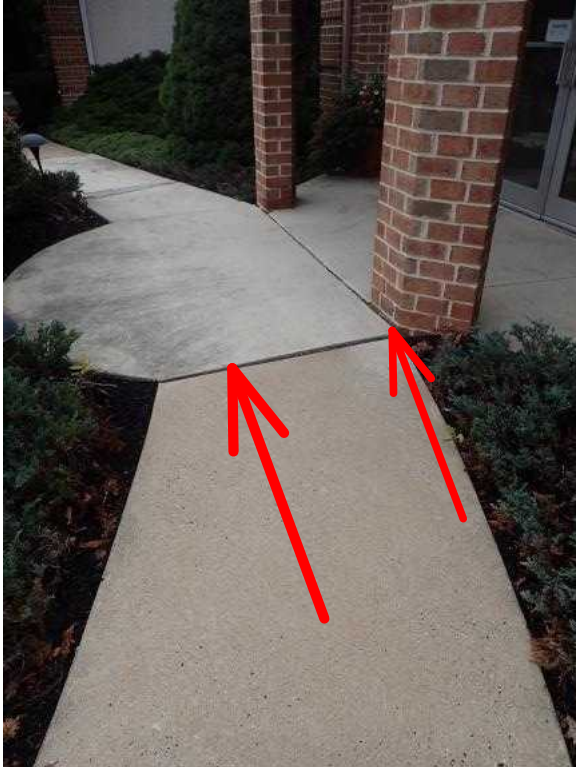
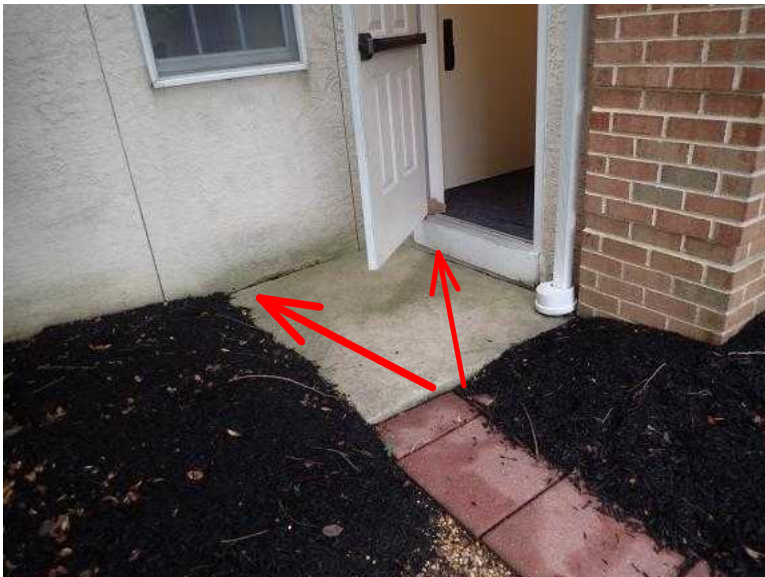
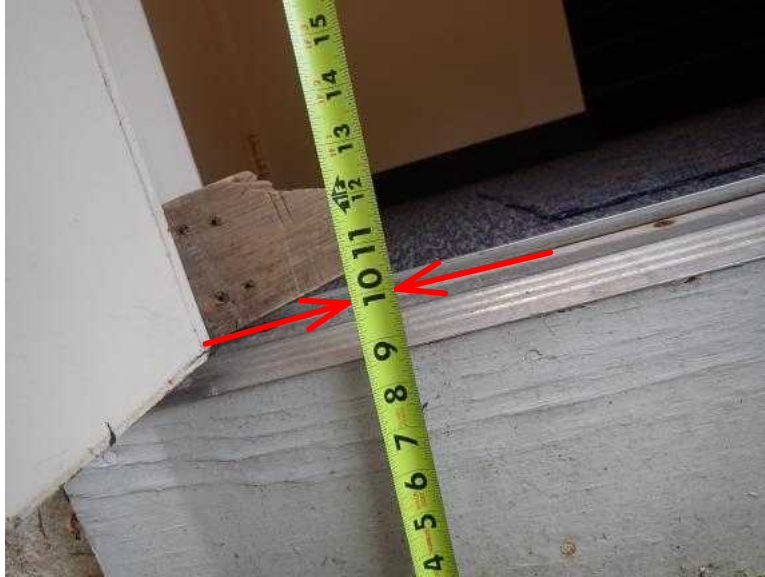
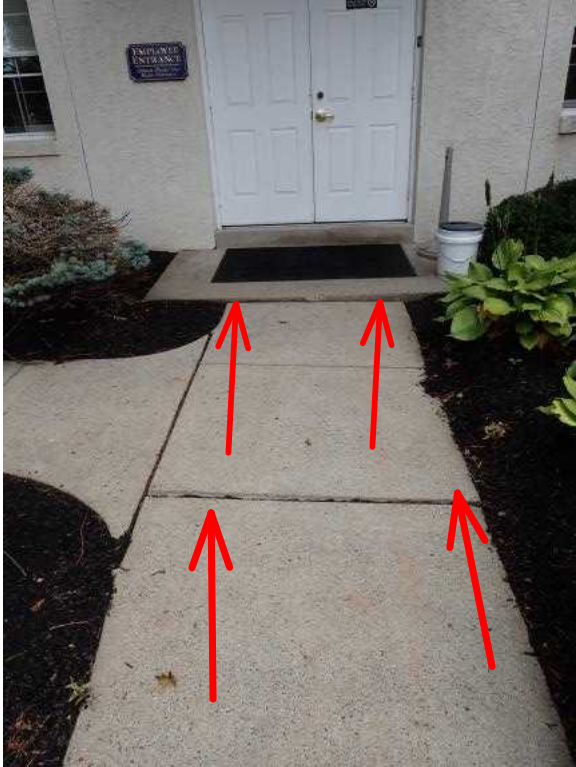
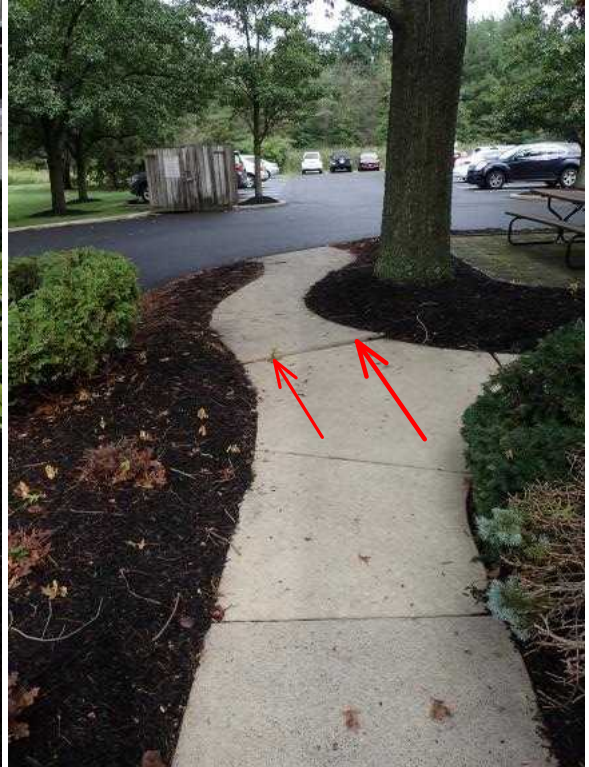
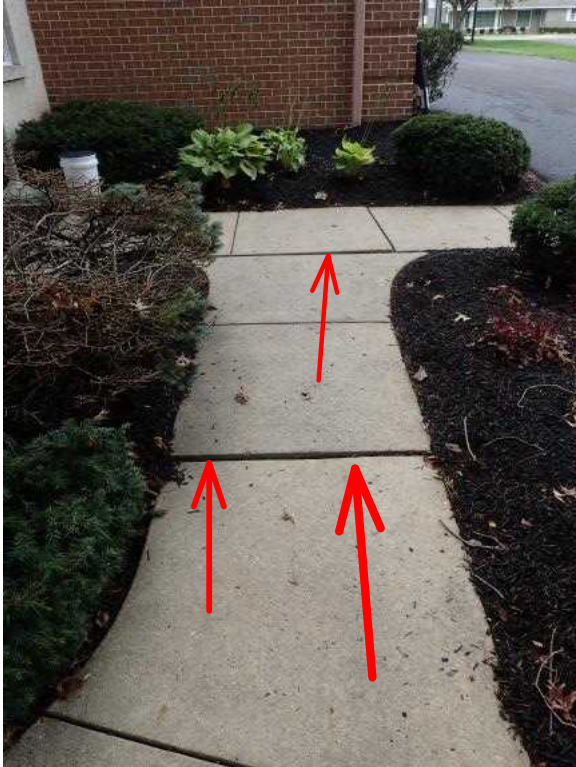
1.      Walks: Concrete: **Walk has settled throughout leaving a trip hazard and step into right rear side door too high, recommend repair to reduce risk of injury.**

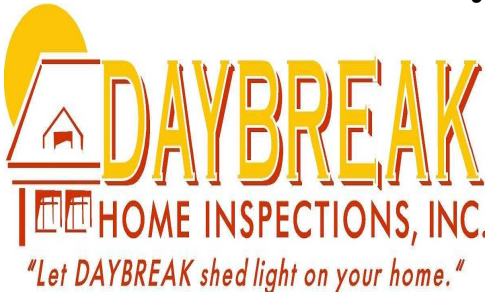
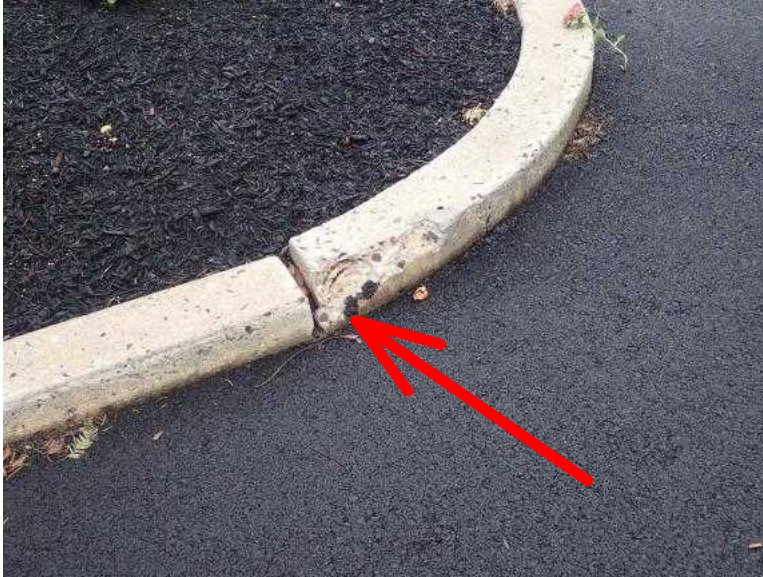
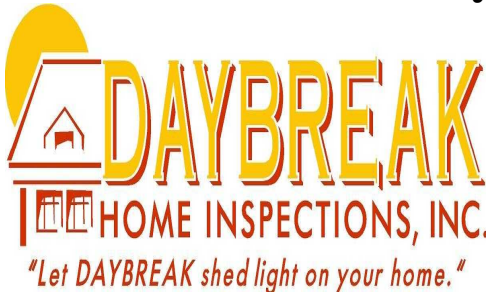
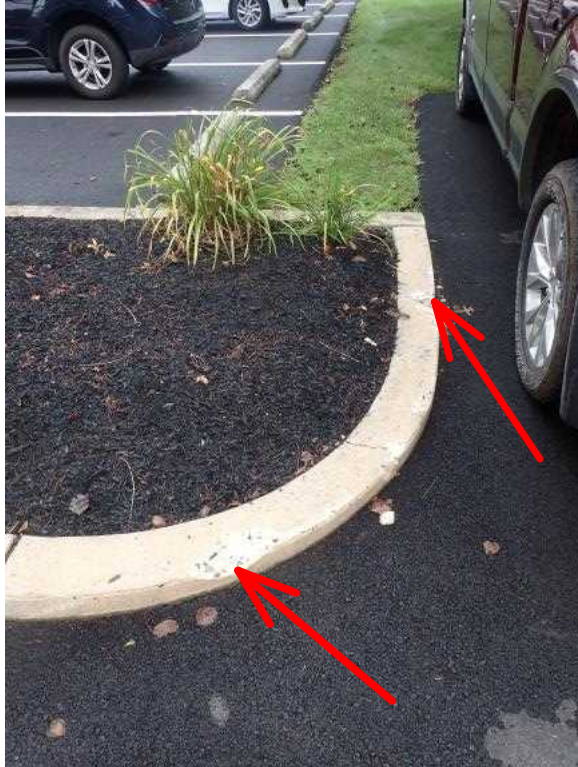
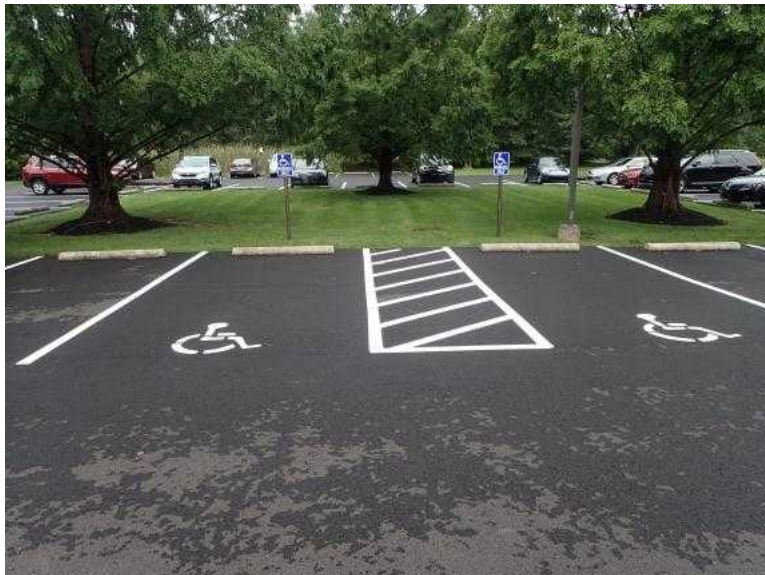
- 4.      Basement Stairwell: Concrete
- 5.      Exterior Surface Drain: Surface drain
- 6.      Vegetation: Shrubs/Trees
- 7.      Grading: Minor slope: **Improper soil slope towards foundation, recommend the addition of fill dirt below the mulch to improve grade**
- 8.      Driveway: Asphalt
- 9.      Parking Lot: Asphalt: **Approximately 64 parking spaces, 2 handicap. Damaged curbing from impact, recommend replacement of damaged curbing.**

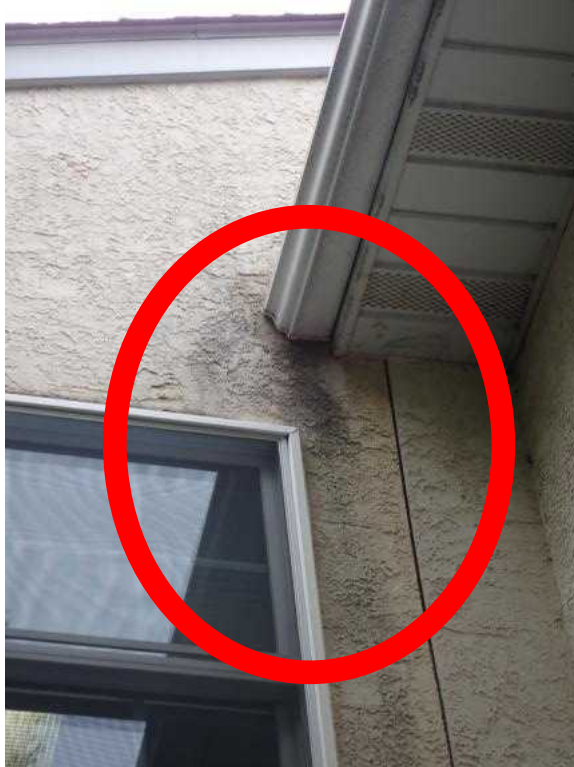
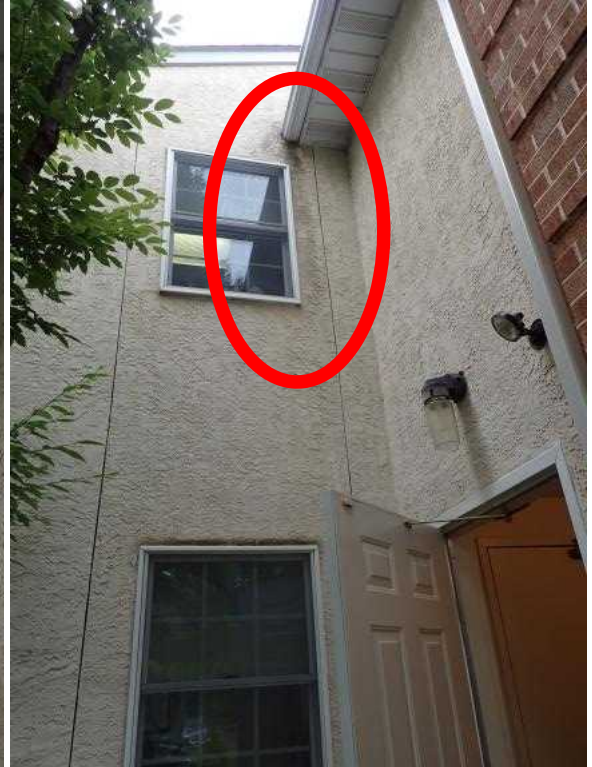
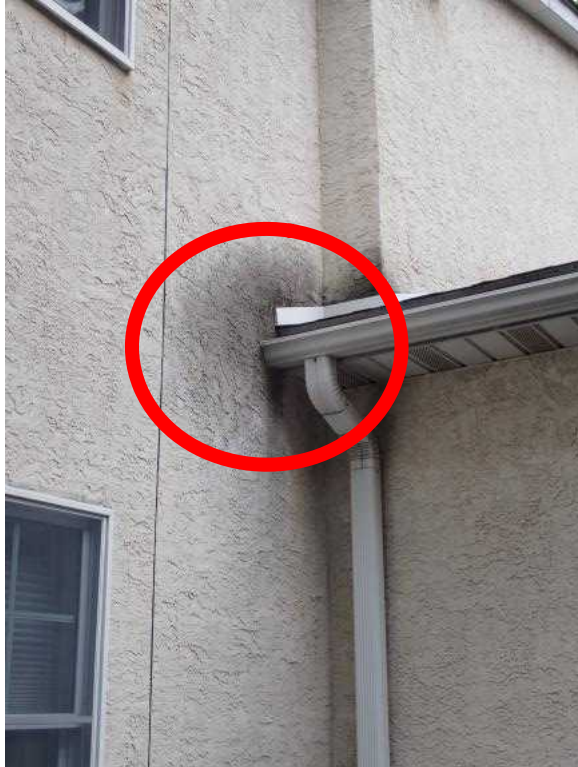
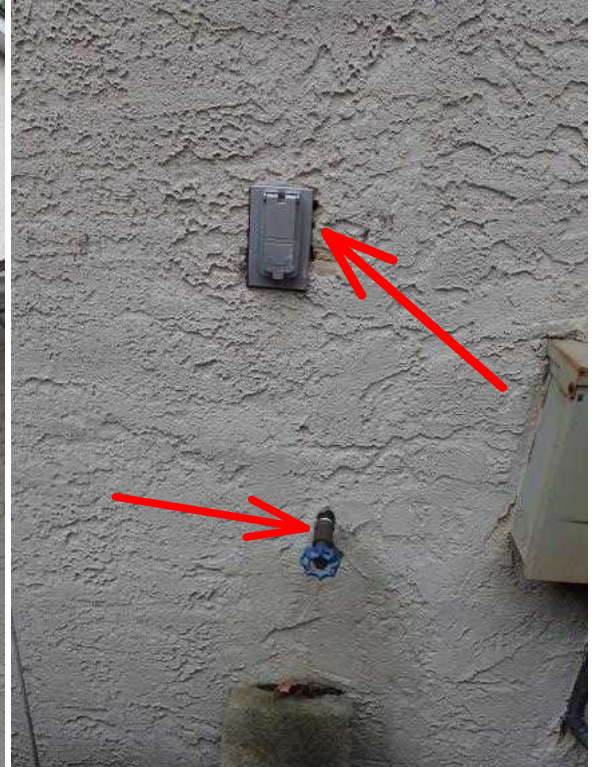
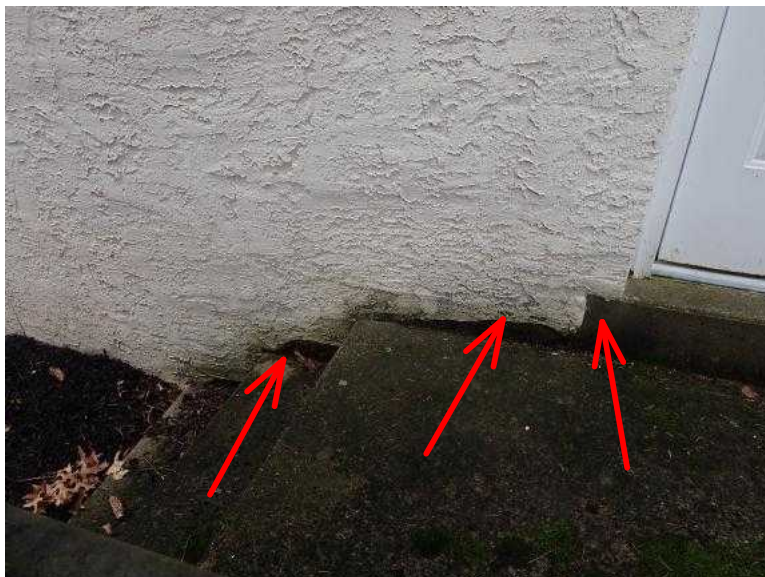
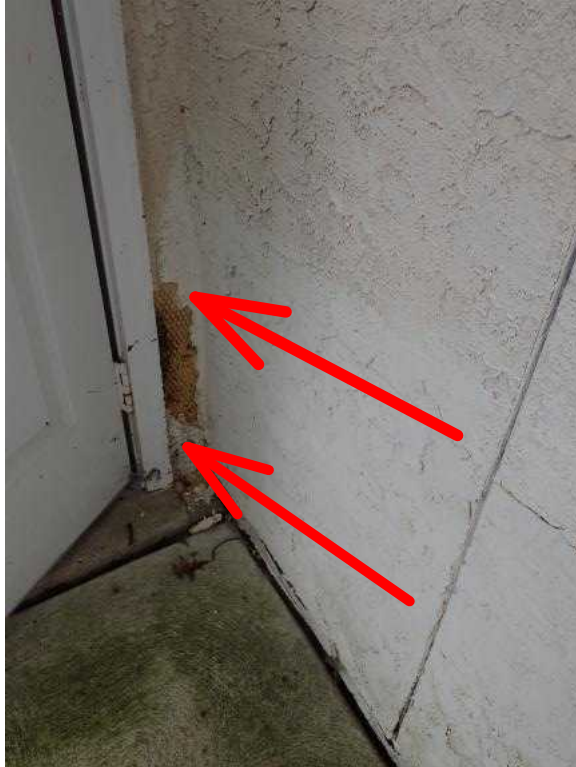
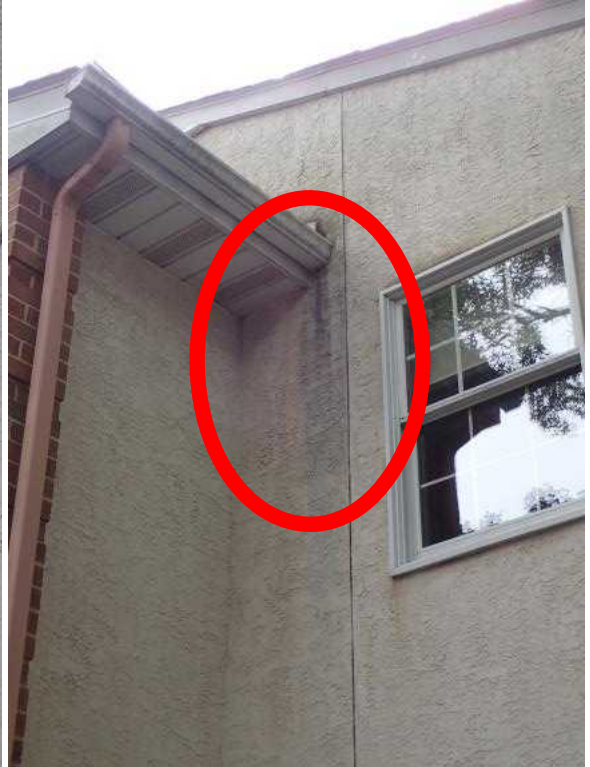
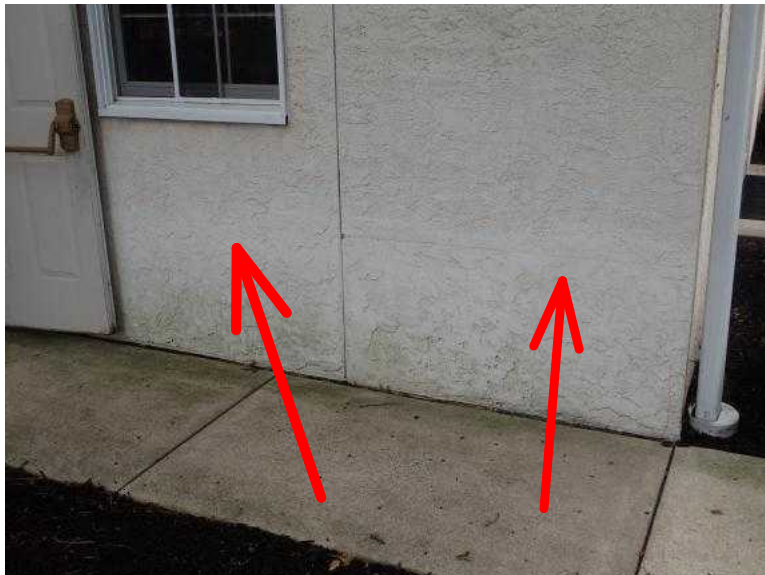
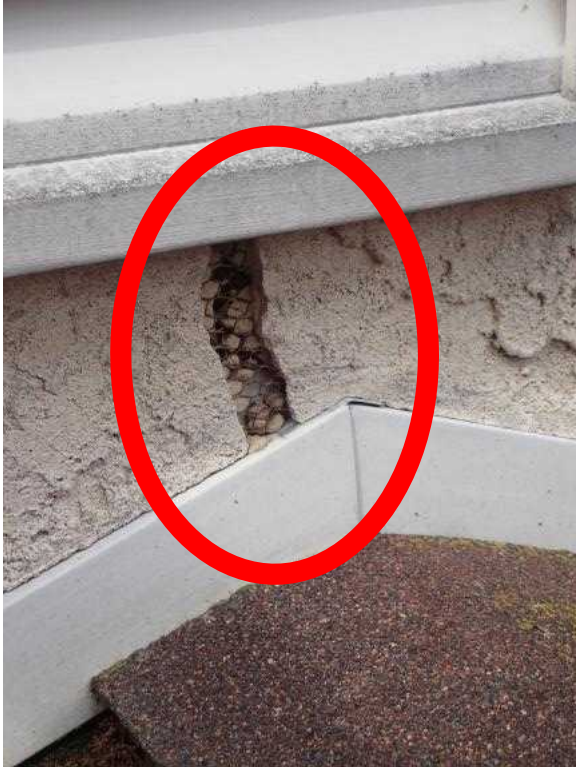
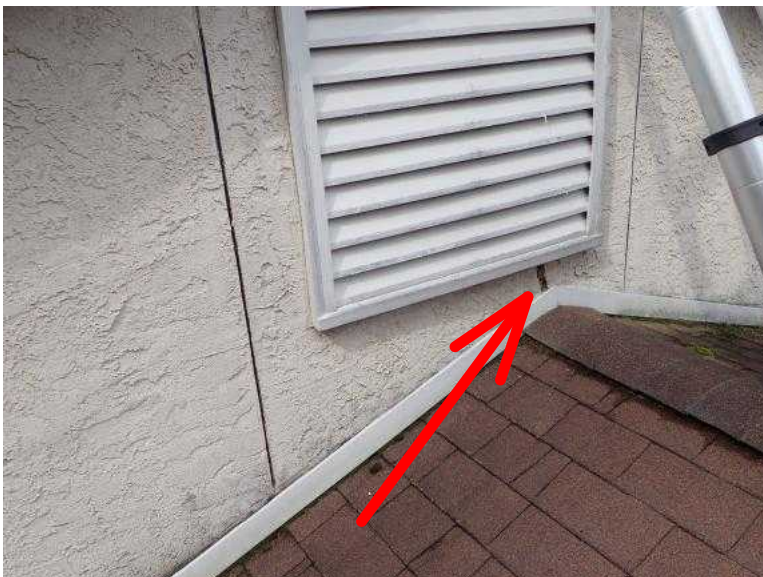
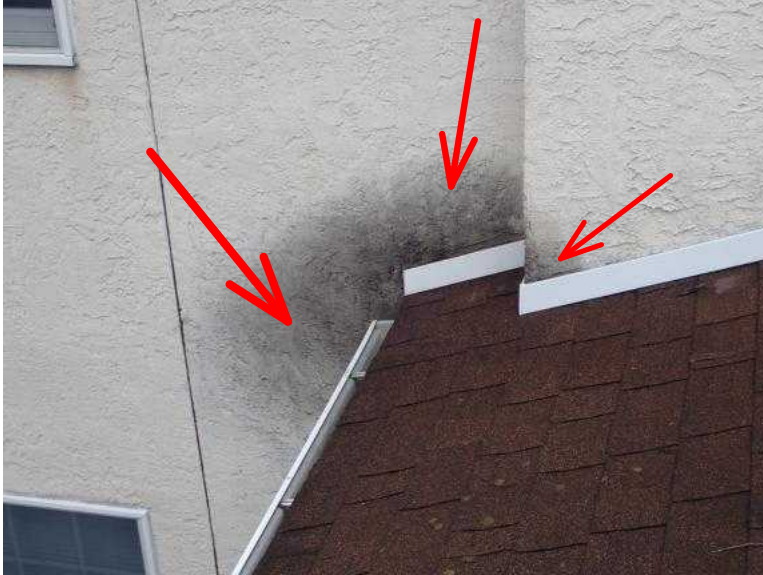
- 1.      Type: Brick, Stucco: **Gaps not properly sealed at the penetrations in the stucco, gaps, loose and missing stucco in areas. Stained, recommend an intrusive stucco test to determine if there is a moisture problem in the substrate prior to repairs.**  
**Cost estimate is for testing only.**

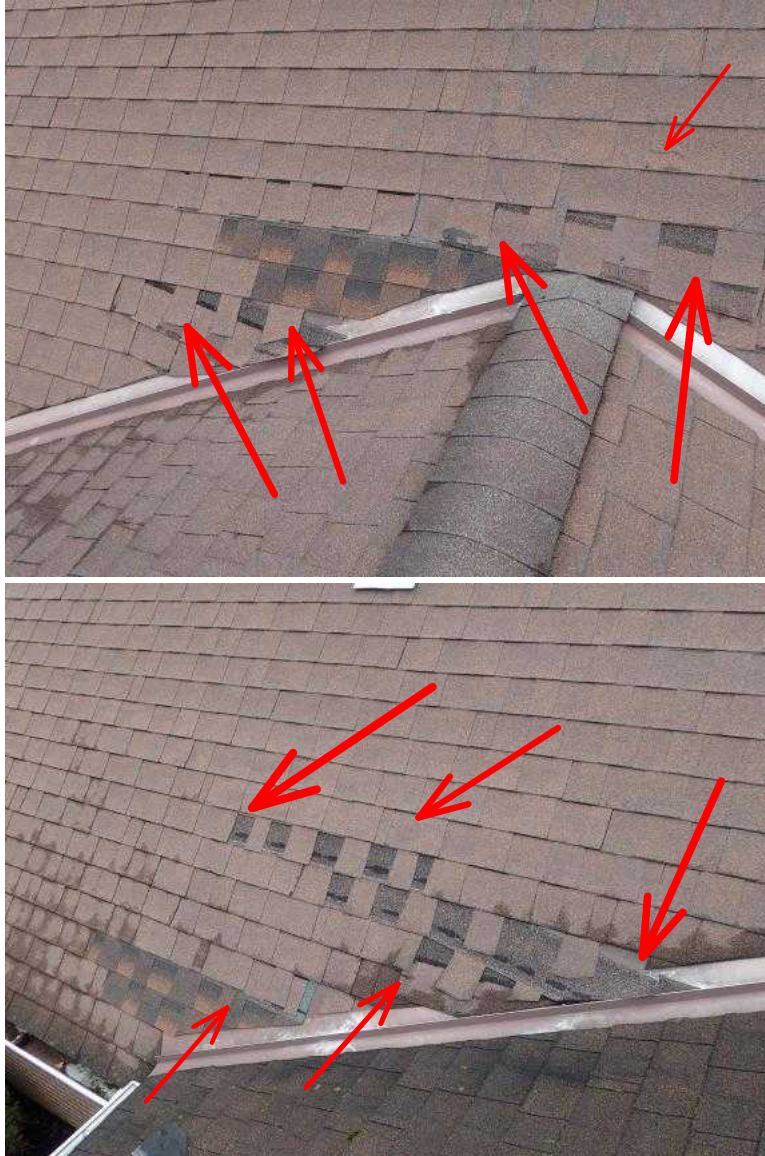
1. Method of Inspection: On roof
2.  Unable to Inspect: 10%
3.  Material: Asphalt shingle: **Roof existing beyond design life, Roof shows signs of deterioration with brittle, cracked and missing shingles throughout. Fiberglass showing throughout, recommend replacement to reduce the risk of water damage.**

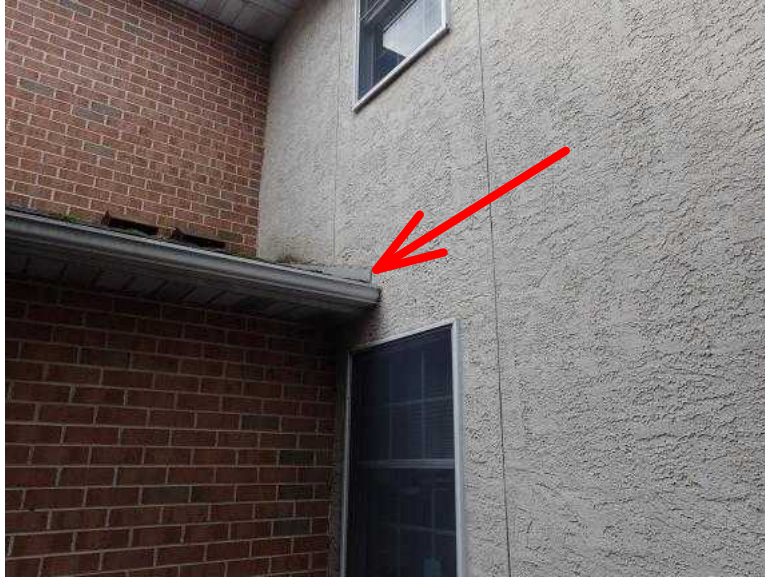
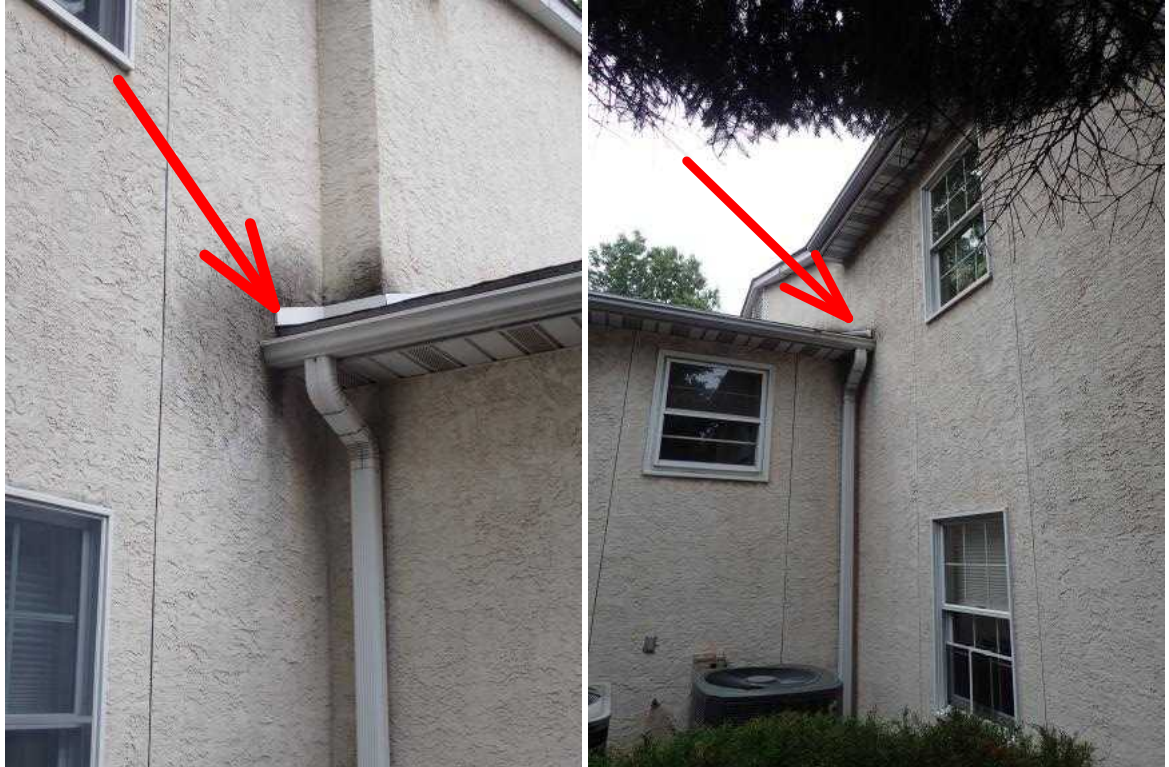
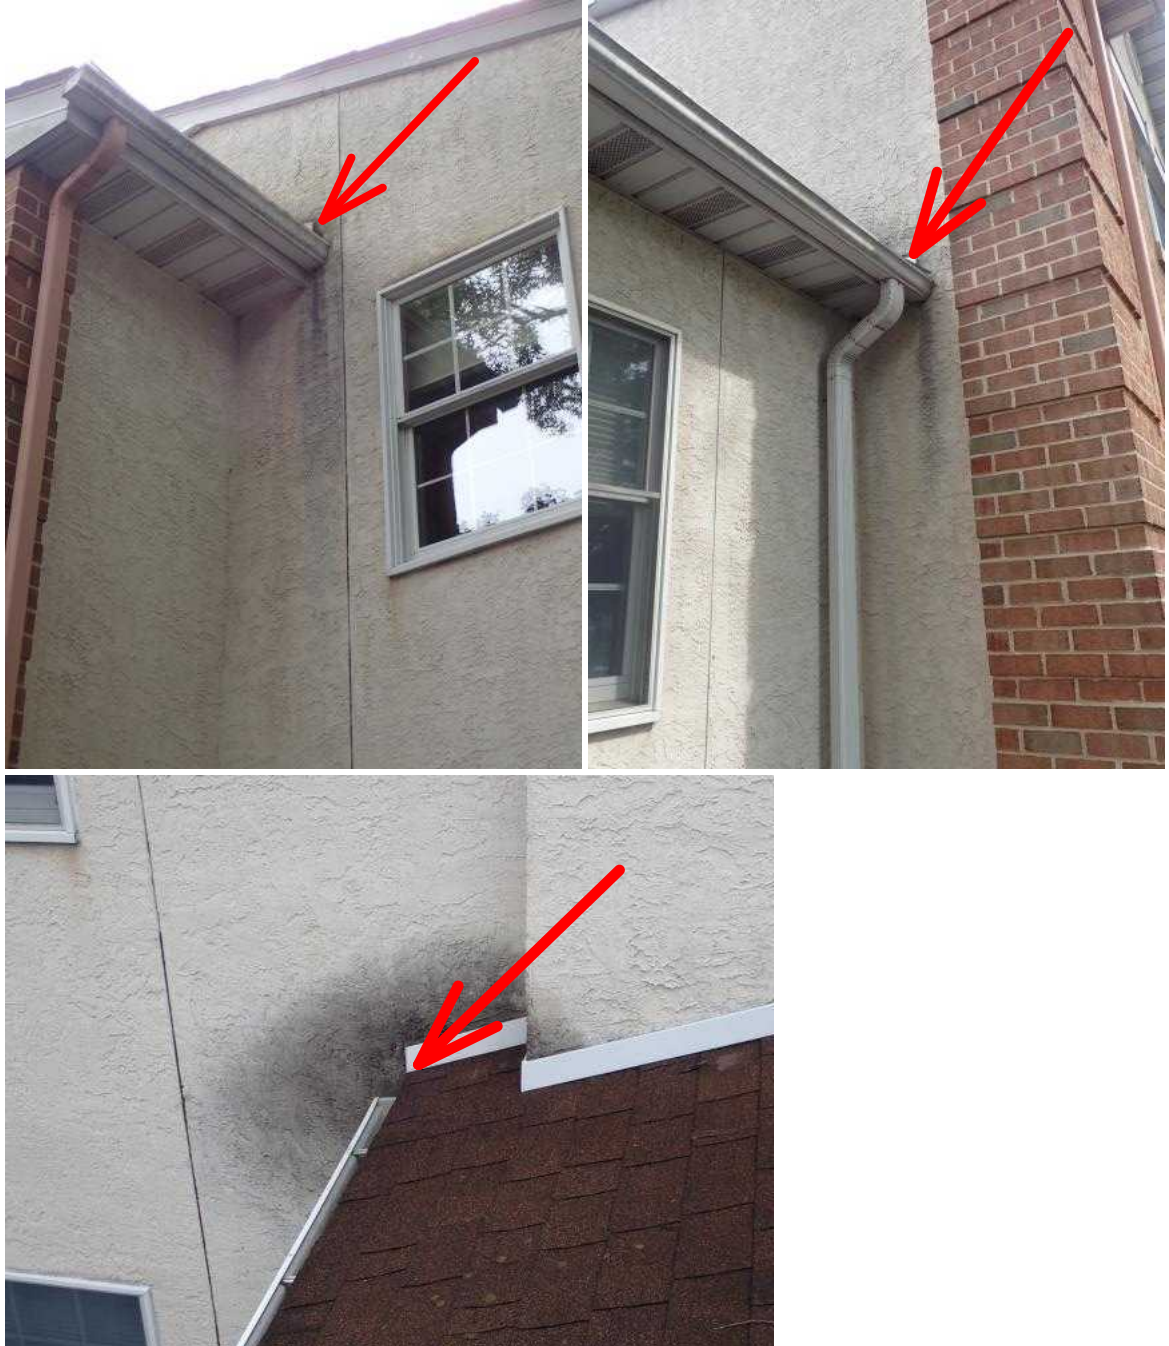
Flashing: (continued)

- 4. Type: Gable
- 5. Approx Age: 23 Years
- 6.      Flashing: Aluminum: **Missing diverter flashing where the roof ends and the wall continues, recommend installation to reduce risk of water damage.**

Flashing: Missing diverter flashing where the roof ends and the wall continues, recommend installation to reduce risk of water damage.

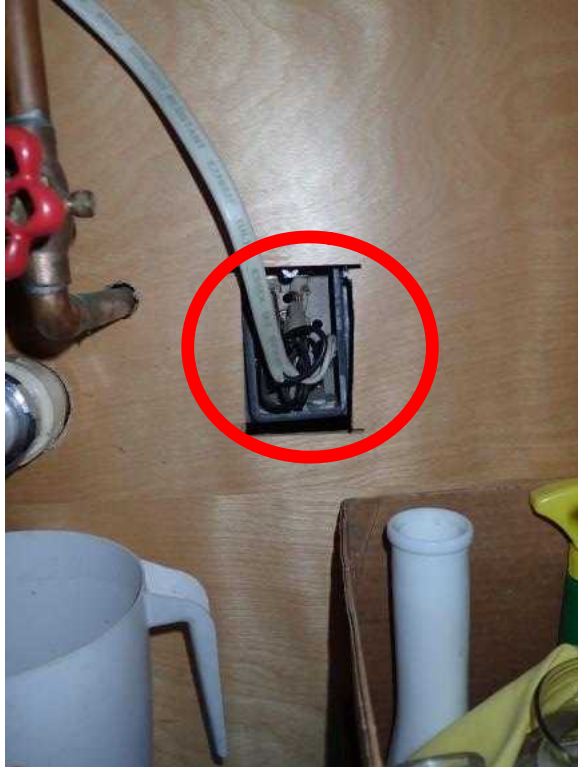
Electrical: (continued)

1.      Sink: Stainless Steel
2.      Electrical: 120 VAC: **Non-GFCI outlets at sink and missing a cover plate under the sink, recommend installation to reduce risk of shock.**

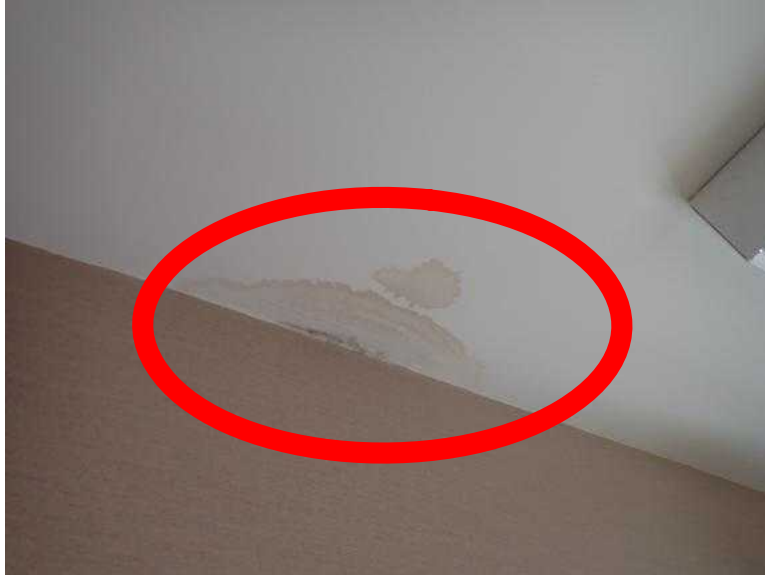
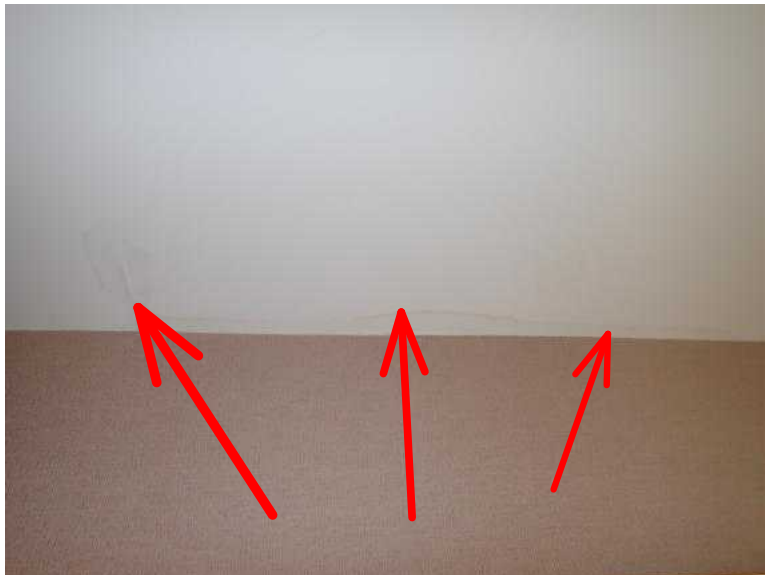
Ceiling: (continued)

1.      Ceiling: Paint: Water stains present in left front office, Clemens office and left side office with active leaks, recommend repair to damaged areas.

<u>Plumbing</u>		
Water Heater Operation: Corrosion from dissimilar metals at the top of unit, recommend repair.	\$ 150	\$ 200
<u>Office Space</u>		
Ceiling: Water stains present in left front office, Clemens office and left side office with active leaks, recommend repair to damaged areas.	\$ 500	\$ 800
